The Engine House and Wheel House at Brookwood Mine, Buckfastleigh, Devon

a survey of the standing structures

December 2006
(minor revisions April 2012)

Dr Phil Newman MIFA, FSA

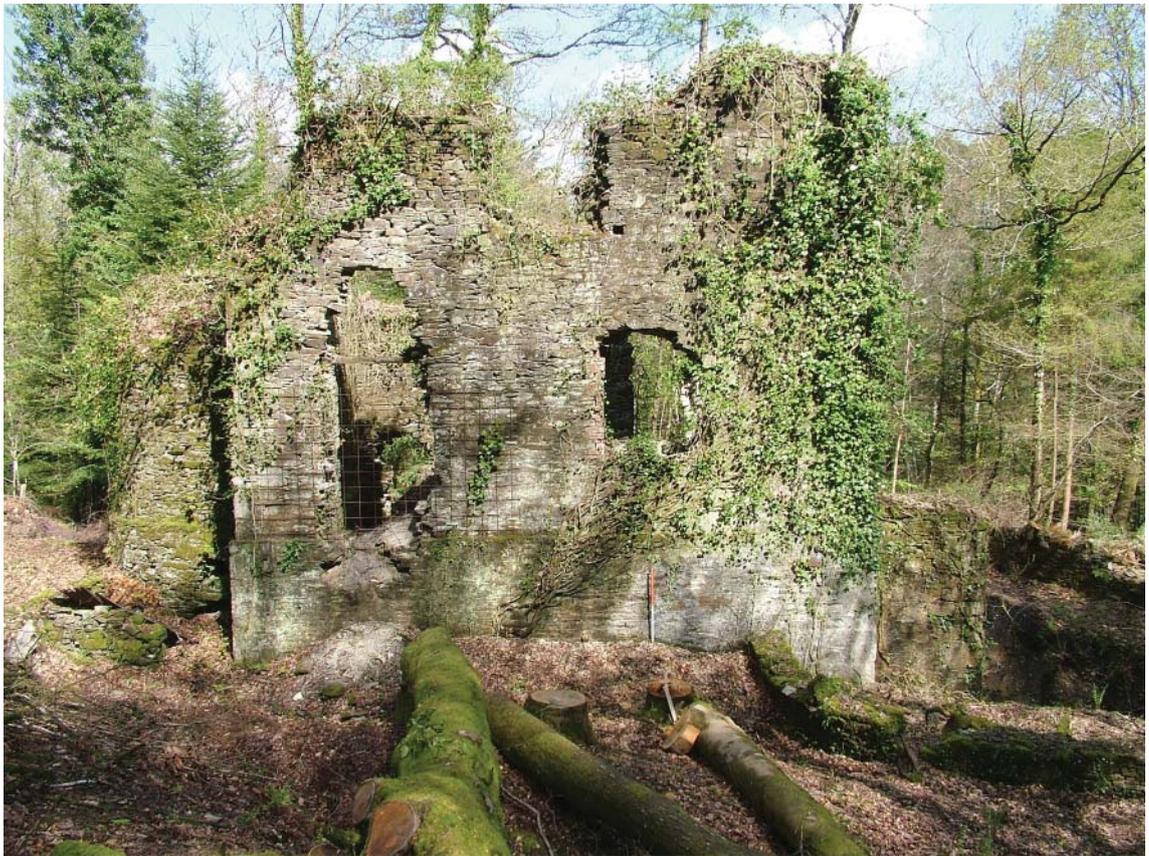
Figure 1. The southern wing wall showing entrance and window openings.

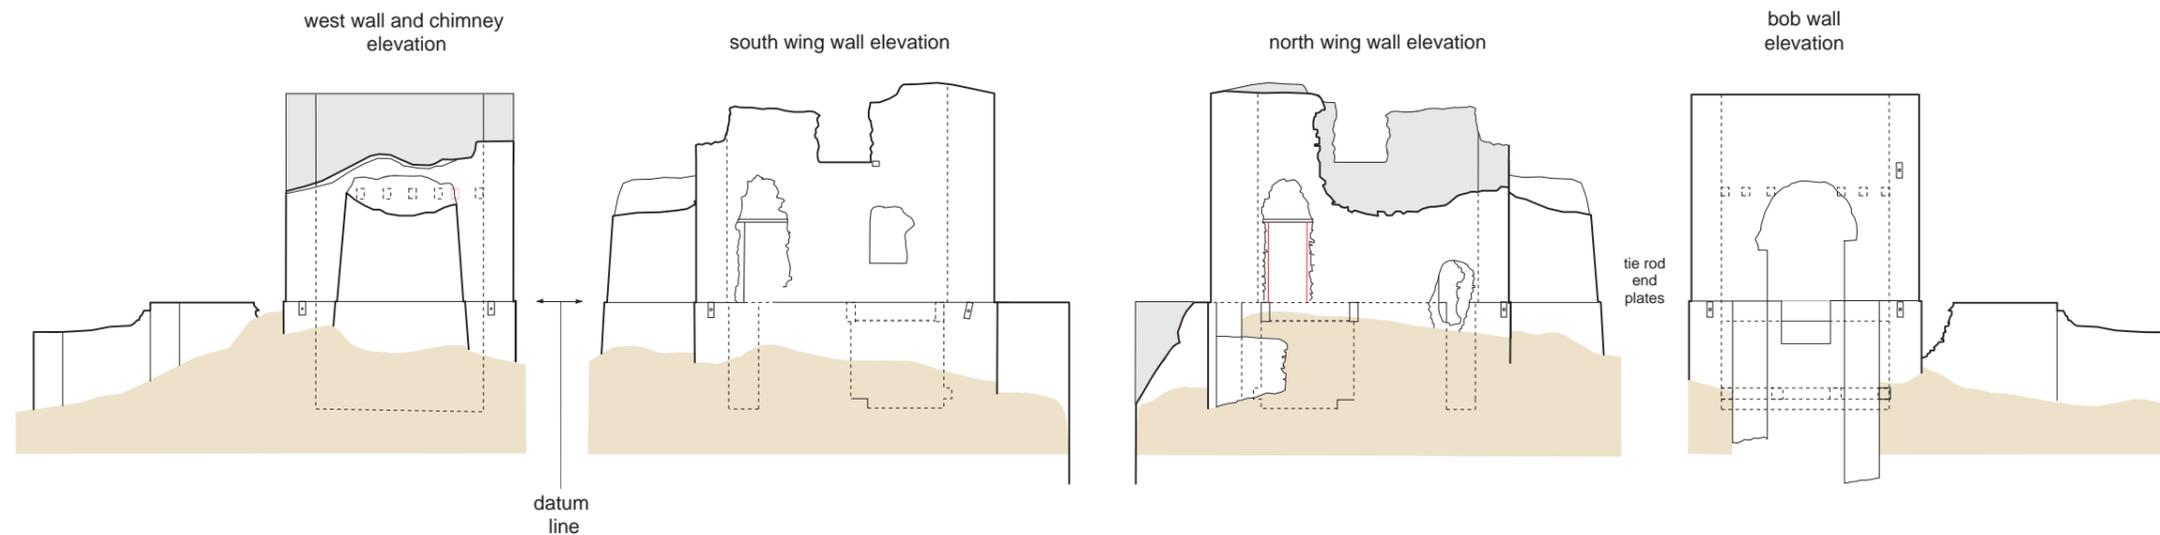
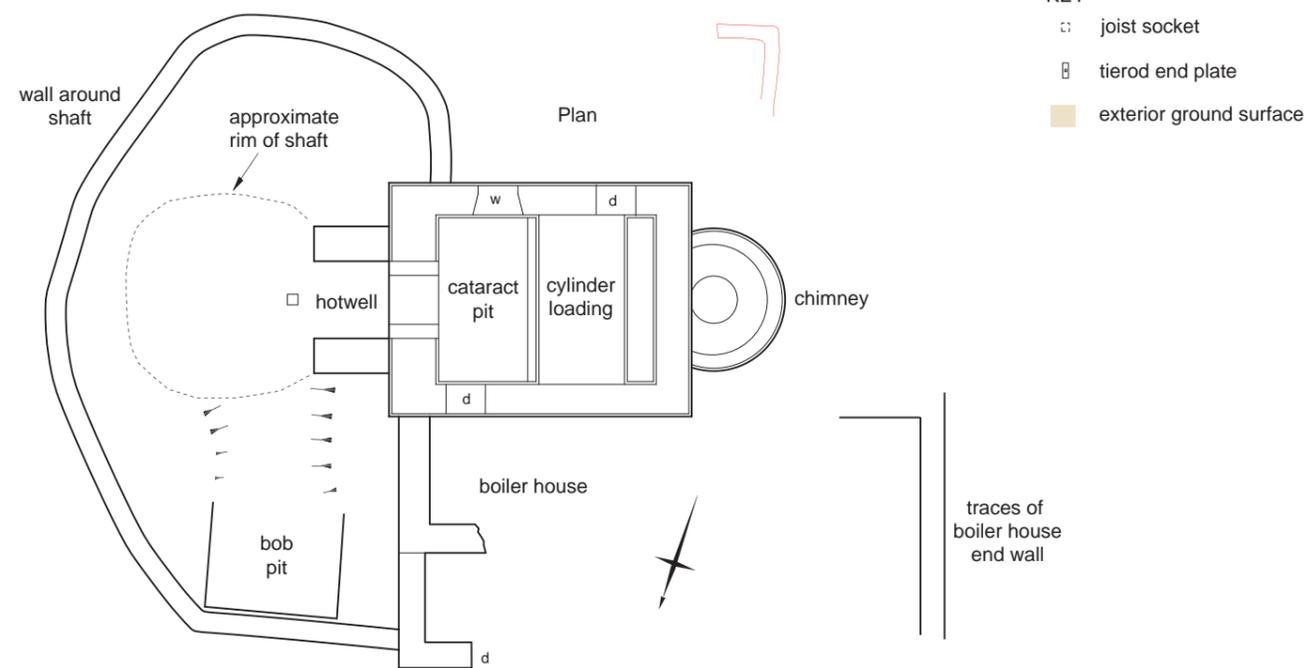
Figure. 2

**Brookwood Mine
Pumping Engine House**
Condition of standing walls

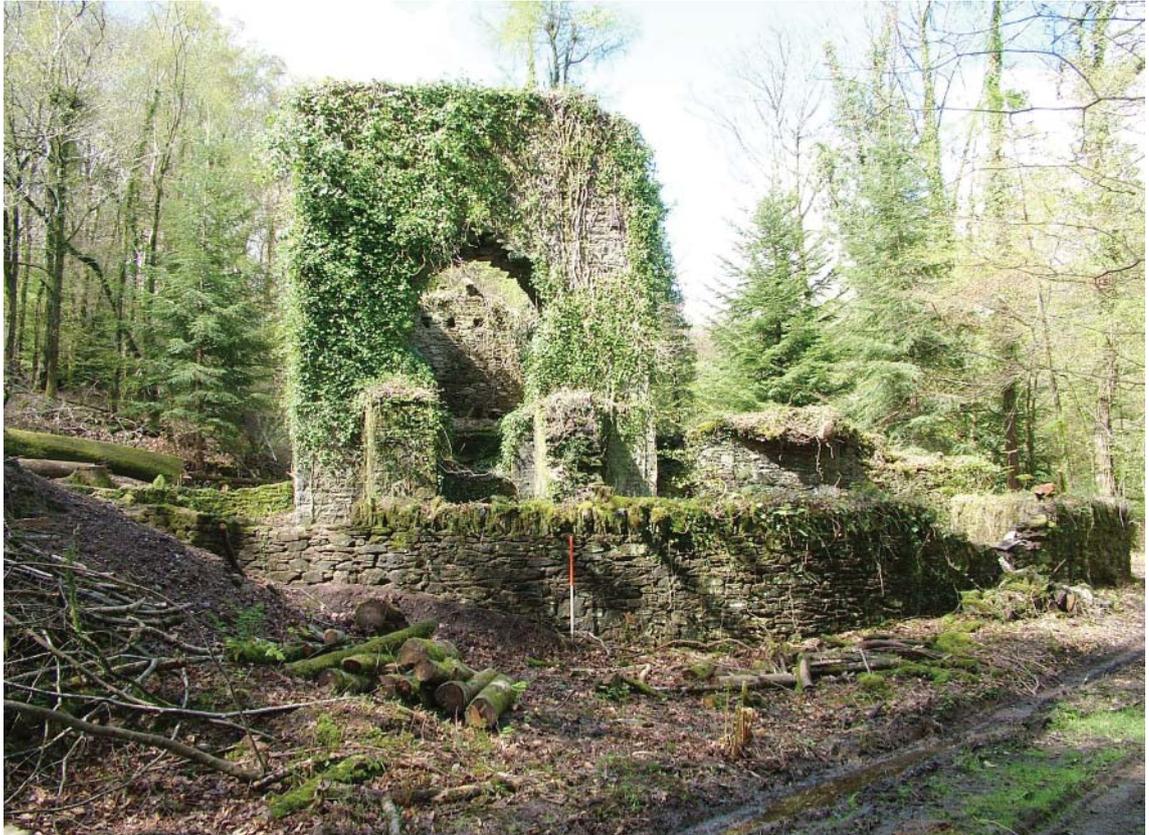
Figure 3. View from the east showing the bob wall.

Of all the surviving walls, only the bob wall, which supported the beam or 'bob', on the eastern end adjacent to the shaft, appears to be standing to its original height of 5.8m. However, this is by no means certain, as due to its inaccessibility and ivy covering, it was not possible to inspect the upper section of stonework. Nevertheless, the top surface of

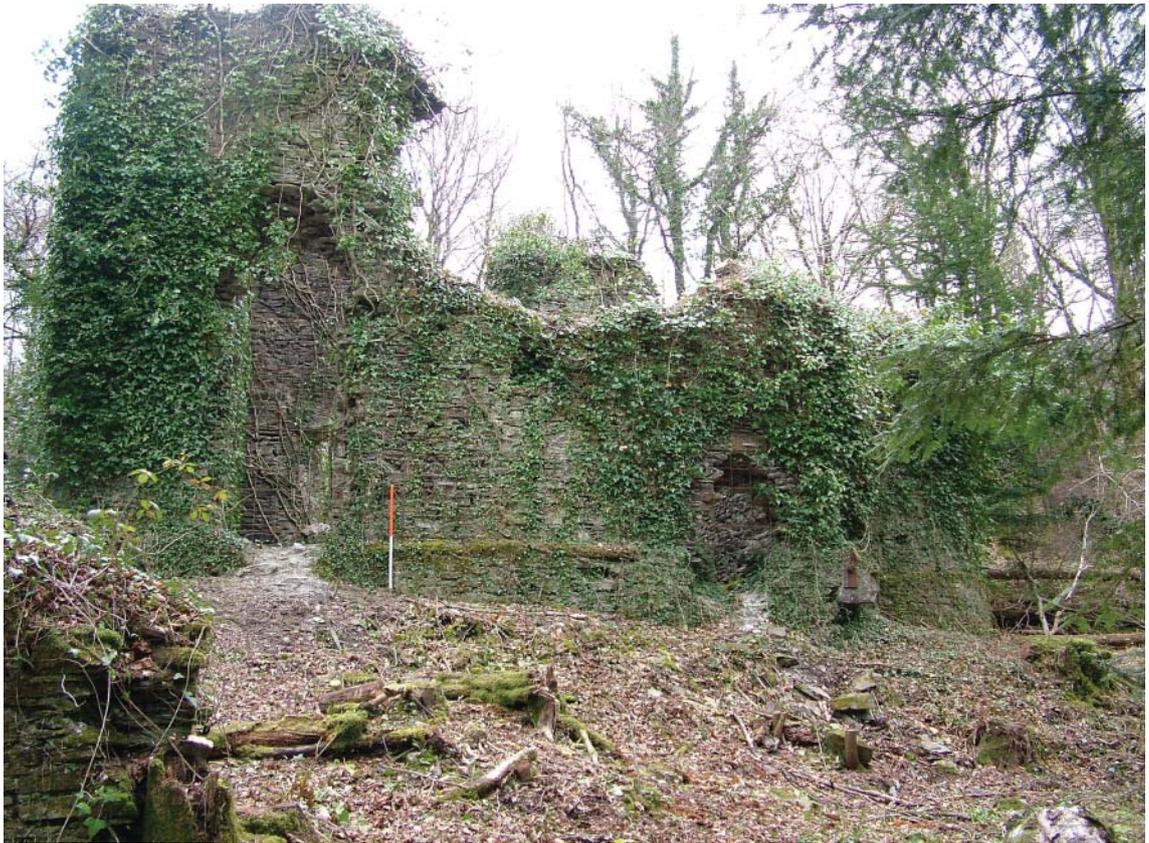
Figure 4. The northern wing wall showing the entrance on the left and the probable steam inlet opening on the right. The ruined boiler house is in foreground (January 2005)

An opening in the base of the north wall, near the west corner, of the engine house, is likely to be the inlet for the steam pipe from the boilers to the cylinder. The opening straddles the plinth and the main wall and has been much enlarged as a result of stone falling away.

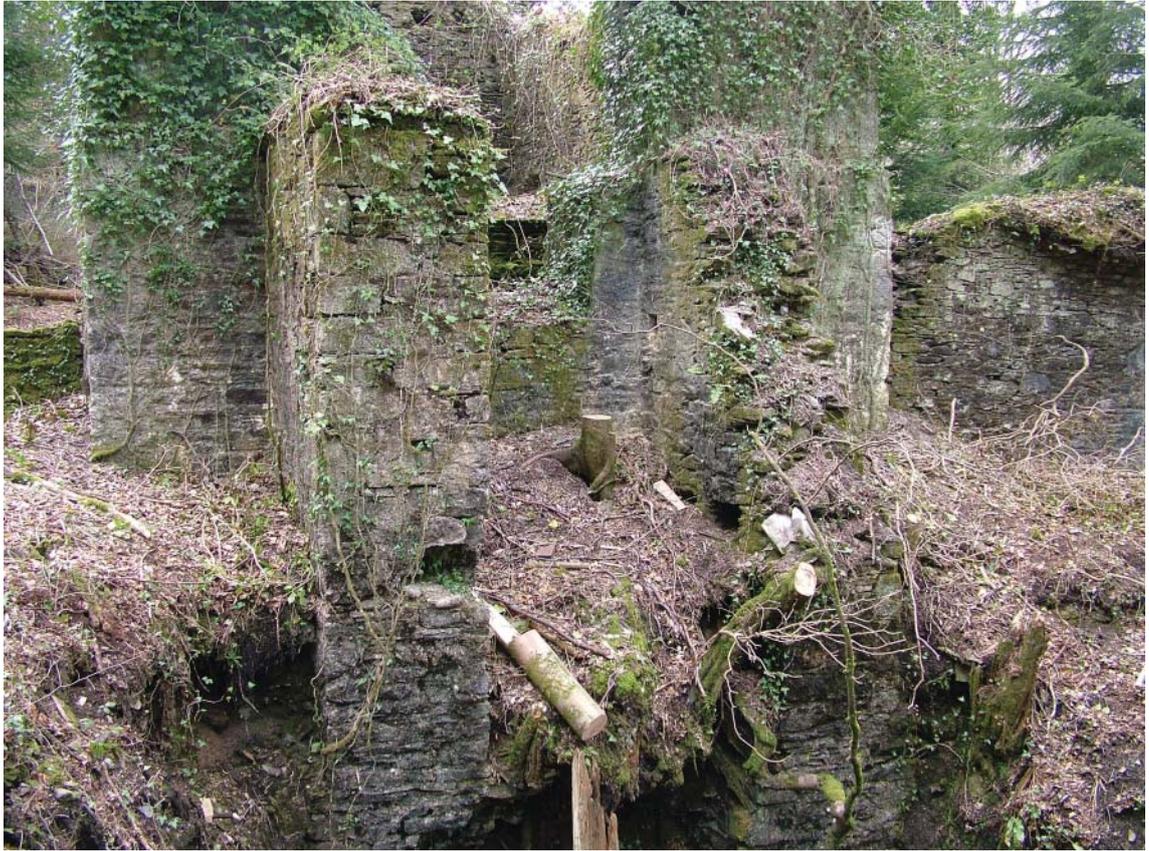
On the eastern exterior of the bob wall, directly adjacent to the shaft, are the two protruding walls of the hotwell, between which the condenser and condenser cistern would have been contained. The top of these walls is level with the top of the plinth and they extend 2m towards the shaft. The distance between them is 2.18m. The original depth of the hotwell cannot be determined as it is now full of rubble, but the front edges of the walls extend down into the shaft. The southern of the two sides is intact but for the odd absent stone, though that on the north side is missing a substantial section of masonry.

Figure 5. The hot well and top of shaft.

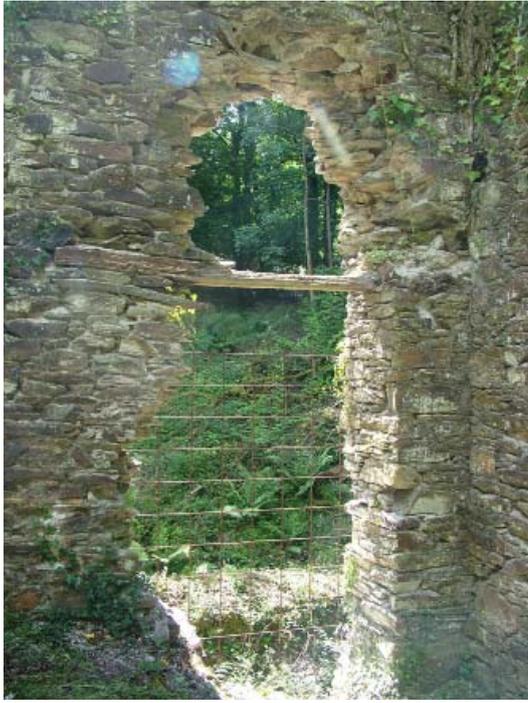
The building has two door openings, one on each of the wing walls, set near opposite corners, with the thresholds sitting on the top of the plinth. The current openings suggest the doors were approximately 0.6m wide by 2.2m high, with timber lintels defining the tops; that on the south side survives in place. The doorways were once lined with brick though this is now missing, likely to have been robbed. Exterior steps, probably built from timber, would have been needed to enter the building. Two window openings survive in the south wall. That on the ground floor, set towards the eastern end, has angled reveals with brickwork lining surviving in places. Vestiges of a recess in the wall indicate the position of a now missing timber lintel, although some masonry from above the window has fallen away. The window opening measures approximately 1m wide by 1.1m high. A more ruinous opening survives on the first floor, set centrally into the wall. The top of the opening is missing but it was probably of similar dimensions to that below it. The window configuration on the north wing wall is uncertain although none were present on the ground floor. A centrally positioned window on the first floor, similar to that on the south side is likely, and it is almost certain that at least one window, existed on the upper storey, probably also positioned centrally.

Figure 6. Interior view of the southern doorway, with lintel in situ.

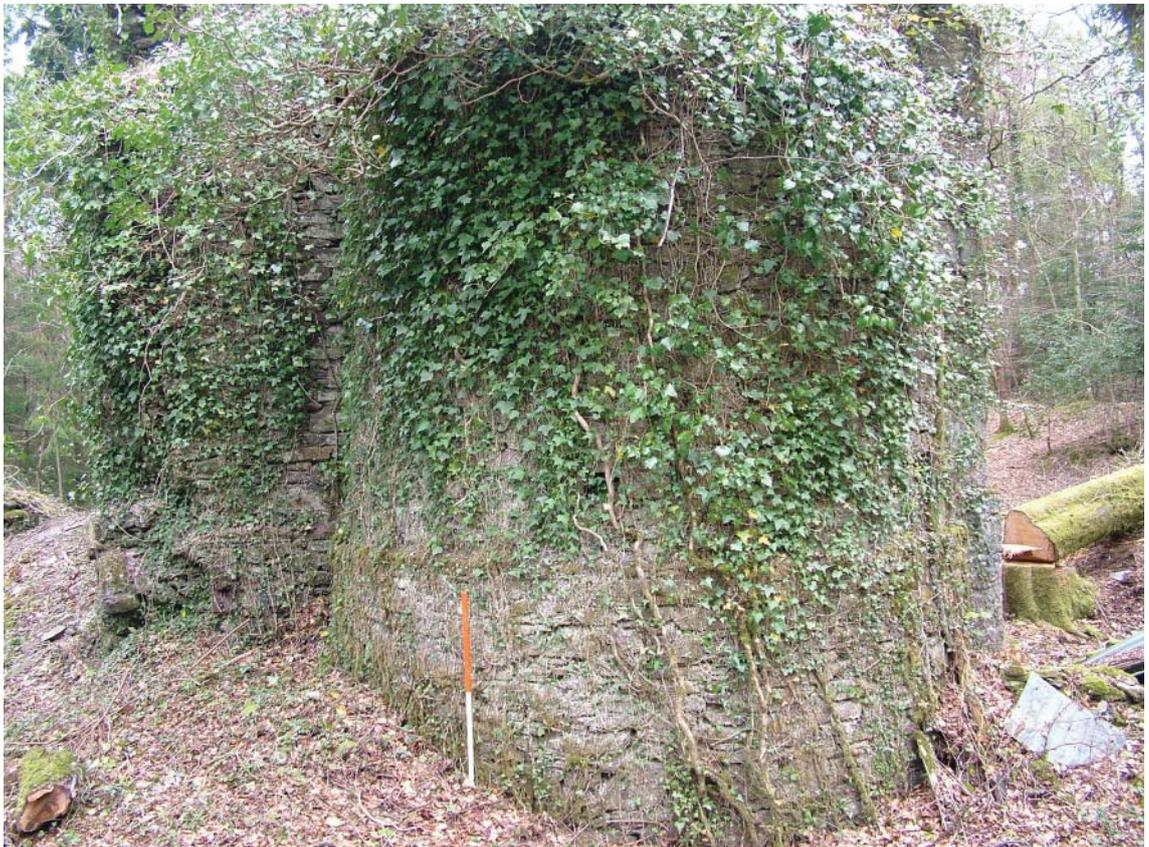
The chimney stack is built against the exterior of the western wall, giving it a 'C' shaped arced footprint with a base diameter of 4m. The taper is 4° off vertical. It is positioned centrally between the two corners of the building, and takes up sufficient space for there

Figure 7. The base of the chimney.

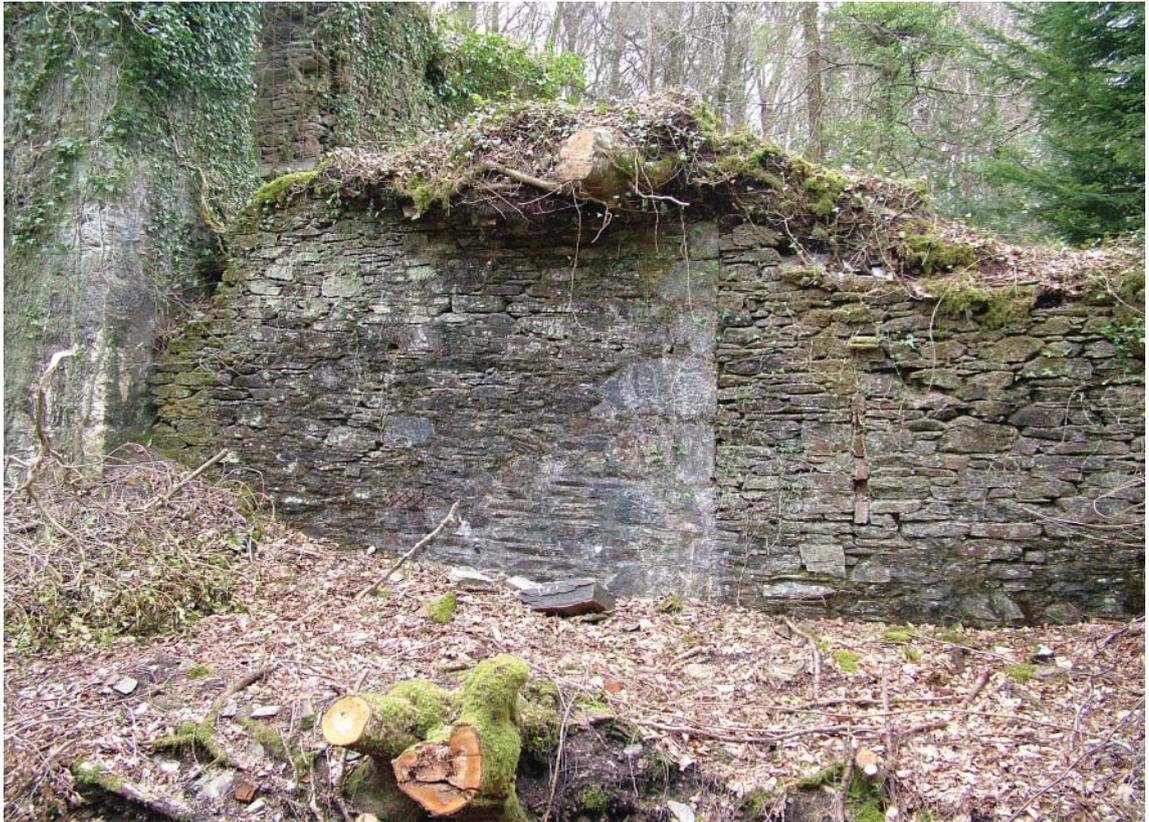
The twin-chambered boiler house is the most ruined part of the building. Only the eastern end with its corner detail still stands, and it is likely that much masonry has been robbed as little of the remainder of the building is visible. Also, much of the masonry from the badly collapsed north wing wall of the engine house has fallen into to the boiler house, filling it with rubble. Fortunately some faint traces of the west end of the boiler house survive and the precise ground plan can be determined. As is common with pumping engines, there were two boilers, almost certainly of Cornish pattern. It is likely that the outer boiler and its containing structure were a later addition as the surviving eastern wall has evidence of two building phases. A short stub wall marks the original outside of the first, inner, chamber, but there is no

Figure 8. The boiler house end wall, showing two phases of construction.

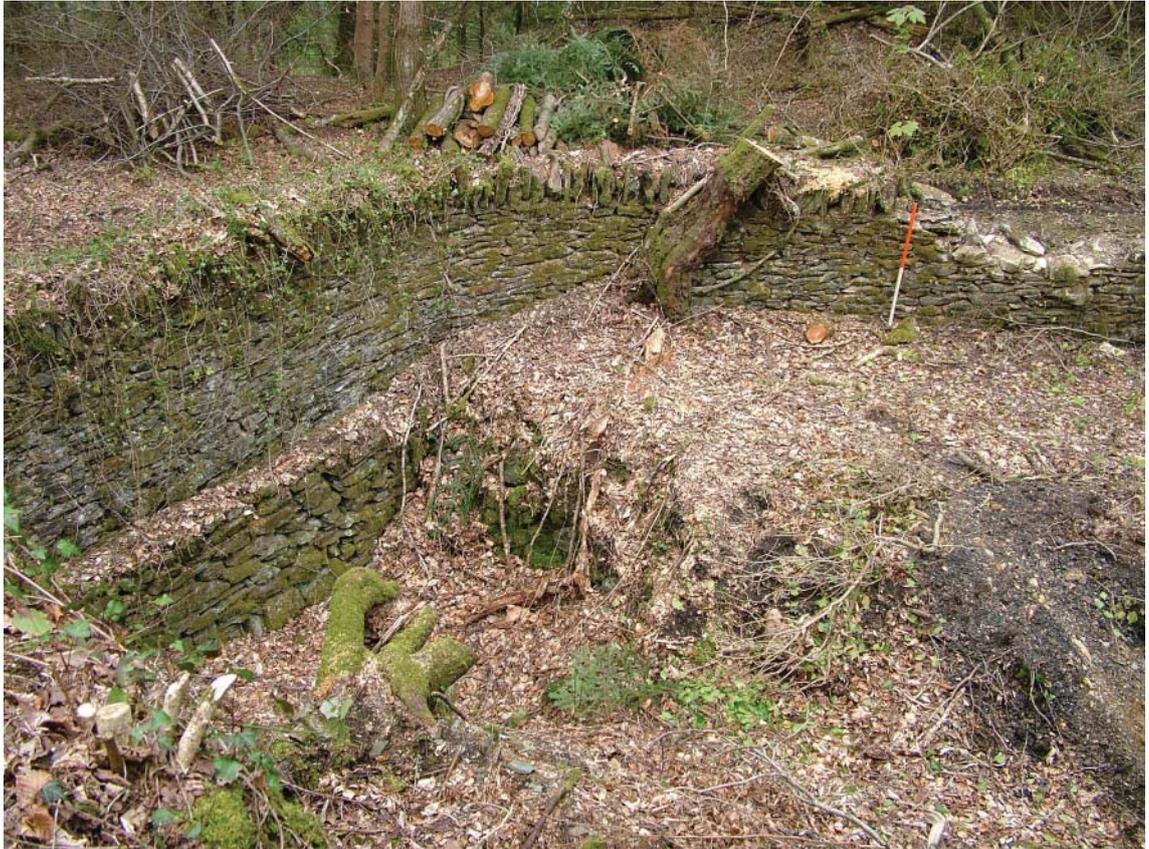
Figure 9. The stone lined bob pit.

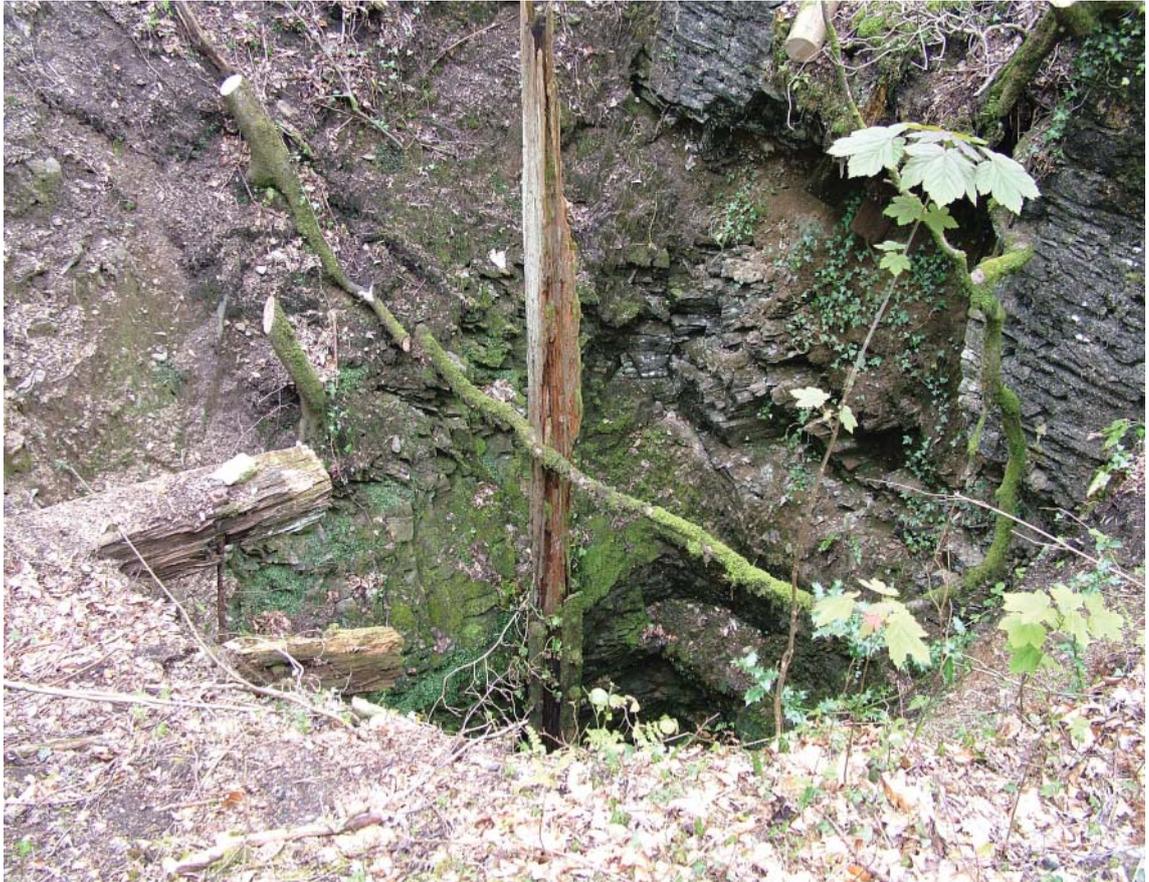
Figure 11. The shaft opening with timber pump rod in situ.

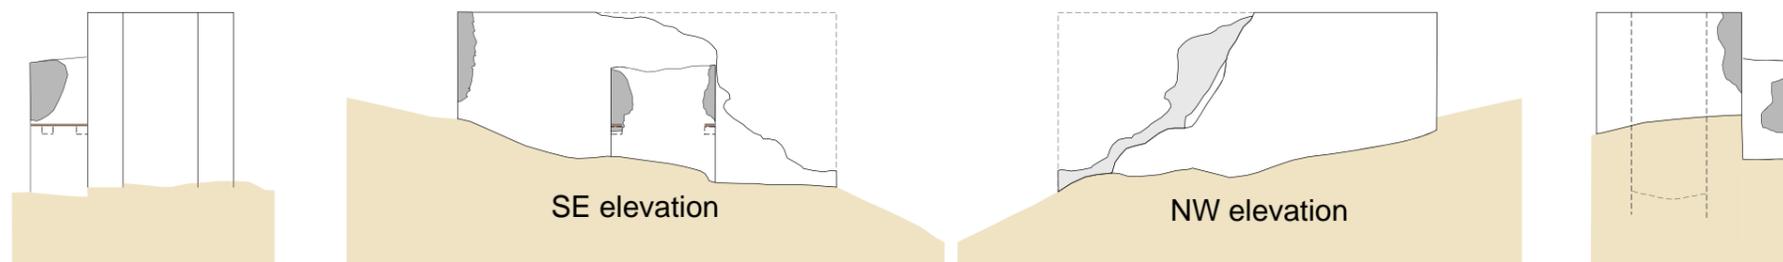
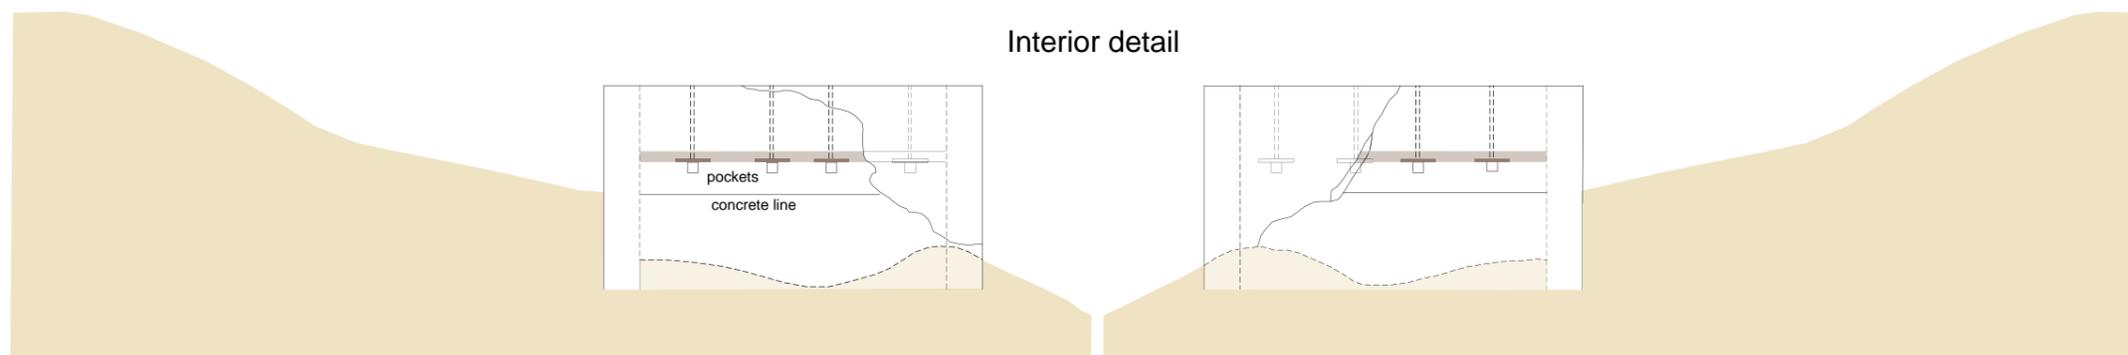
Figure 13

Condition of standing walls

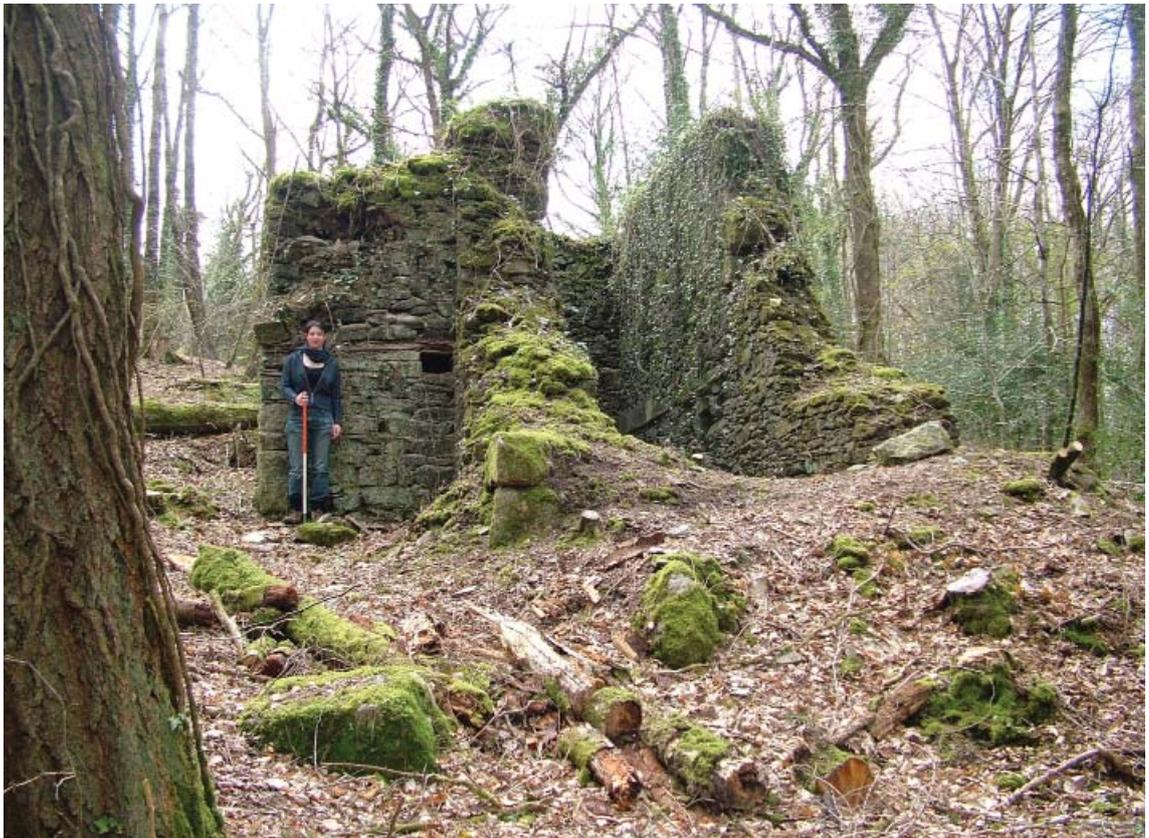
Figure 12. The wheel house viewed from the north showing the collapsed section and open end. The butress stands behind the figure. April 2005.

The wheel house is located on a gentle slope and all walls project above the ground, hence the term wheel house is used in preference to wheel pit. The narrow south wall appears to remain to its full original height as do the adjoining sections of the long side walls. However, both side walls have collapsed at the northern end and it is not clear if a northern end wall ever existed as there is no trace of it remaining. It is not unusual for a wheel house to have an open lower end.

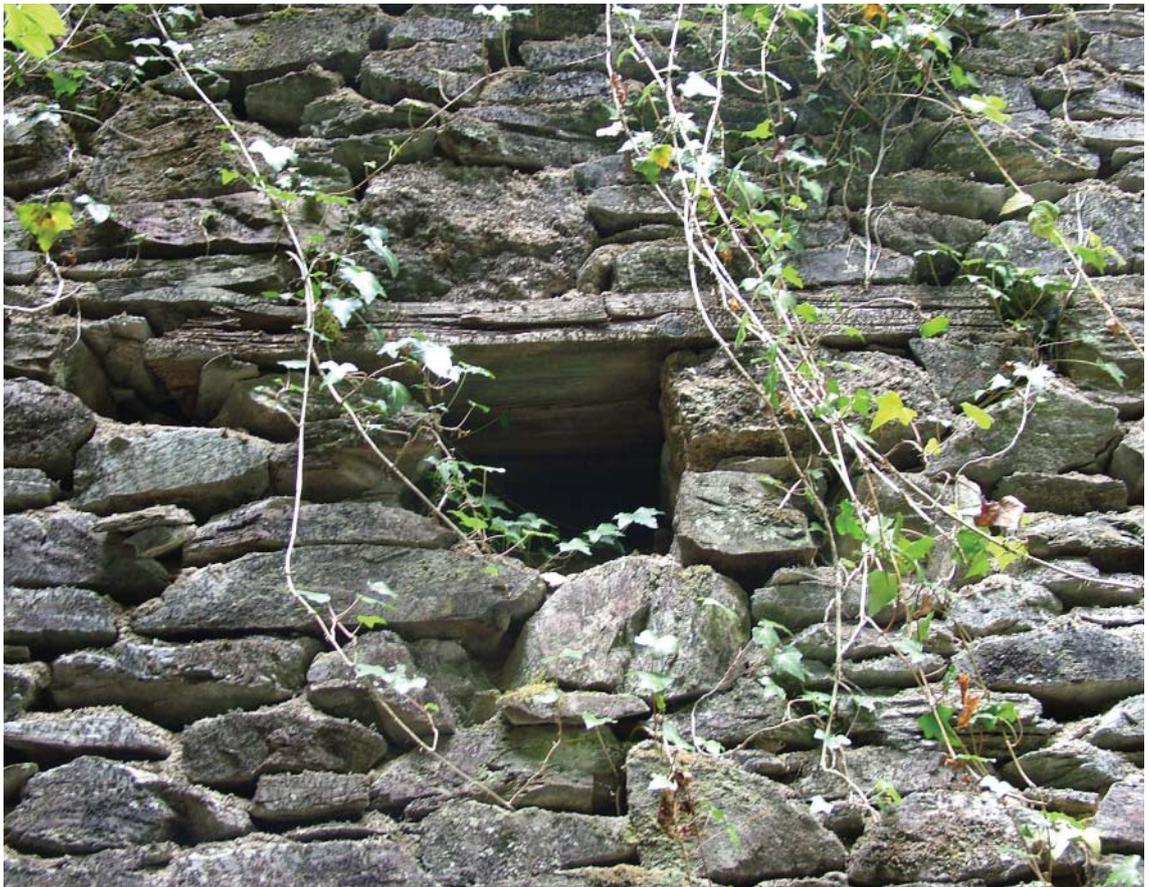
The fixtures and bearings which supported the wheel were bolted to large baulks of timber running along the top of the long walls of the wheel house, though these do not survive. This timber was in turn secured to the wall by long iron bars running vertically inside linear cavities within the wall. One of these cavities is visible where the stone has fallen away (Figure 15). Open pockets or niches, were used to give access to the lower end of the bars. Three of these pockets are visible on the east wall and two on the west, c.2m down from the top of the wall. Each pocket is 0.30m square and recessed into the wall approximately 0.45m. Baulks of timber 0.15m by 0.3m are laced into the fabric of the walls, running the full length of the structure along the top of the recessed pockets and it was against this timber that the iron bars were tensioned either with threaded nuts or with iron wedges forced through slots in the bars. The timber survives and is exposed in the pockets and at the north end of the wall where collapsed. The exposed face of each

Figure 14.
Recessed pocket
on wheel house
interior. Lintel still in
place.

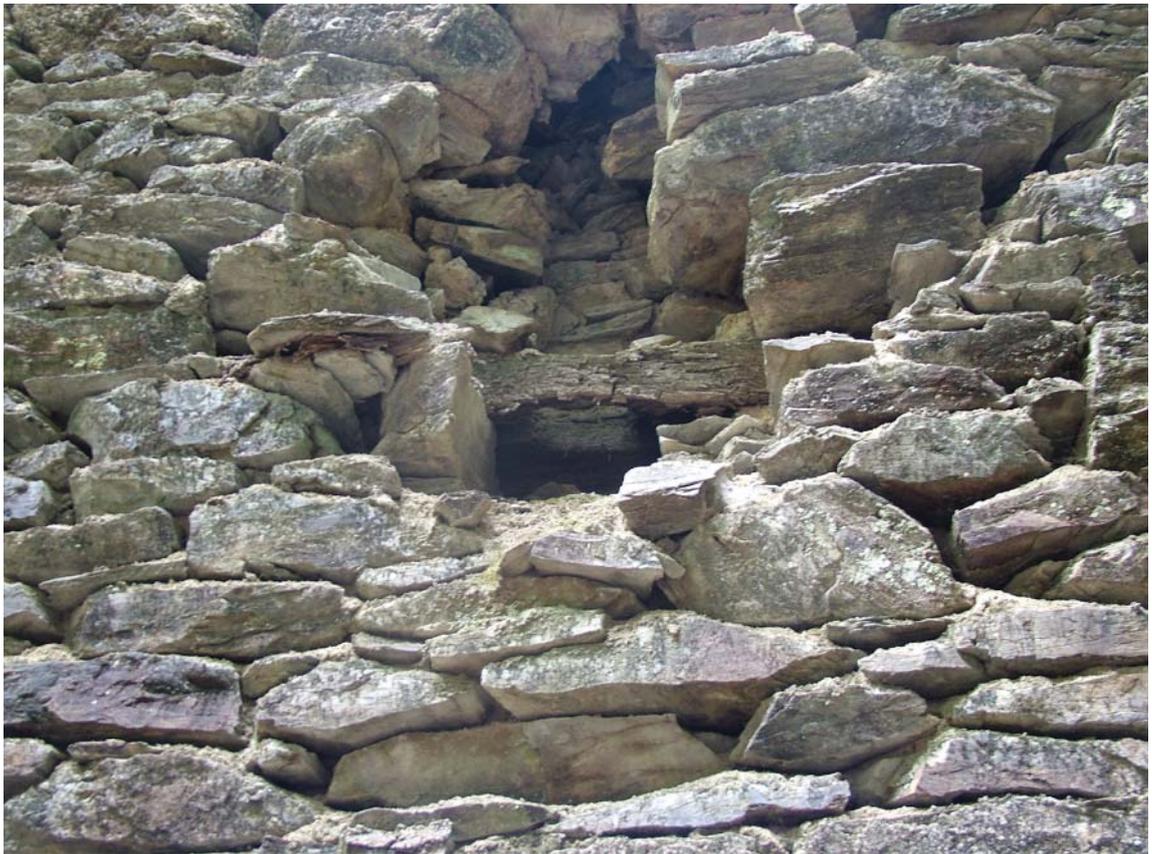
*Figure 15.
Recessed pocket
partly fallen
away showing
vertical cavity for
iron fixtures and
horizontal timber
lacing.*

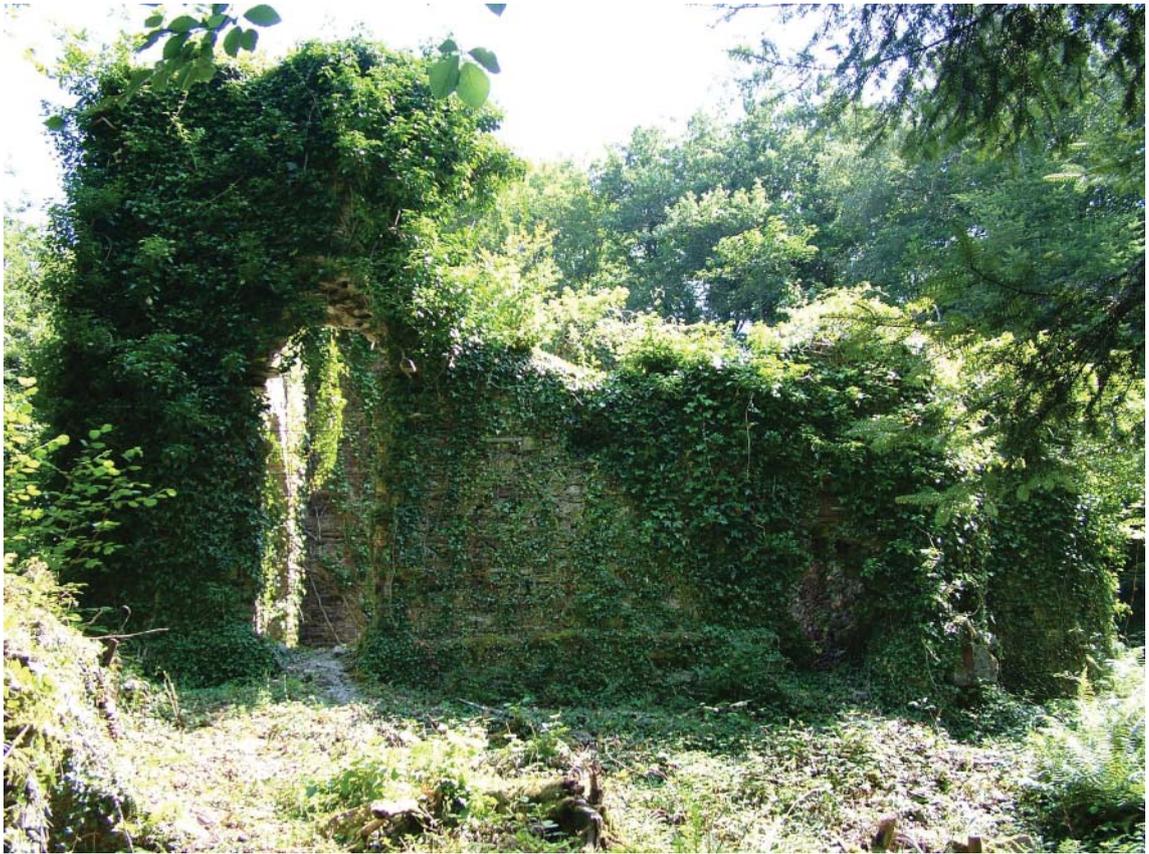
As has been discussed above, the condition of these two buildings is fragile. The non-enduring construction techniques, together with dereliction and the inevitable forces of attrition have combined to reduce the structures to their current perilous state. In the winter of 2004-5 a programme of tree felling was undertaken to remove large trees which were threatening the structures, either by growing close to them, or in some cases having roots within the fabric. While the threat from these trees has now been lessened, the removal of the tree canopy has increased the available light in the vicinity of the buildings and this in turn has allowed many shrubs, ferns and brambles to establish on the walls and for the existing ivy to flourish. If unchecked, this will certainly accelerate the demise of the structures in the future. See Figures 4, 16 and 12, 17 for comparisons.

Figure 16. The northern wing wall of the engine house in August 2006 after just one season following clearance work. Compare with Figure 4. Already the ivy growth has accelerated and small shrubs and brambles are becoming established in the walls, taking advantage of the additional light.

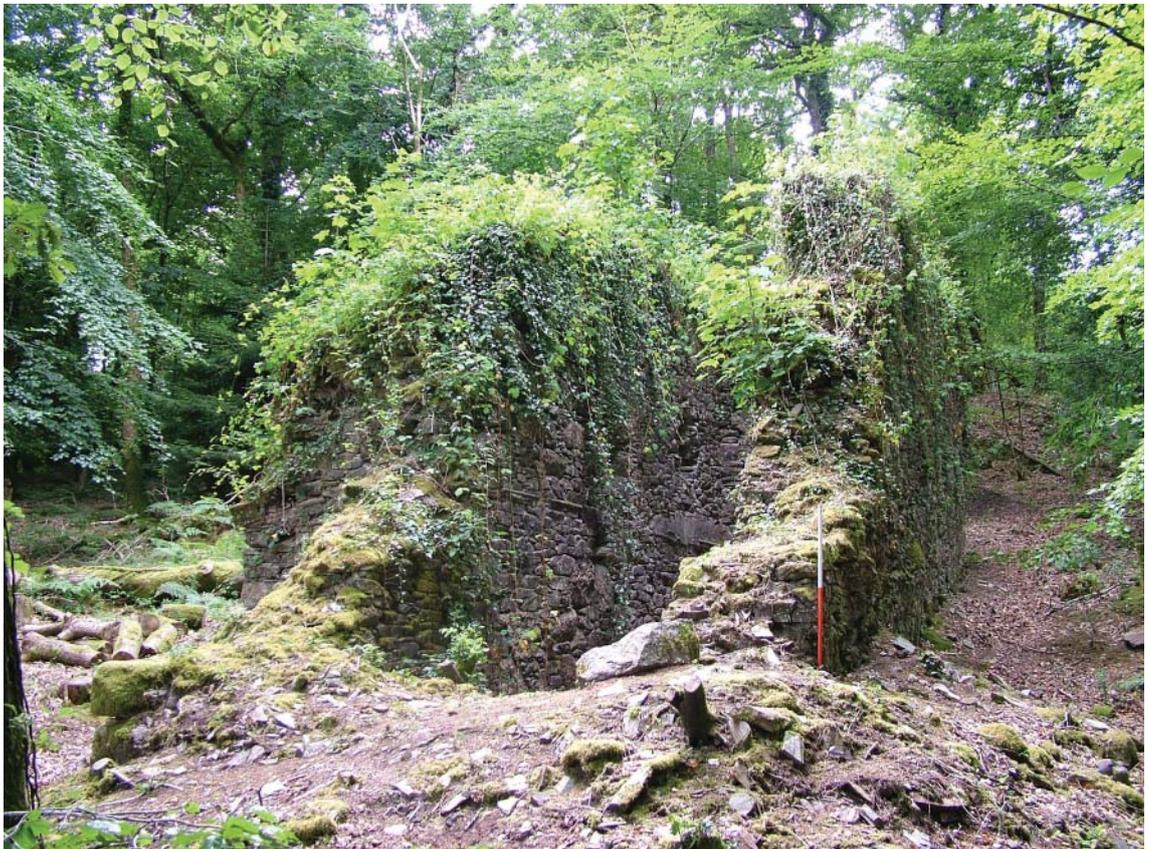
Figure 17. The wheel house August 2006. Showing accelerated growth of vegetation since clearance. Compare with Figure 12.
