An Archaeological Assessment
of
Castle Plantation,
Milber Down Camp, Newton Abbot, Devon
in advance of damage remediation

March 2015
(revised May 2015)

Phil Newman

Southwest Landscape Investigations

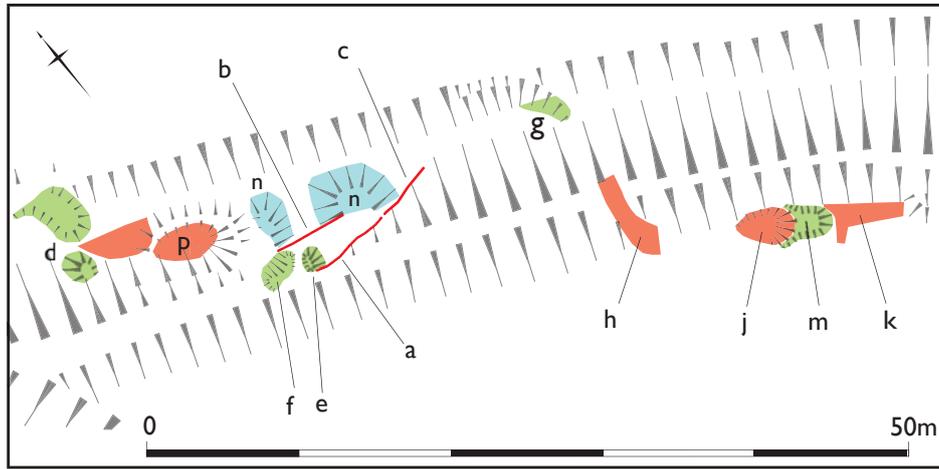
Fig 3 Enlarged plan of middle rampart showing damaged earthworks and outline instructions for repair.

Fig 3 is an earthwork plan showing the extent of the damage. Red shaded areas represent negative (i.e. cut) features which require filling and consolidation. Green shading highlights positive features, such as mounds, which should be carefully removed and blue shows positive features sculpted from the rampart and should be left *in situ*.

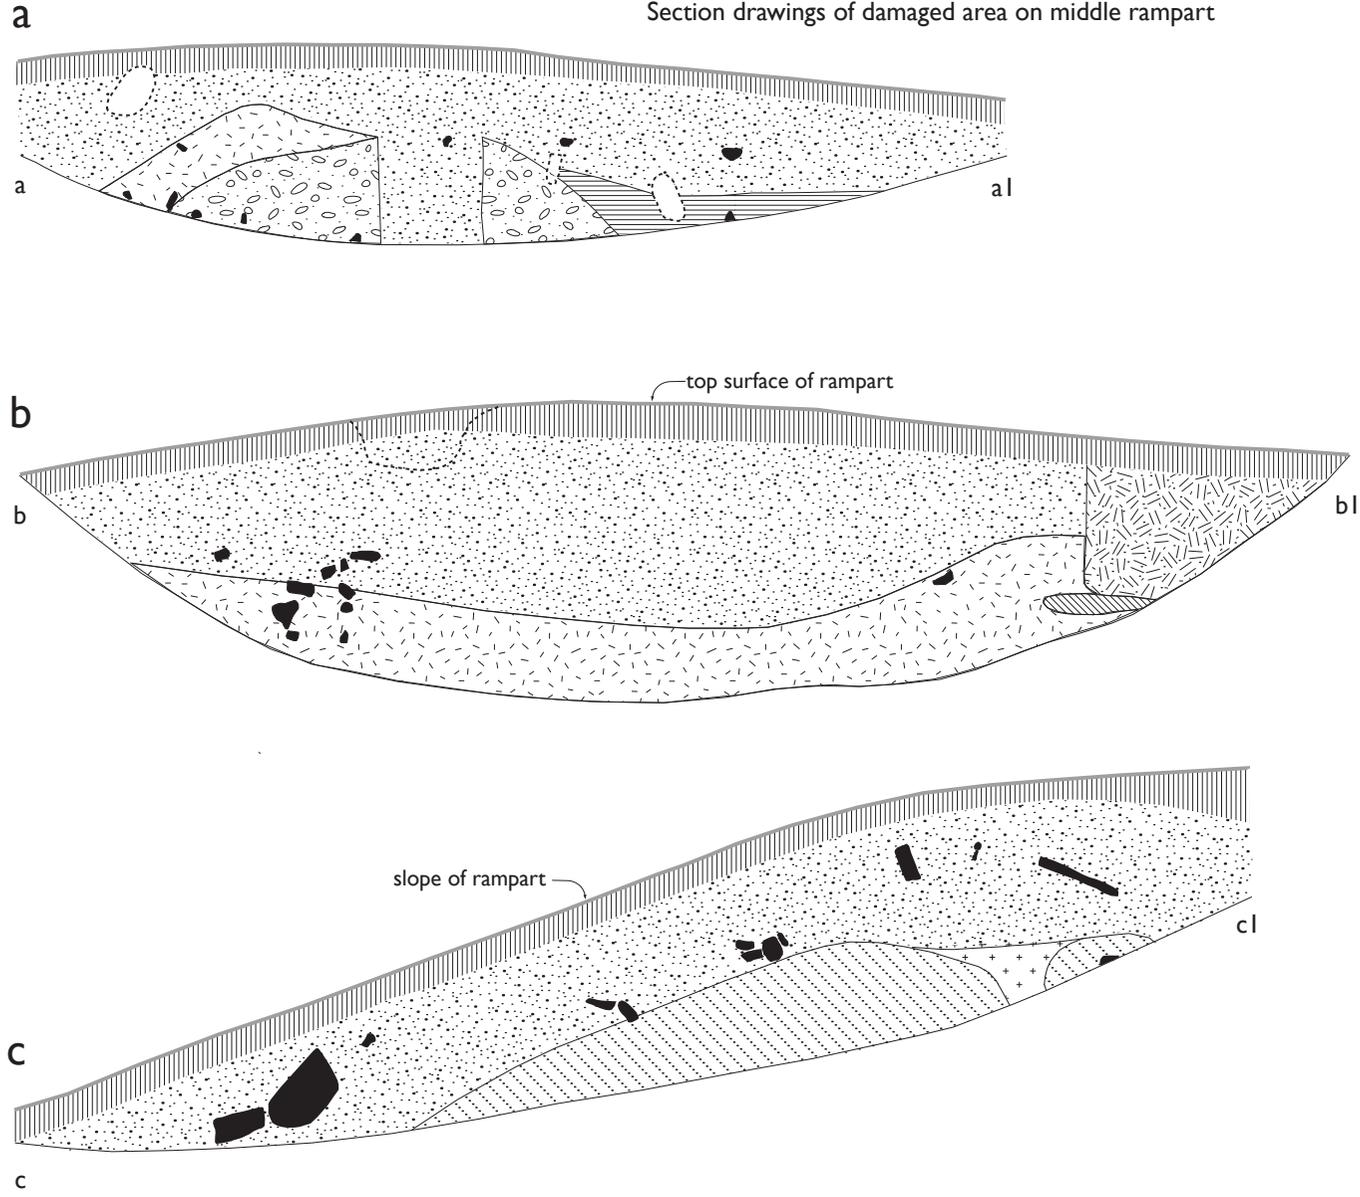
Fig 4 Milber Down Camp

Section drawings of damaged area on middle rampart

The sections (a-c) have revealed the upper portions of the constructed rampart bank, where the natural clays and sandy soils were dug out in prehistory to form the ditch, and redeposited onto the bank. The upper strata of all three cuts comprises a brown sandy soil, which probably represents a natural build up of earth since abandonment of the settlement.

Section a (Fig 4a) represents the south face of a hollow, which was cut obliquely across the upper rampart bank. Although only 0.8m deep, the cut has exposed the arched upper profile of the rampart bank, constructed from a redeposited pale sandy clay, with small flinty inclusions, with an addition layer of an orange, sandy loam. A 0.2m-wide cut feature with parallel, vertical sides (h), could be interpreted as a post hole, though it is rather high up the bank for a palisade.

Section a (Fig Fig 4b) is sited 2m north of a, slightly lower down the rampart. The same pale grey sandy clay was encountered but very little variation in the stratigraphy.

Section c (Figs 4c) follows the same axis as 'a', cutting obliquely across the lower section of the rampart into the upper section of the ditch. At the base of the cut, orange clay with darker orange flecks probably represents undisturbed natural subsoil, its rounded, sloping profile may have resulted from the digging of the ditch. Within the upper layer of brown sandy soil are two largish boulders and several smaller stones.

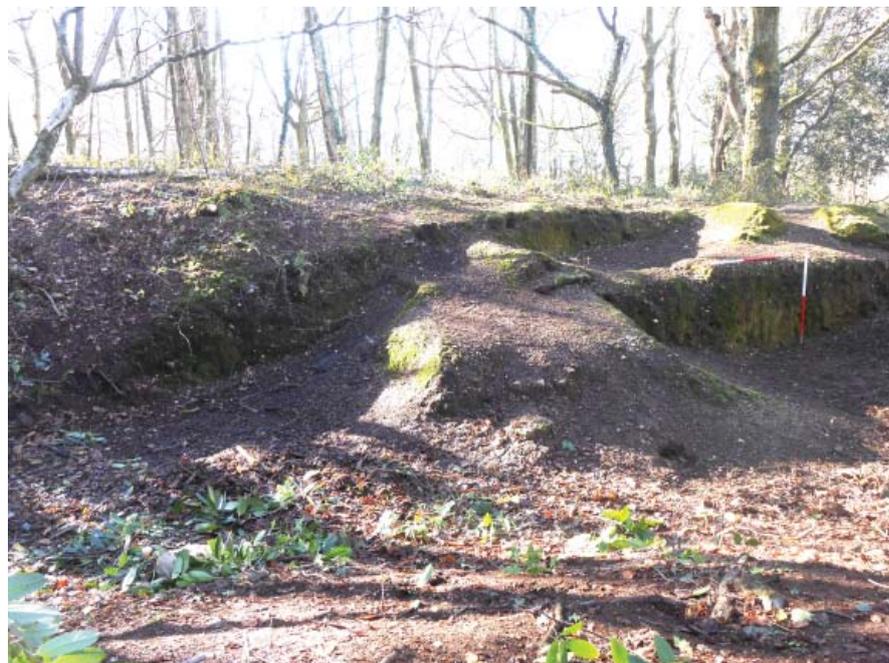
Damage has been inflicted on the northern, straight section of the middle rampart, approximately 55m south of the footpath. Approximately 62m of this earthworks has been subjected to a deliberate, unauthorized intervention in which unknown perpetrators have re-shaped the bank and part of the ditch to form an apparent mountain biking obstacle course. The most severe of these interventions are three, vertical cuts into the bank of the rampart to form hollows (a – c). These have sliced not only into the turf and topsoil but quite severely into the substance of the built earthwork. The deepest (b) has a vertical cut face of over 1m. Substantial amounts of earth have been removed from these cuttings and either dumped on two small spoil heaps (d) in the centre of the rampart ditch, or used to form artificial humps (e and f) as additional obstacles for the cycle riders. Additional damage was inflicted to the base of the ditch (g) where a cutting has been made into its flank on the north side. Other, less severe cuttings have been made at the top of the rampart on the inside (h-k). These have the appearance of shallow trenches but have not penetrated the ground to a depth likely to have affected the archaeological layers. A ramp (n), comprising two lumps, has been sculpted from the rampart, and stands to 1m high; the remaining soil appears to be undisturbed. A large scooped hollow at the western extremity of the disturbed area (p) is unlikely to have inflicted deep damage.

Fig 5 View across the damaged area looking south west.

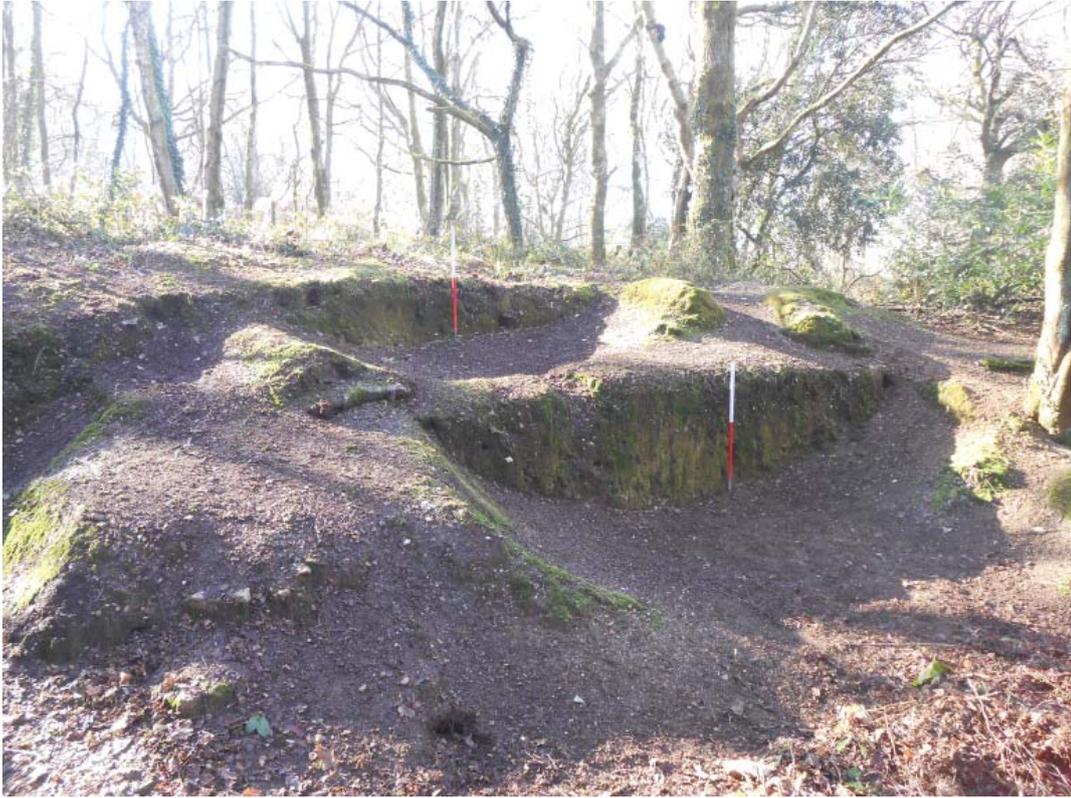
Fig 6 View looking south west across damaged area and sections a and b, before cleaning back and recording.

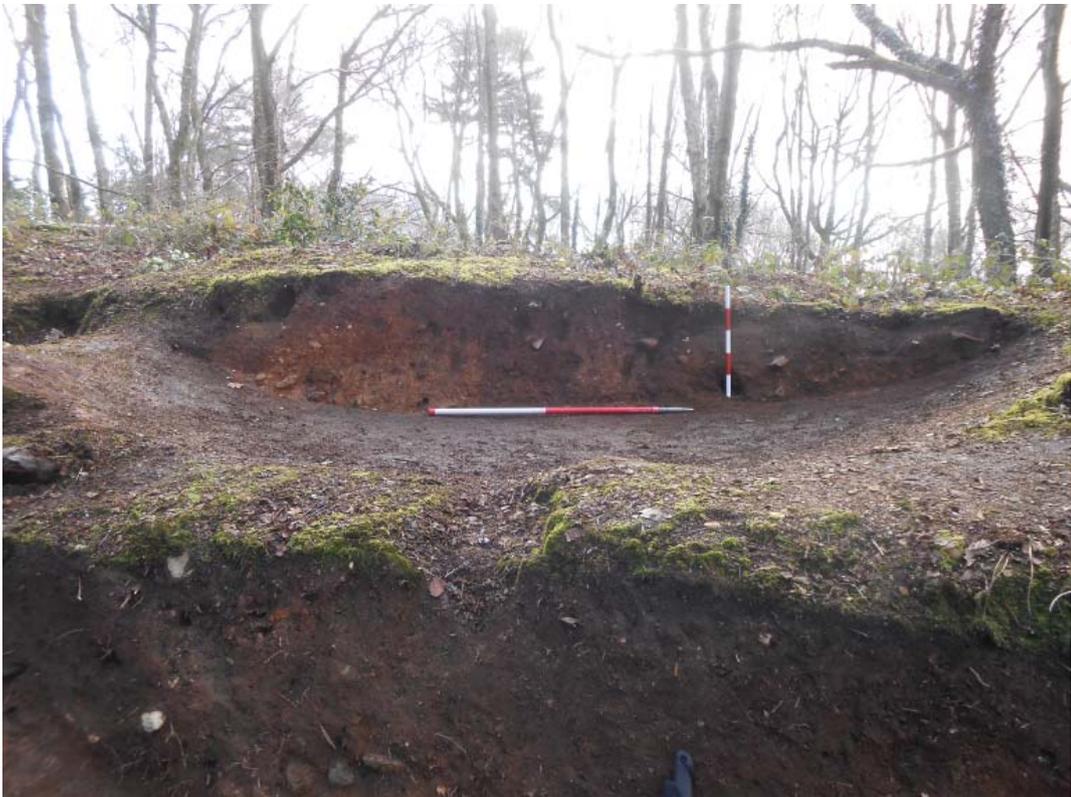
Fig 7 Section a following cleaning back and recording.

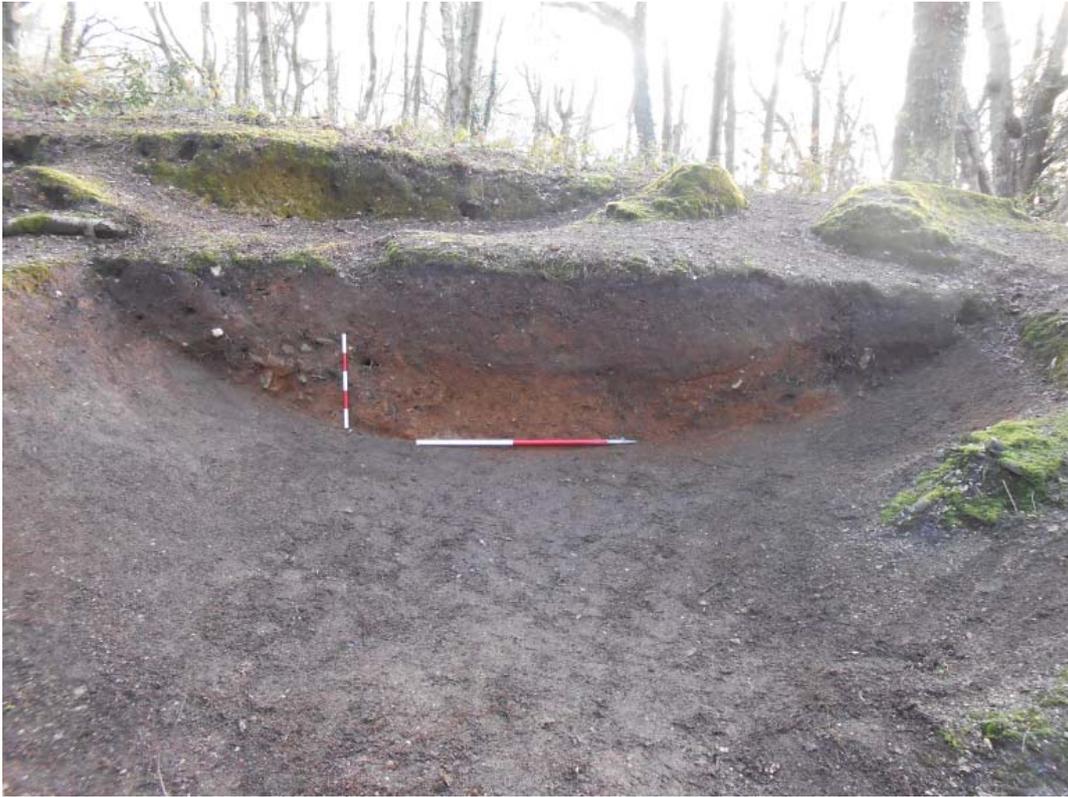
Fig 8 Section b following cleaning back and recording.

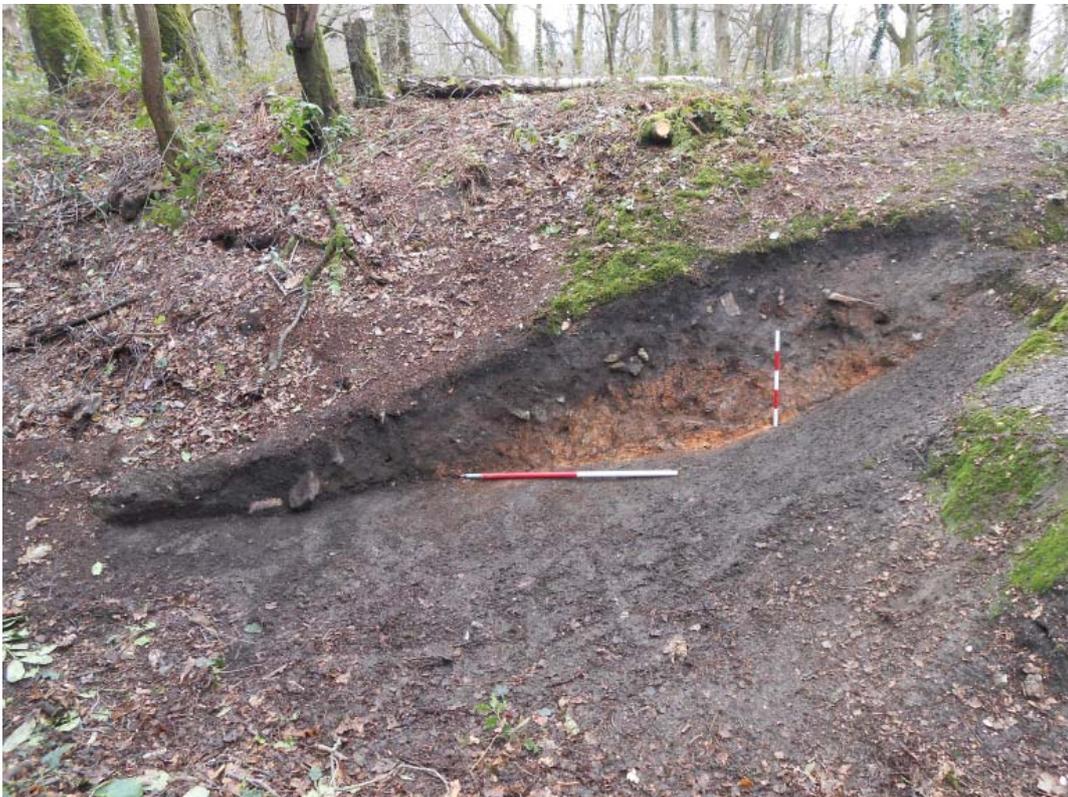
Fig 9 Section c following cleaning back and recording.
