An Archaeological Assessment of Bolt Tail, Bolberry Down and East Soar, South Hams, Devon

August 2014

South-West Landscape Investigations

The National Trust

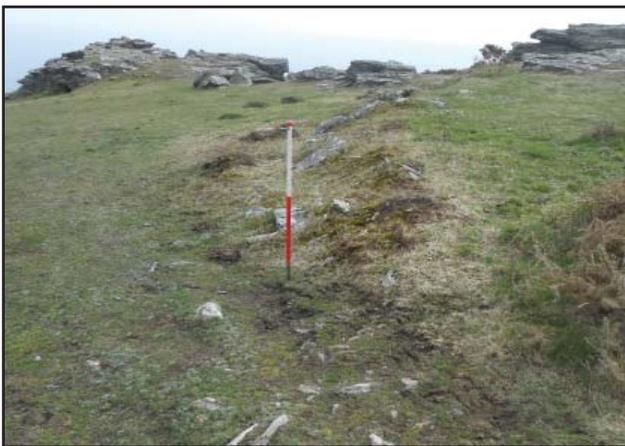
Stony banks: A subtle, usually spread, linear earthwork, almost flat to the ground containing stone, including some surviving *in situ* and upright. Some of these walls may have prehistoric origins but are likely to have been reused later.

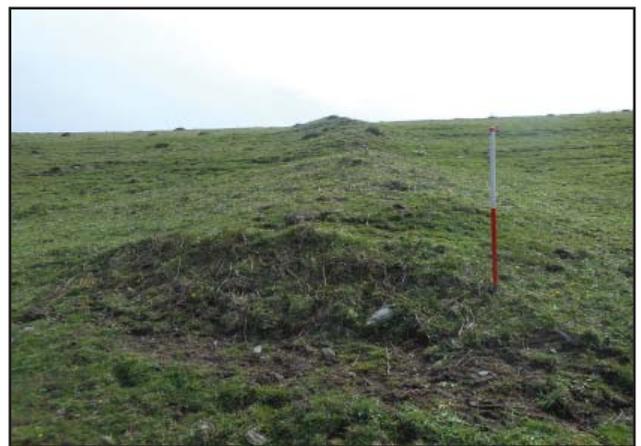
Earth banks: Similar in character to the stony banks but without visible stone and often surviving in a more upstanding state. Probably medieval or post-medieval in date.

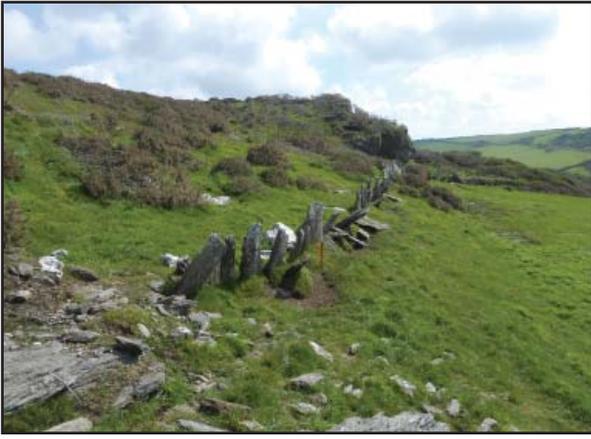
Orthostat walls: Alignments of closely set upright schist slabs, approximately 0.5-1m tall, forming an effective livestock barrier. Some examples are fragmentary and disused but others at Bolberry and West Cliff are more intact. Despite their prehistoric appearance, surviving examples are probably medieval or post medieval in date.

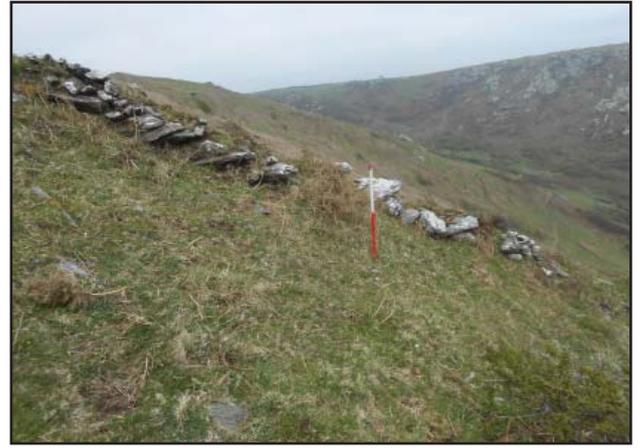
Faced wall banks: A substantial earthen bank with an external facing of stone, including some upright slabs. Post-medieval or modern.

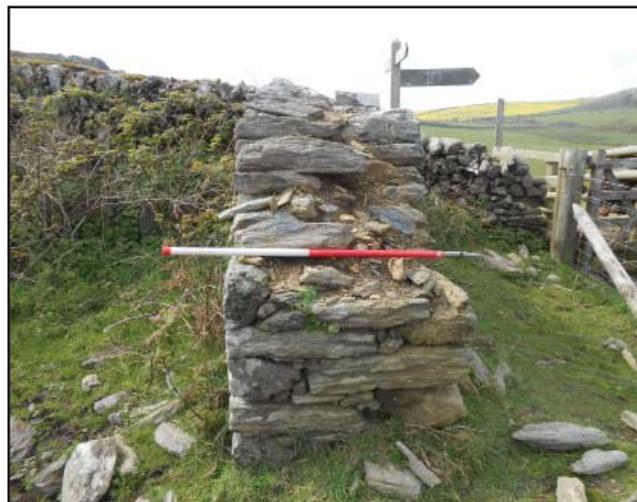
Dry stone wall: A built wall, constructed solely from local stone. 18th century or later.

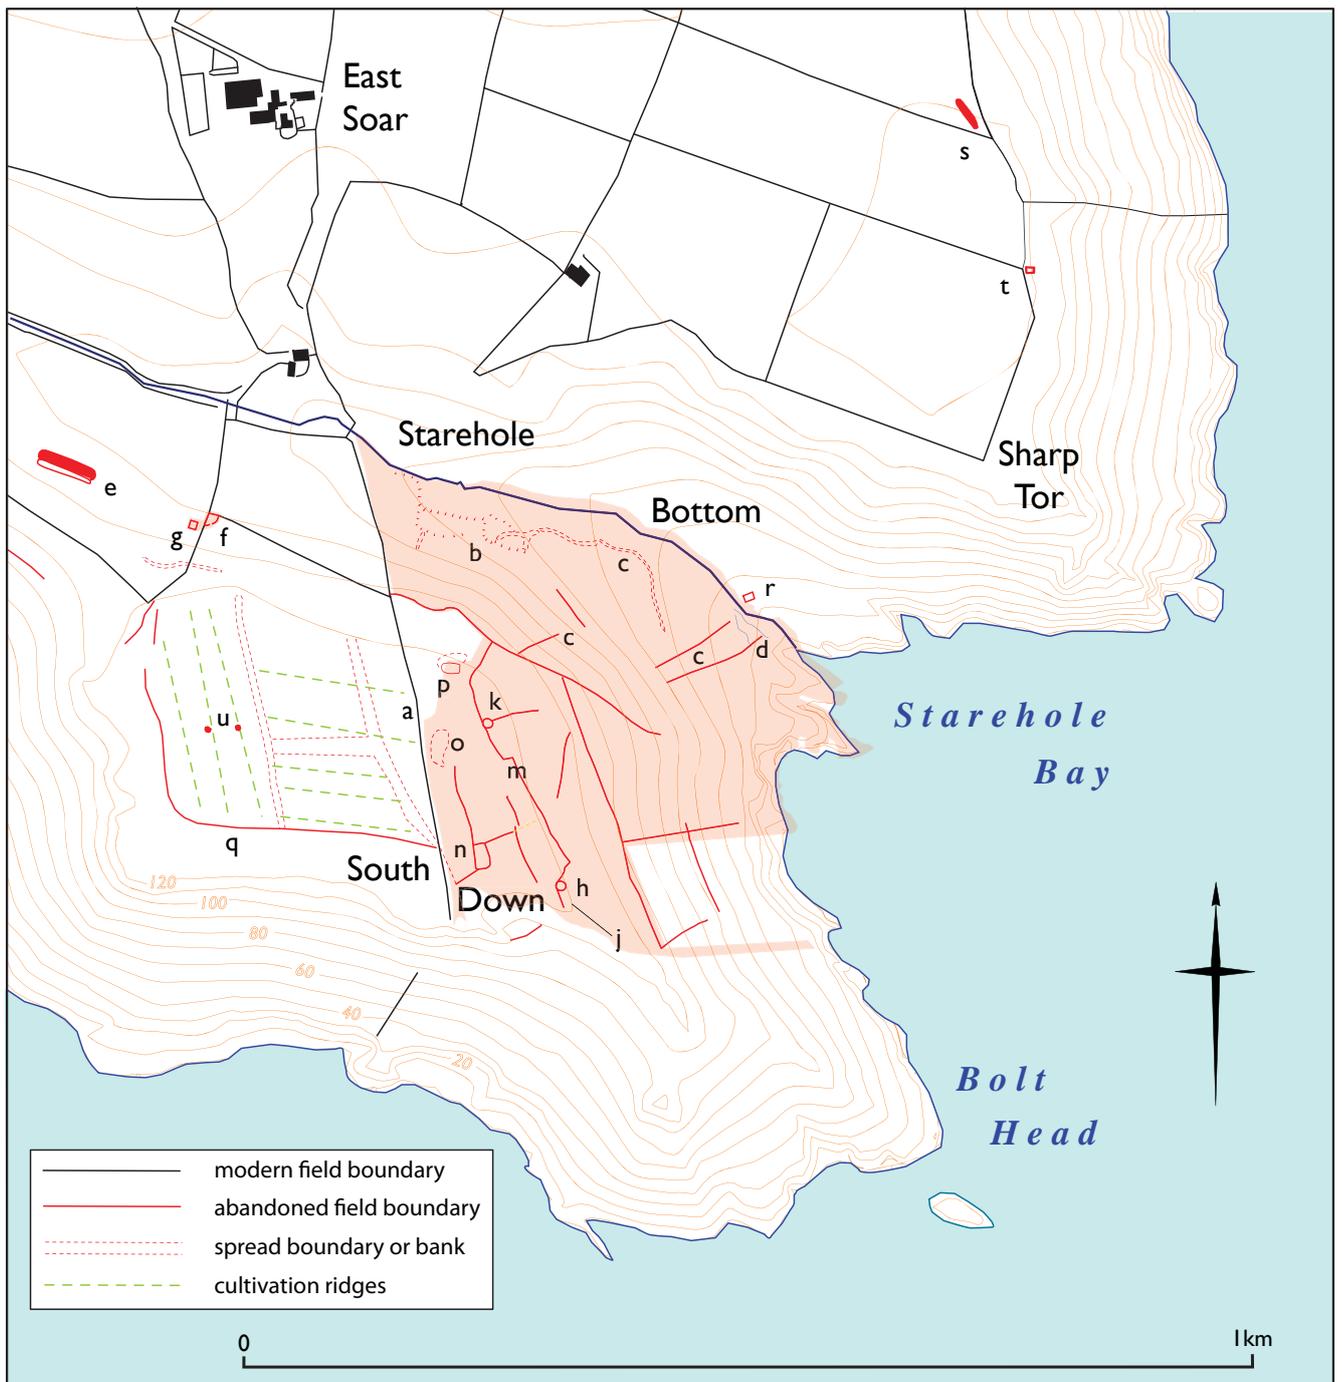
At the upper western limit of Starehole Bottom is the linear earthwork known at Giant's Grave (e). This comprises a 60m by 11m stony mound, over 1m high, with parallel sides and rounded ends. A 0.5m-deep ditch runs along the south side only and was the source of the material used to construct the bank. This mound defies explanation: it was recorded by Hawkins in 1819, who also struggled to explain its origins, although believed it to be part of a much larger monument or 'Danish encampment'. However, it is not suitably sited to be part of a defensive entrenchment, it is rather too regular in shape to be a Neolithic long barrow, and it is incorrectly oriented and too stony to be a pillow mound for rabbits. Its origin remains obscure, although Hawkins' account

Fig 5 Archaeological sites and landscape features at Sharp Tor, Starehole Bottom and South Down. Shaded zones show extent of scheduled areas. Contains Ordnance Survey data © Crown copyright and database right (2014), from OS open data sources.

The likely earliest section of field boundary surviving in original condition is a short curvilinear, spread stony bank (j), extending from an outcrop at the top of the cliff above Bolt Head. In a kink in this ruined wall sits a hut circle (h), comprising a circular stone bank, forming the ruined foundations of a roundhouse. Winton and Bowden dismissed this feature as 'certainly not the remains of a hut circle' though did not qualify their doubts (Winton & Bowden 2009, 14). However, ground investigation confirms this to be a good candidate, comparable in size and appearance to many similar huts on upland Dartmoor. A second hut (k) is built against the north side of the bank 180m to the NNE.

Fig 5 h, k		MDV66004		1020577	Hut circles in Starehole field system	272380	36310	Two hut circles associated with the field system on South Down, south of Starehole Bottom.	Southern hut currently affected by brambles and bracken. A reduction in vegetation would be beneficial. Priority: Medium	013 014
Fig 5 d		MDV66006		1020577	Post-med leats at Starehole Bottom (from EH schedule)	272560	36573	Two faint earthenwork channels appear to have origins on the stream in Starehole Bottom, then run east towards the cliff top. A dam across the stream described in the EH schedule was not found.		010
Fig 6 d	100548	MDV66009 MDV22807	1369319	1020575	Remains of farmstead SE of Middle Soar	271242	36865	Earthenwork foundations of a rectangular building with small annex, south of the Warren boundary wall near Middle Soar. Two orthostat stones mark the opening of an entrance or gateway. A section of collapsed brick wall and other rubble from a WW11 structure occupies the interior of the ruin (see 100549)	A large patch of bramble on the earthenwork could usefully be removed. Affected by bracken. Priority: Medium	031 032

Fig 5 r	100538	MDV51252	1468986		Remains of cable house, Starehole Bay	272566	36599	Earthwork foundations and a small section of ruined wall are all that remains of this building, which is believed to have been part of a submarine communication cable system.	No action required	008
Fig 6 s		MDV66010		1020574	Field system at Little Goat, south of Middle Soar at foot of coastal slope	271092	36597	Two attached rectangular enclosures and other fragments of a field system, on a ledge of sloping ground near the bottom of the coastal slope. The walls are stony and very spread. The larger enclosure is very approximately 65m long, the smaller enclosure is attached to its eastern end and is 20m. Both are between 19 and 25m wide. Hut circles mentioned in the schedule entry were not found.	The site has a covering of bracken which needs to be reduced. Furze has not yet encroached to a serious level. Grazing should keep this area under control. Priority: Medium	027 028 029 030

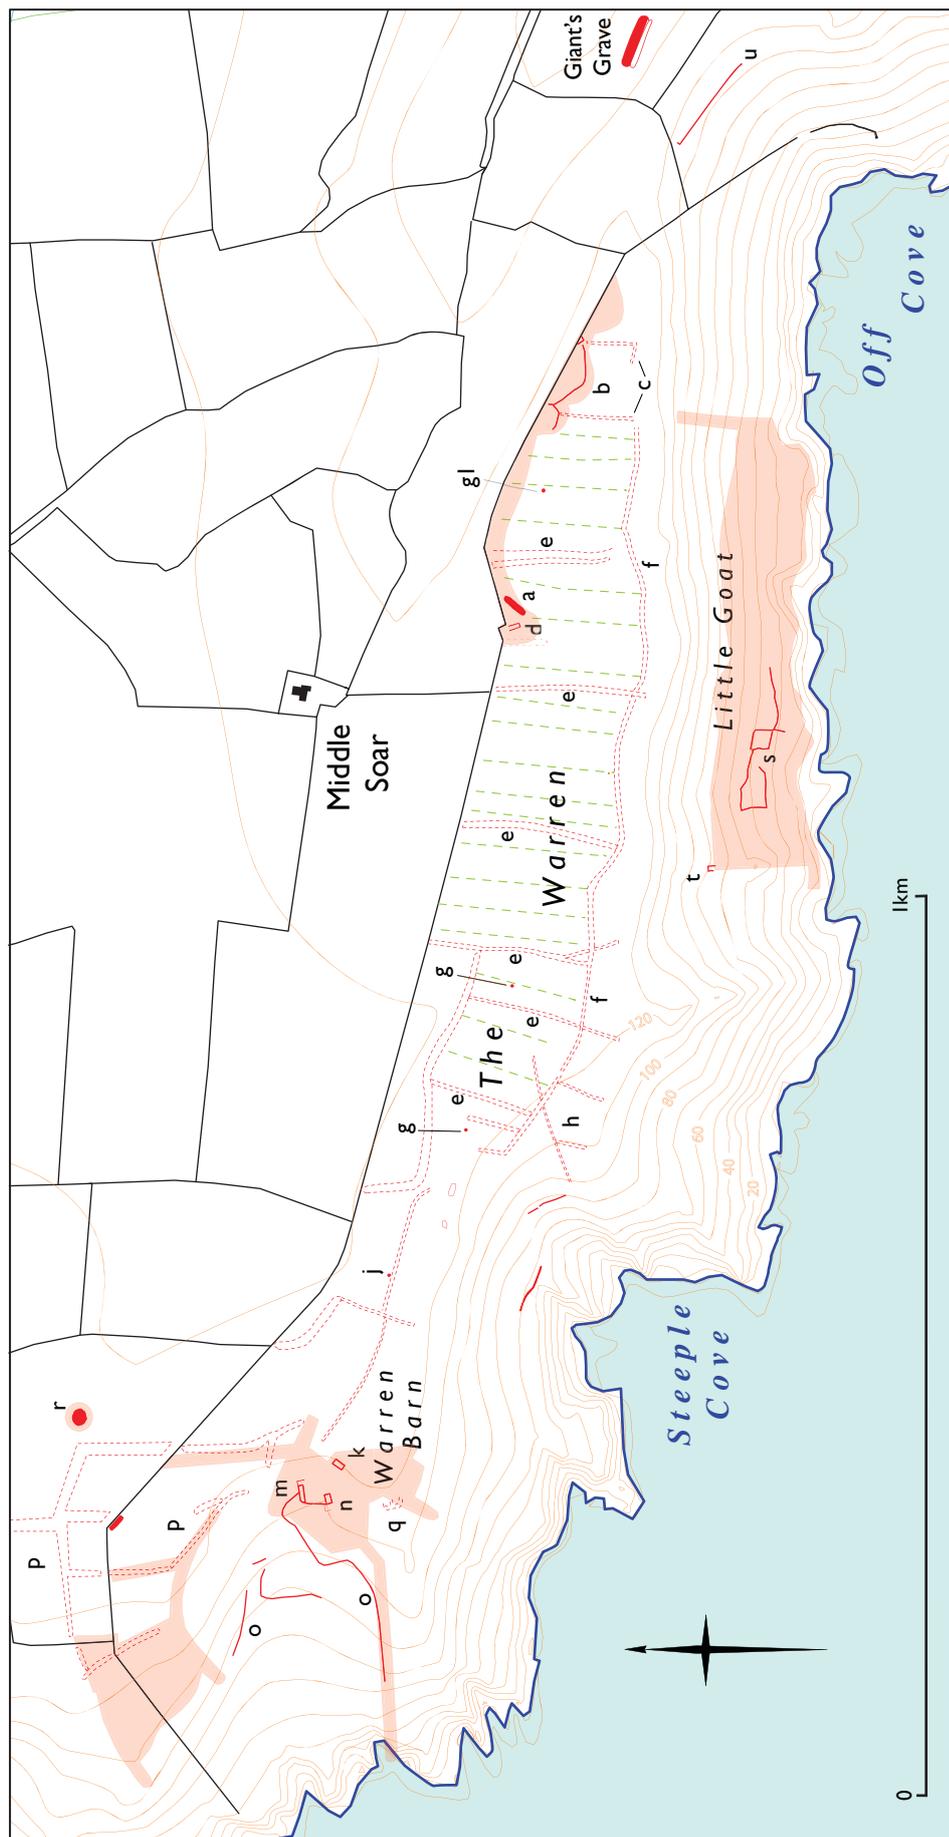
Fig 6 Archaeological sites and landscape features in The Warren. Shaded zones show extent of scheduled areas. Contains Ordnance Survey data © Crown copyright and database right (2014), from OS open data sources.

This warren shows remarkably few archaeological signs of its former purpose, with none of the usual earthwork or structural evidence associated with rabbit farming. There are no obvious pillow mounds, structures or vermin traps. A large elongated earthen mound (a on Fig 6) close by the warren wall, is the only candidate but is untypical of pillow mound appearance and has been recorded in the past as both a Neolithic long barrow and a section of medieval boundary work. Its true function is yet to be established for certain. It is worth noting here that there is a long tradition in British archaeology for confusing pillow mounds with long barrows (Williamson 2007, 127-53), and it is not always possible to distinguish them on the appearance earthworks alone. The location within ground known to have been a warren should give weight to its status as a pillow mound.

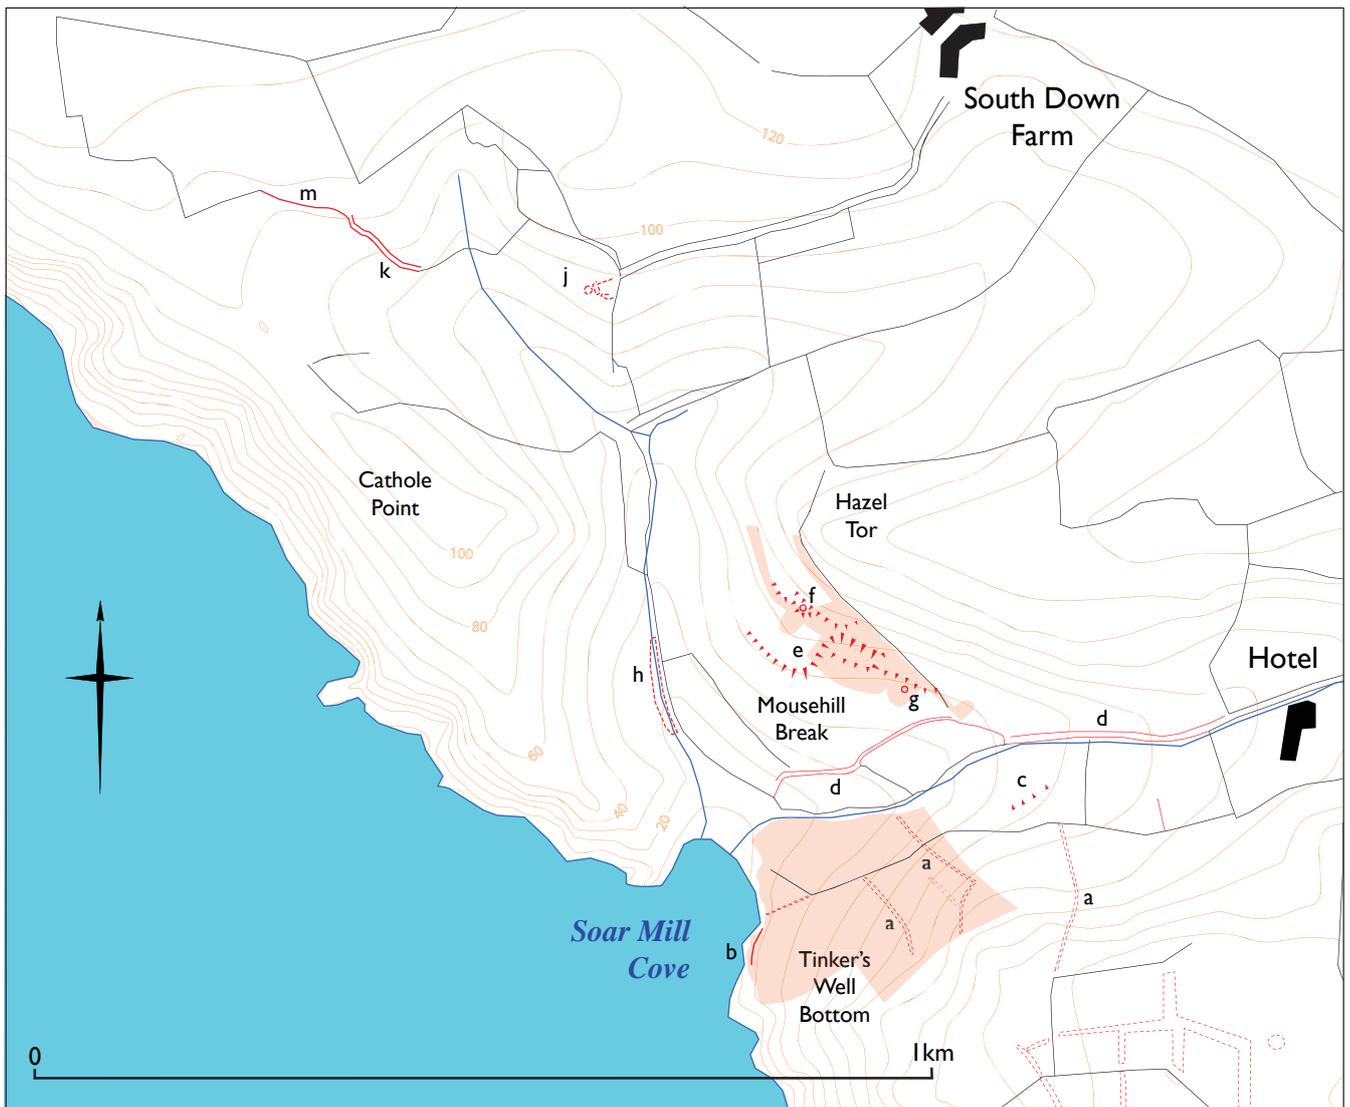
Fig 7 Archaeological sites and landscape features at Tinker's Well Bottom, Mousehill Break and Cathole. Shaded zones show extent of scheduled areas. Contains Ordnance Survey data, ©Crown copyright and database right (2014), from OS open data sources.

Also, slightly up the valley to the west is a vestigial lynchet (c), redolent of those on the opposite valley side at Mousehill Break (see below).

Access to the cove for residents of West Soar and beyond was, in the past, via a hollow way (d) which cuts approximately east to west along the north side of the valley below Mousehill Break. Although now disused and overgrown the hollow way survives in fine condition, comprising a sunken lane, lined for much of its route with stones and slabs. The modern footpath runs close by, approximately parallel, crossing it near its centre section.

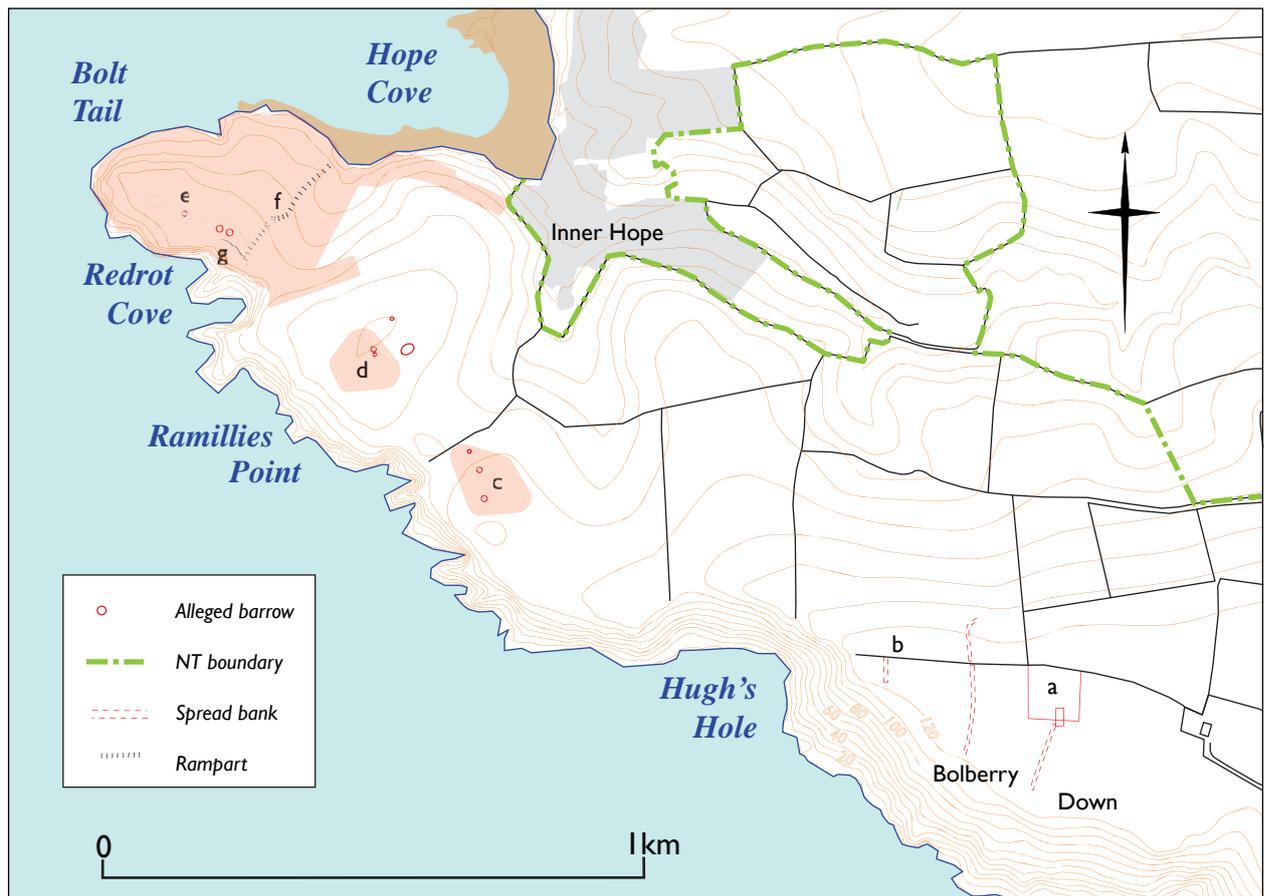
Fig 8 Archaeological sites and landscape features between Bolberry Down and Bolt Tail. Shaded zones show extent of scheduled areas. Contains Ordnance Survey data, ©Crown copyright and database right (2014), from OS open data sources.

Between Bolberry Down and Bolt Tail, a series of round barrow groups have been reported by past investigators (Fig 8, c & d). However, although all these features are scheduled monuments, some if not all, are probably erroneous examples, more likely to be natural topographic or geological features. Five barrows are recorded just north of the summit of Gray Stone, of which only two (Fig 8, c) are possible candidates. However, if they are barrows, then their current condition as extremely slight earthworks reflects a massive and prolonged deep-ploughing regime that is unlikely to have occurred on the shallow soils at this location.

More certainty surrounds the existence of the Iron Age promontory or cliff fort itself, which is defined by a spectacular rampart that runs uphill from NE to SW across the neck of the peninsula, cutting it off from the mainland beyond (Fig 8, f). The rampart comprises a substantial earth and stone bank, in excess of 2m in height, with traces of an external ditch on the south side, though this is less easily observed further up the hill to the SW. A stone revetment runs along the upper section of the exterior, though this was probably a later addition. A natural valley runs parallel to the rampart on the eastern exterior, giving the artifice an even more formidable appearance when approached from the SE. A likely original entrance, pierces the rampart about two-thirds of the way along, where inward facing hornworks on the terminals of the earthwork, guide the current track through into the interior. Where the SW terminal of the rampart meets the clifftop above Redrot Cove, much modern erosion has occurred, brought about by the existence of the coastal path. Evidence of past remedial works are present, but the problem is worsening as visitor pressure grows (see below). At the northern end of the rampart the EH site schedule describes and includes an additional section of bank running along the landward side of the cliff. The relevance of this feature to the promontory fort is arguable, and it appears more likely to be a natural undulation. It is, however, heavily shrouded in vegetation, including bracken, and is difficult to see in its entirety.

Fig 8 e			MDV4840	440921		Three alleged round barrows between Redrot Cove and Bolt Tail (not found)	266932	39583	<p>These alleged barrows are sited on the highest point within the scheduled promontory fort at Bolt Tail but do not form part of the schedule. An anecdotal record of a barrow was first made by Hawkins in 1819, but with the exception of the OS investigator in 1987, subsequent recorders have failed to find the remains. These barrows are almost certainly geological features and appear so on the 1946 RAF vertical APs (CPE/UK 1890.10-Dec-46. 4031) (NB Devon HER has incorrect NGR)</p>	Maintain as appropriate to fort interior.
Fig 8 d	106559		MDV63614	13450005	1019785	Three alleged bowl and one bell barrow above cliffs at Ramillies	267226	39370	<p>First recorded for EH schedule. Although some very spread, low domed areas of the terrain are visible on 2007 EA LIDAR and on the ground, these are very unlikely barrows and more probably topographical features. No sign of the ditches said to be surrounding the barrows could be found.</p>	In pasture. No action required. Current grazing level to continue.

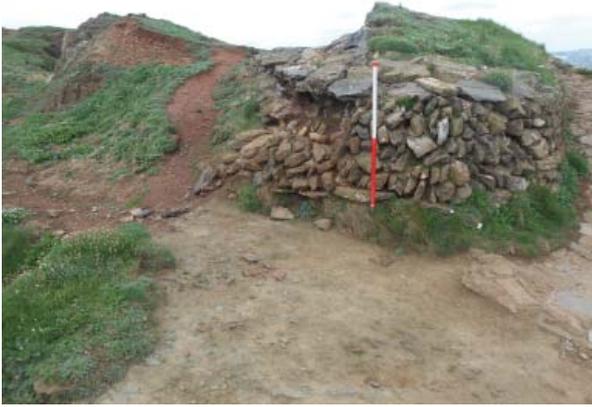
The most severe problem is at the southern end, where works undertaken about 20 years ago are now falling short of what is required. The public's failure to adhere to the stone path has denuded the rampart and its surroundings of turf and vegetation, including on the cliff top, exposing the soil to weathering and run off. This problem has been exacerbated by walkers' boots together with livestock movements, causing further erosion. A protective stone revetment, which was built around the terminal of the rampart earthwork in 1995, is crumbling and in imminent danger of collapse (Fig 9), while a series of *ad hoc* footpaths are carving trenches into the soil.

Fig 9 Damaged section of protective wall on the southern terminal of the rampart

A temporary barrier recently installed to prevent passage between the terminal and the clifftop is no longer functioning. The stone and cement path still serves its purpose well but more members of the public need to be encouraged to use it.

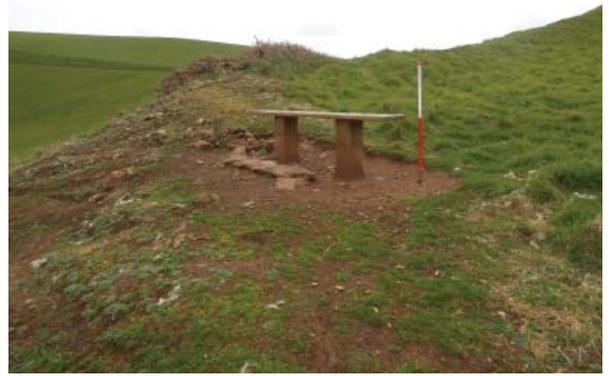
Fig 10 Erosion caused by the public using the seat fixed to the rampart near the entrance.

The midway opening through which the coast path passes, is likely to be the original entrance to the fort, dating from the Iron Age. Although the path itself is broad enough to accommodate the large number of walkers without significantly affecting the rampart, serious erosion is occurring where walkers have mounted the earthwork bank to use the seat located on its summit (Fig 10). Denuding of the turf and displacement of rampart fabric is occurring as a result around the seat and the area leading up to it. The following remedial actions are recommended:

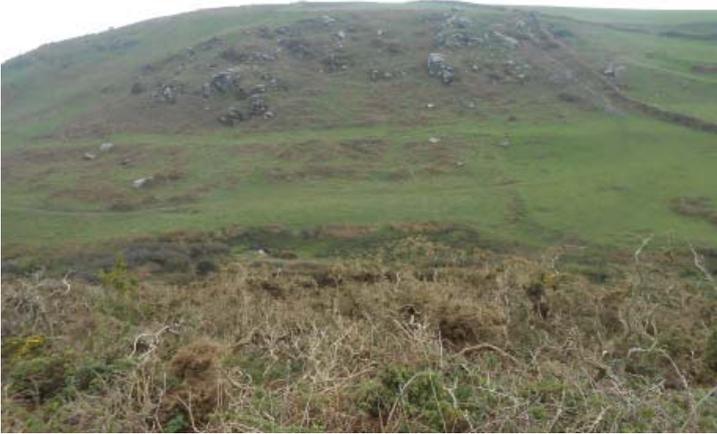
Fig 11 Earthwork remains of an alleged settlement and field boundaries in Starehole Bottom. View from the north.

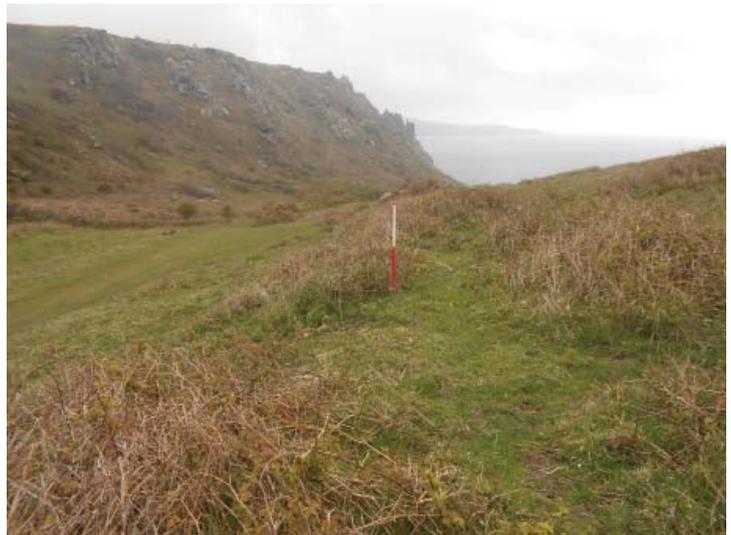
Fig 12 An earthwork boundary in Starehole Bottom (c on Fig 5).View looking south east.

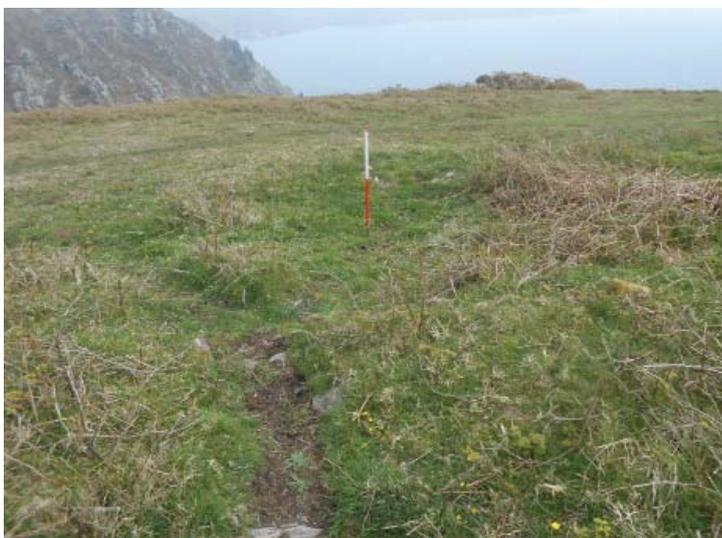
Fig 13 Earthwork remains of a hut circle on South Down (k on Fig 5) .View looking east.

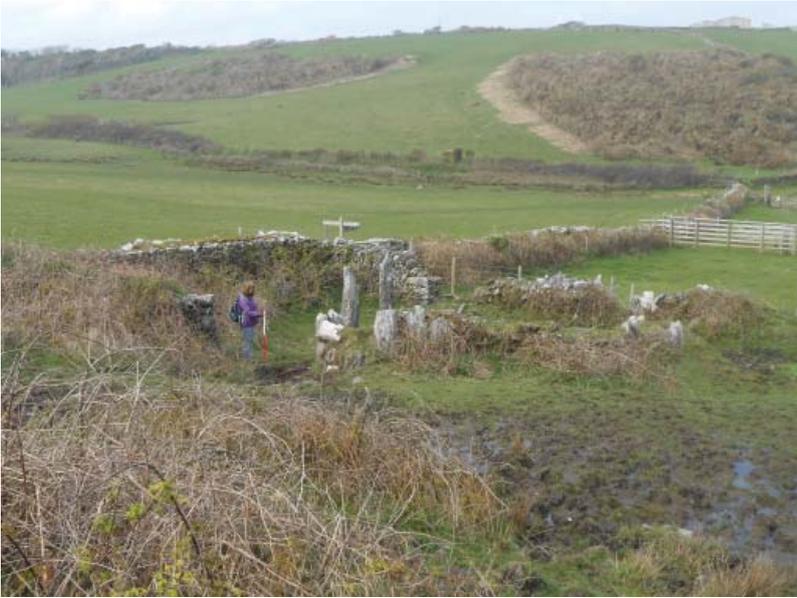
Fig 14 The linhay at the head of Starehole Bottom (f on Fig 5). View looking north west.

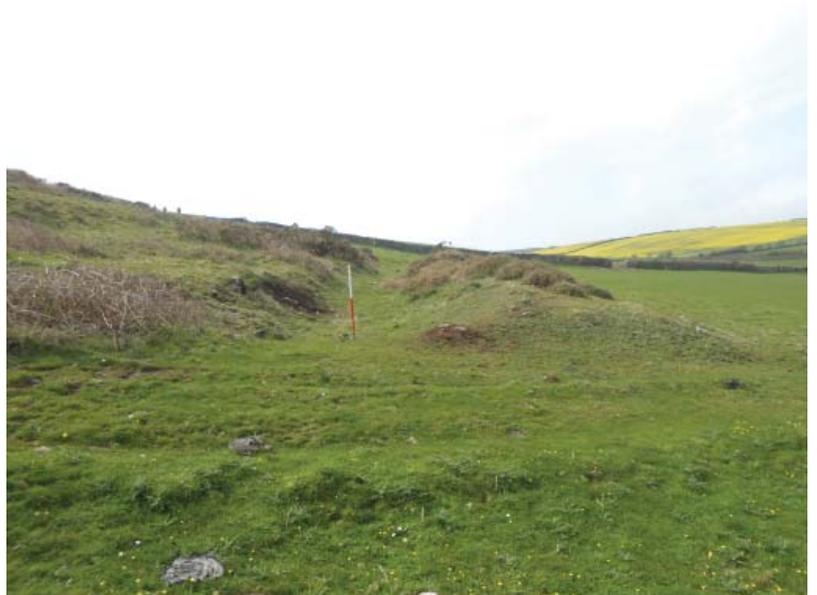
Fig 15 The Giant's Grave (e on Fig 5). View looking WNW.

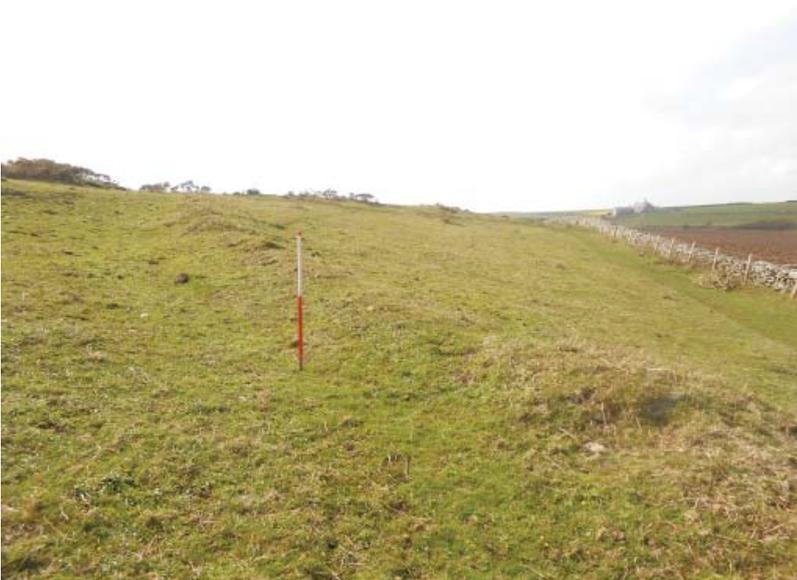
Fig 16 A semi-circular enclosure wall to the south-east of Middle Soar (Fig 6). View looking north west.

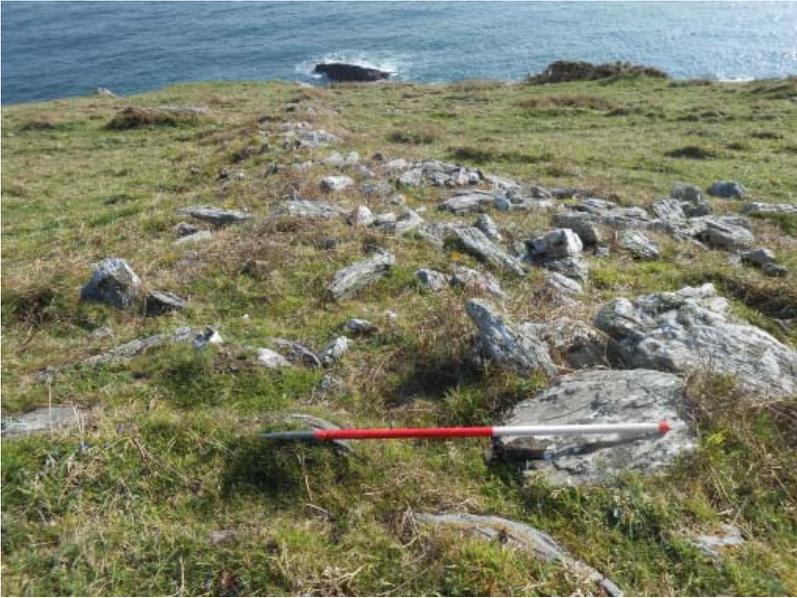
The hut circles were not found by Winton and Bowden (2006) and their location is still not certain, as no field evidence was located during fieldwork for the current report (on a second visit the area had become completely overwhelmed by bracken). However, the two adjoined rectangular enclosures are clear on steeply inclined ground, 40m north of the lower cliff edge (Fig 6 s; Fig 17). Although the stony walls are very flat and spread, occasional

Fig 17 Remains of possible prehistoric enclosure wall at Little Goat (s on Fig 6). View looking south.

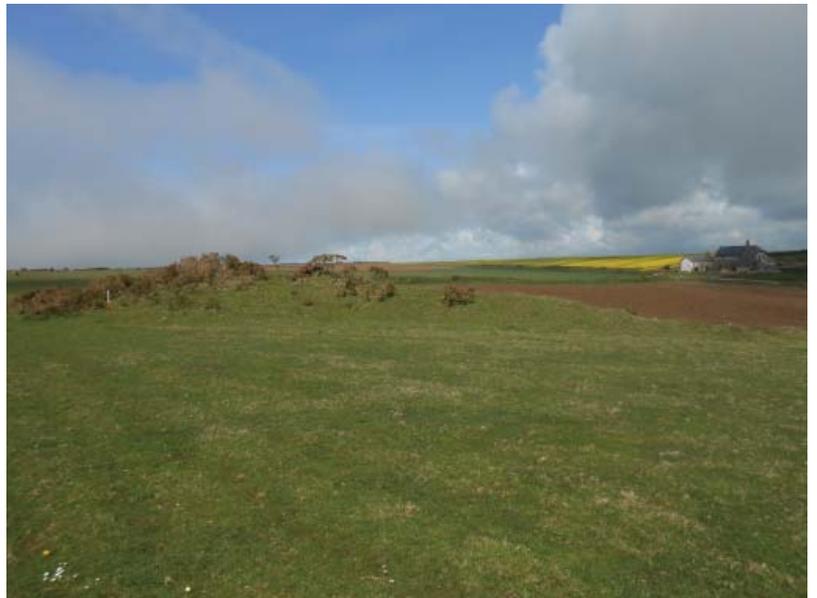
Fig 18 The large earthwork mound to the south of Middle Soar (a on Fig 6). Interpreted either as a neolithic long barrow or a rabbit bury (pillow mound). View from the east.

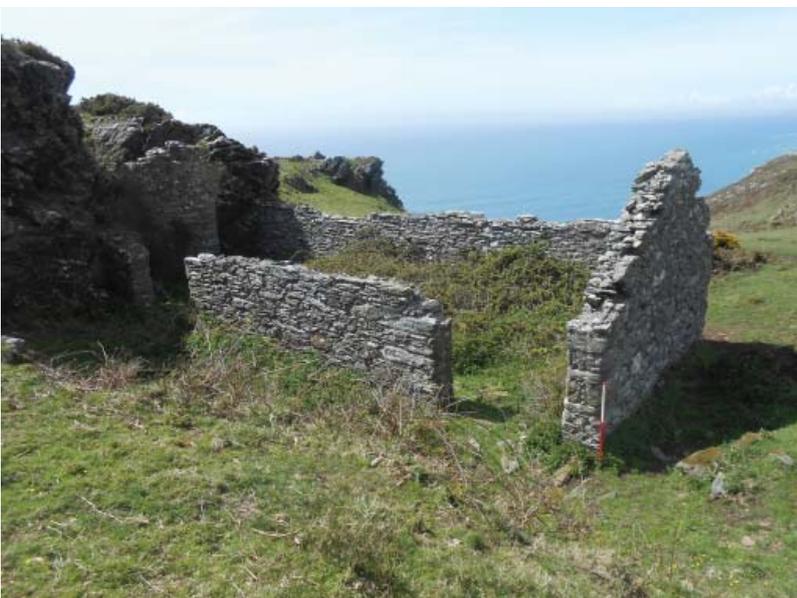
Fig 19 The ruins of Warren Barn (K on fig 6). View from the east.

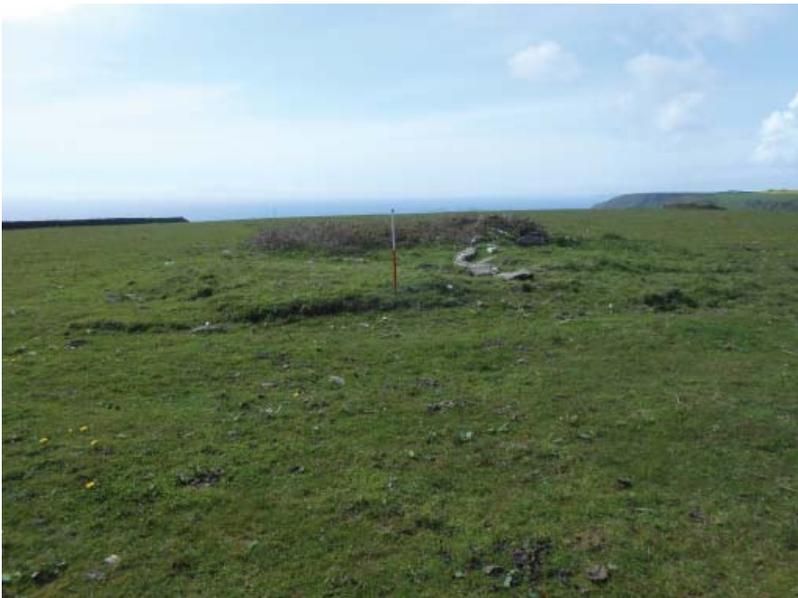
Fig 20 A round barrow (r on Fig 6) in a field north of Warren Barn. View from the north.

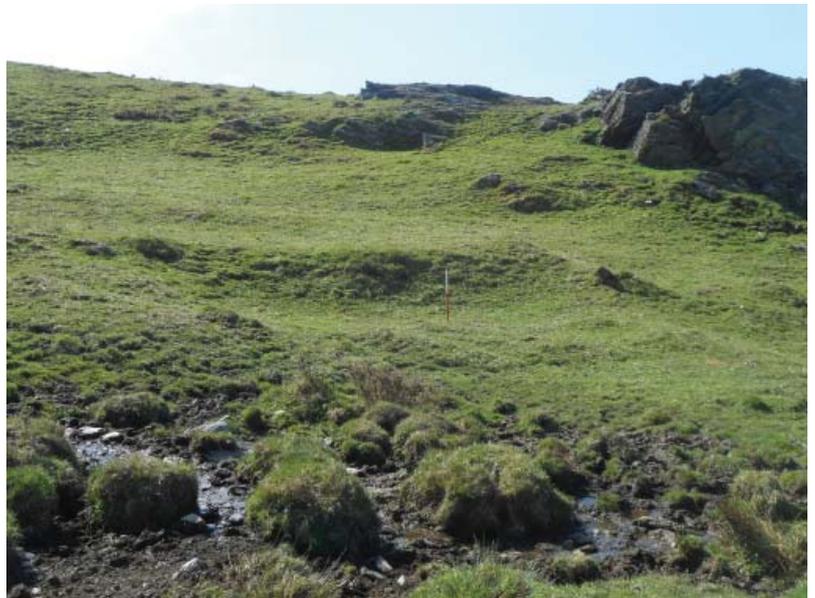
Fig 21 Earthwork remains of a medieval settlement at Warren Barn. View shows building n (Fig 6) viewed from the north west.

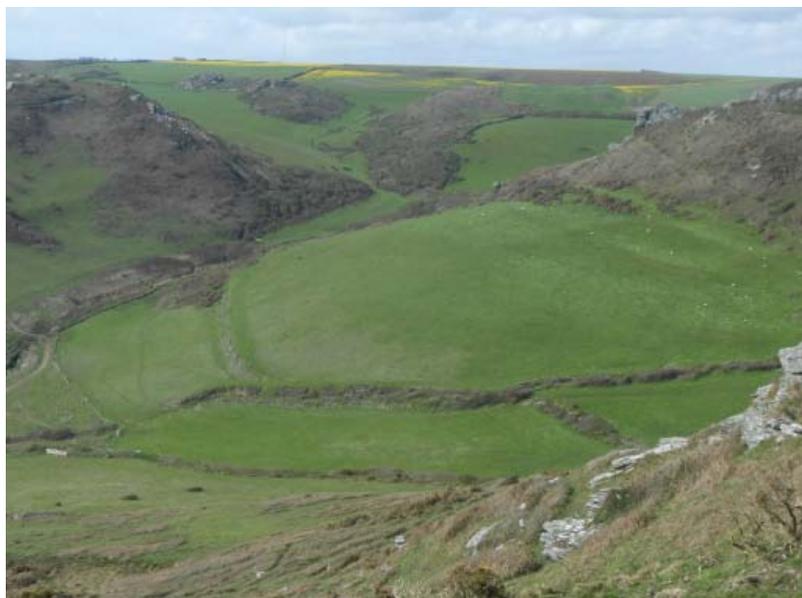
Fig 22 Mousehill Break viewed looking north from Tinker's Well. Lynchets are to the right side of the pasture field.

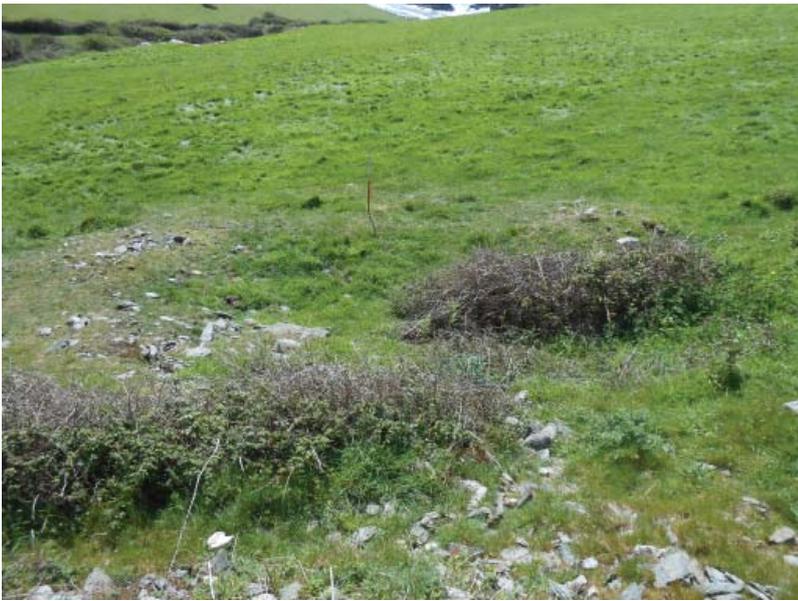
referred to, though there is insufficient stone present to signify a hut circle. A second assumed hut circle is to the SE (g) where a horseshoe bank of small stones, covered by turf and with a sunken centre sits near the bottom of the lynchet.

Fig 23 An alleged hut circle at Mousehill Break (g on Fig 7). View looking south west.

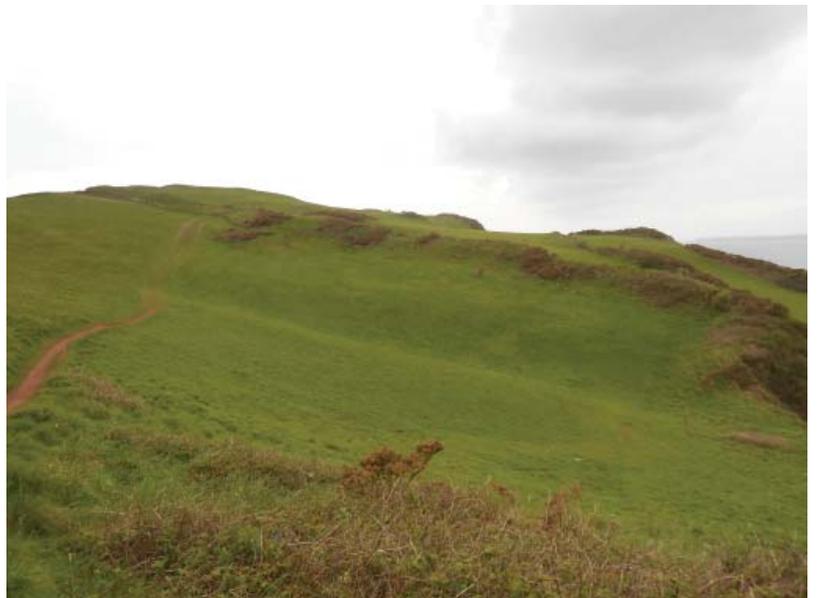
Fig 24 General view of the rampart at Bolt Tail promontory fort. Viewed from the east

A resurvey of Bolt Tail fort is a priority, and will be necessary to provide information during any erosion repairs that take place in the future (see above). The fort was surveyed by the RCHME in 1987, but much appears to have changed in the period since this survey was undertaken and since the EH schedule document was prepared several decades ago.

It is highly recommended that a new earthwork survey of the site is undertaken, using modern electronic recording techniques to provide an accurate, up to date, geo-referenced plan, suitable for GIS usage, together with profiles and ground models. The survey should show graphically the areas of damage, erosion and vegetation
