Archaeological Excavations at Ventiford Basin on the Stover Canal, Teigngrace, Devon

First Interim Report

Report prepared on behalf of the Stover Canal Trust
by
Phil Newman of South-West Landscape Investigations

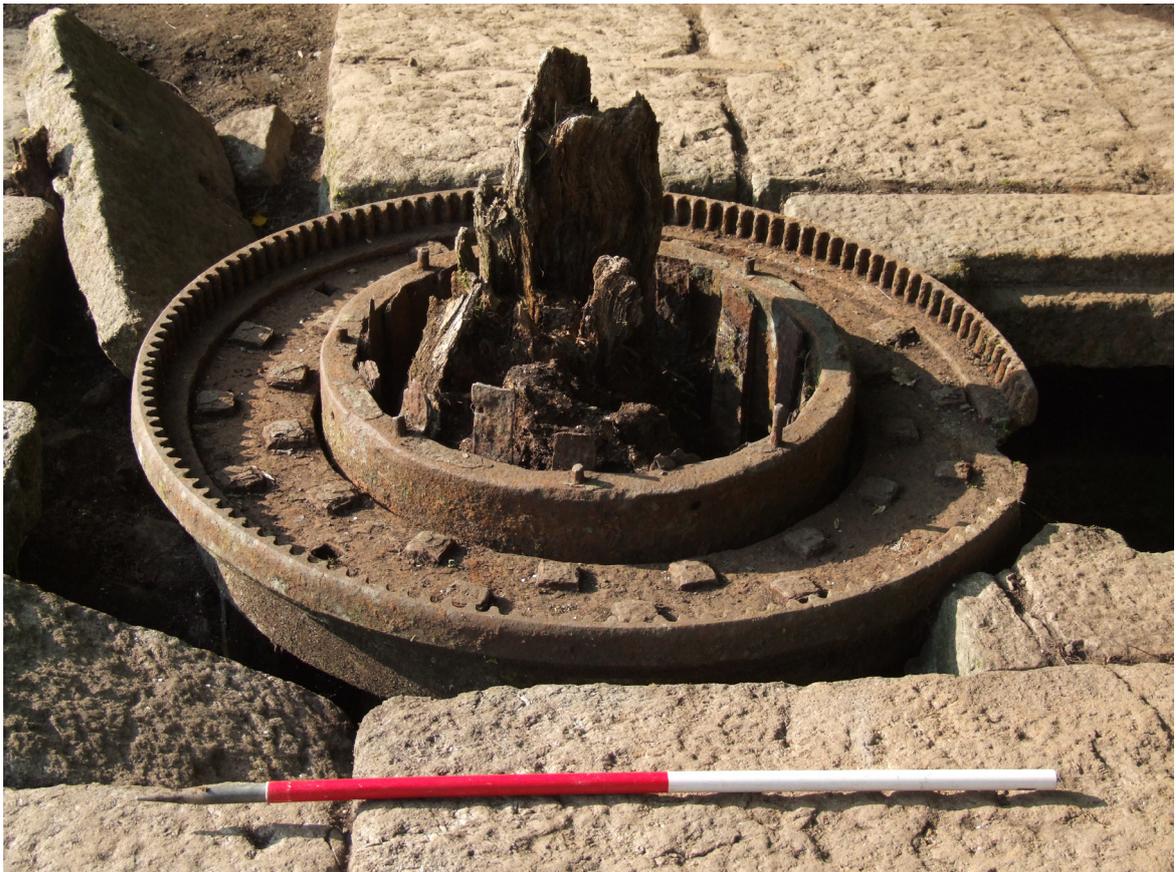
Frontispiece: The iron base of a crane at Ventiford, used for transferring granite from the Haytor Granite Tramway onto barges of the Stover Canal.

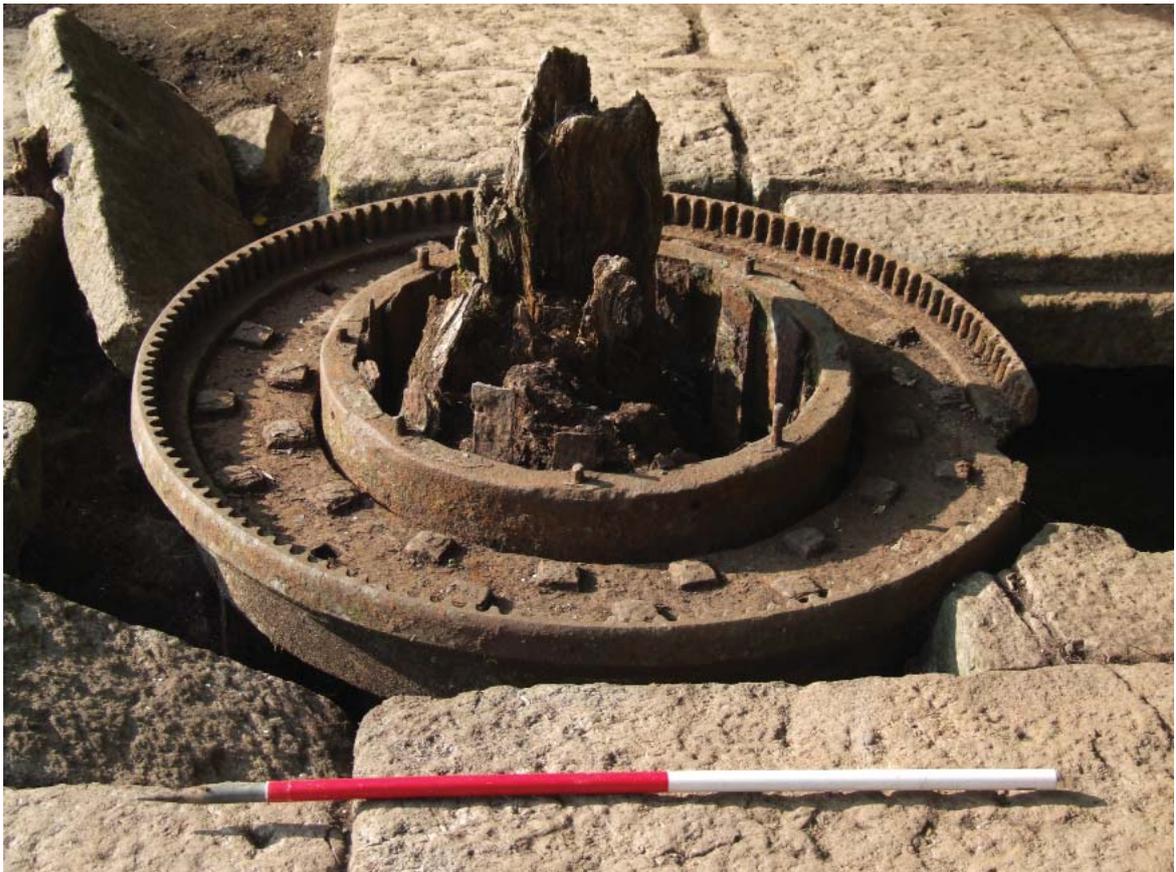
Frontispiece: The iron base of a crane at Ventiford, used for transferring granite from the Haytor Granite Tramway onto barges of the Stover Canal.

The western edge of Ventiford Basin is bounded by the bottom of the railway embankment, constructed between c. 1862-6; this has overwhelmed a large portion of the working area at the quayside, and completely effaced the granite tramway at its terminus on the western side. A narrow wedge of land survives beside the quay, which includes a granite platform and the cast iron base of a crane, used to transfer granite from tramway to barge.

much scope for archaeological discovery, being one of the canal's main hubs from the 1790s to the mid 1860s. For logistical reasons, including vegetation cover, easy access and parking, it was also considered an ideal site as a first dig for an inexperienced team. Historical studies of the canal suggest there is much to discover at Ventiford so the dig and the positioning of individual trenches, has been designed to answer specific questions. The investigation also provided an ideal occasion to remove vegetation from the iron crane base on the western quayside, which was then drawn and photographed in detail (frontispiece).

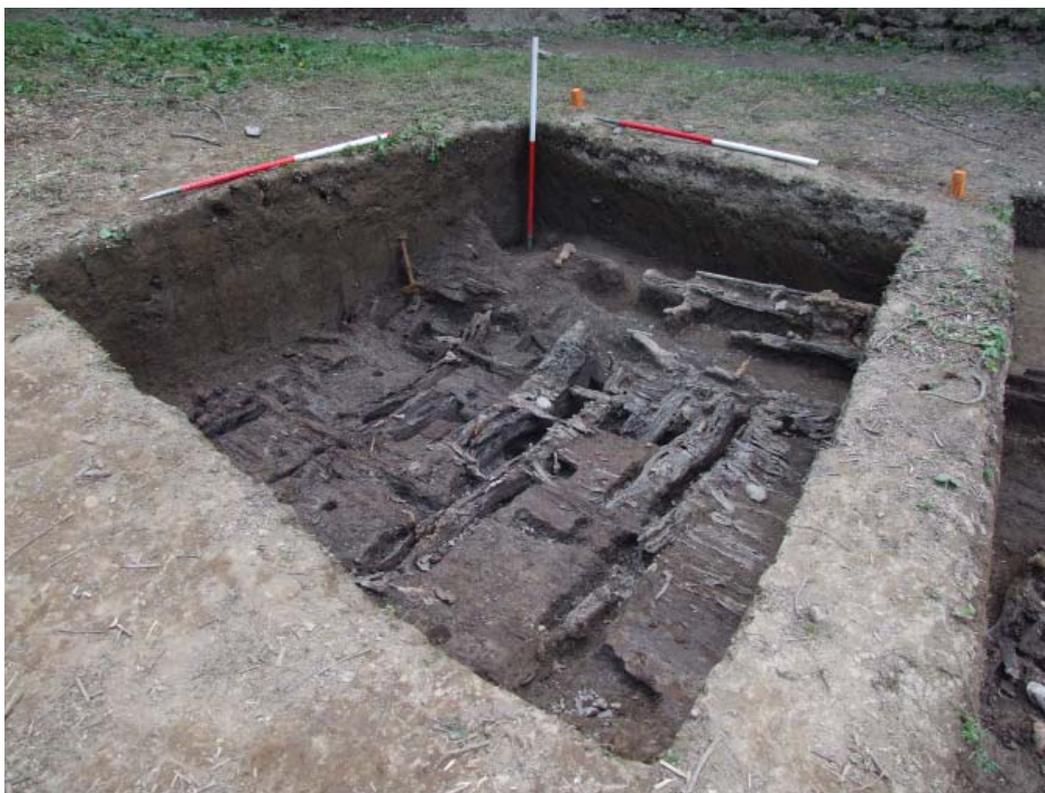
Fig 3 Trench 2b showing the part-excavated barge.

and a little deeper the first timbers began to emerge. A second, larger, trench (T2b) was then started adjacent to the first, with a 0.5m balk left between the two, to allow access to excavate because the timbers could not be walked on.

Over the seven days of work, the timbers were revealed along with much iron work, mostly nails, some of which were still *in situ*, lodged in the timbers. Only the very bottom section of the vessel has survived. The timbers, although wet, were still firm, and although the surrounding silty-clay soil was not easily hand excavated, the moisture it contained did help keep the timbers damp. However, the unexpectedly sunny weather in May 2014, caused problems of rapid drying, so polythene sheets were necessary to cover part-excavated areas when not being worked on.

The excavation reached down to the ceiling² of the hold, revealing its planked structure, nailed to the floors³ with hand-made 5 or 6-inch iron nails. In places the ceiling was rotted away, at which points the floors, with lower sections of the frames still attached at the ends, had become exposed. Sections of the bottom planking were also visible.

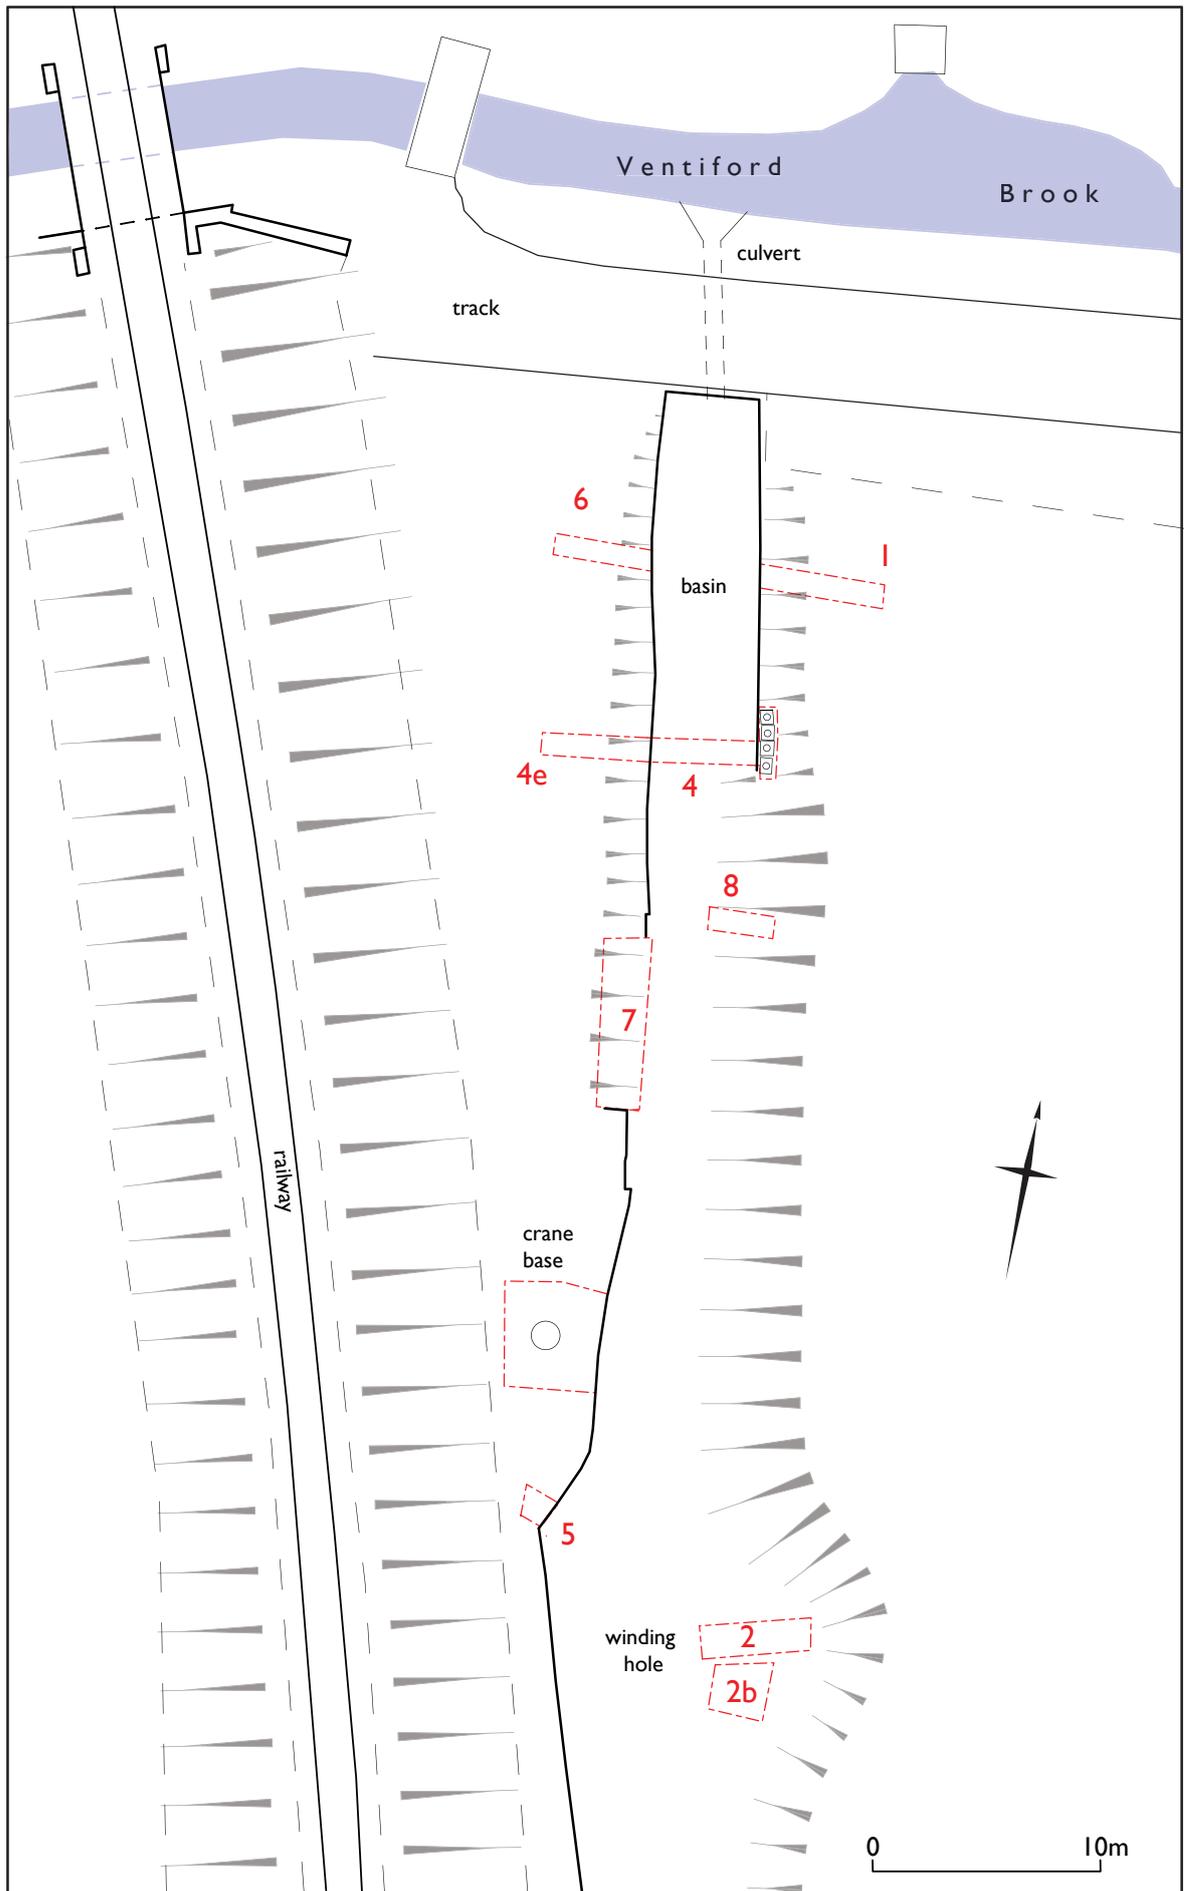
Fig 4 Plan of Ventiford Basin showing excavation trench locations. Based on survey data collected May 2014 with additional material (railway and fences) from a 1:500 scale plan by Paul Taper of SCT (2000).

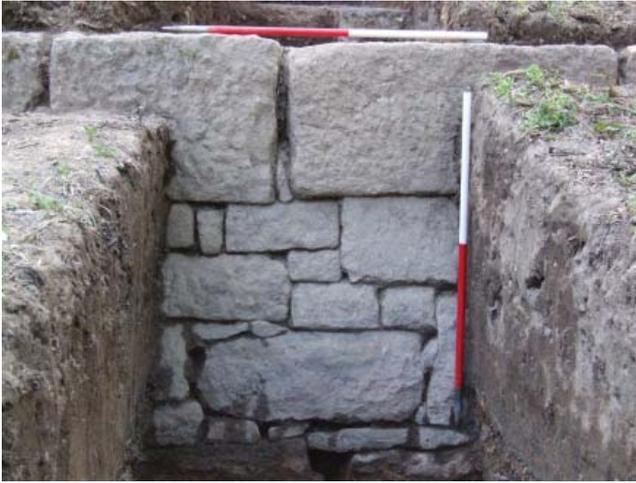
Fig 5 Trench 4 showing the well-constructed revetment on the western quayside.

The stone quayside revetments on the west and eastern sides of the basin are constructed in two different styles. That on the west (Fig 5), is built from dimensioned and dressed blocks of granite, neatly laid with a slight batter. The capstones that form the edge of the quay are particularly large at approximately c.0.5m by 1m long.

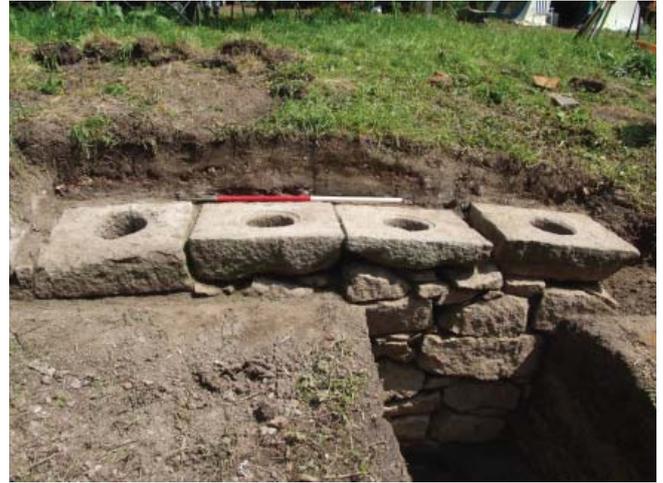
Fig 6 Copings with central holes on the eastern quayside.

On the east side, randomly shaped granite has been used and stacked, rather crudely, to form the revetment. The copings along the section exposed comprise four pieces of squared granite with sides between 0.6m and 0.75m long and up to 0.3m thick. Three have dressed upper faces (the fourth may be facing down) and all have a central hole of 0.23-0.25m diameter, with a shallow rebate around the circumference (Fig 6).

These stones almost certainly had their origin at Haytor Quarry, and were probably cut originally for use as the hatches for coal chutes of a type popular in Victorian cities, especially London. A circular cast-iron cover, usually highly decorated, would sit in the flanged hole. Alternatively, they may have been intended for use as drain openings with a circular iron grate; examples of the latter may be seen at Stover House.

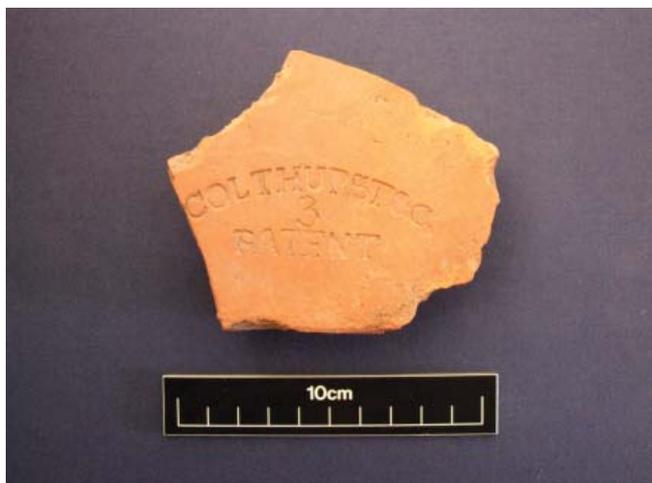
Fig 7 Fragment of a roof tile. One of many found in Trench 3.

Tiles – A large assemblage of terracotta roof tiles was retrieved from Trench 3, assumed to be from the roof of the building that formerly stood to the east of the winding hole. Each tile was impressed with the word 'Colthurst & Co 3 Patent'. This was a Bridgwater company who were making tiles of this type from about the

1840s. Their catalogue shows the tile type as single Roman design. Although this might suggest an approximate construction date for the building in the 1840-50s, it could also represent a re-roofing operation of that date on an already standing building.

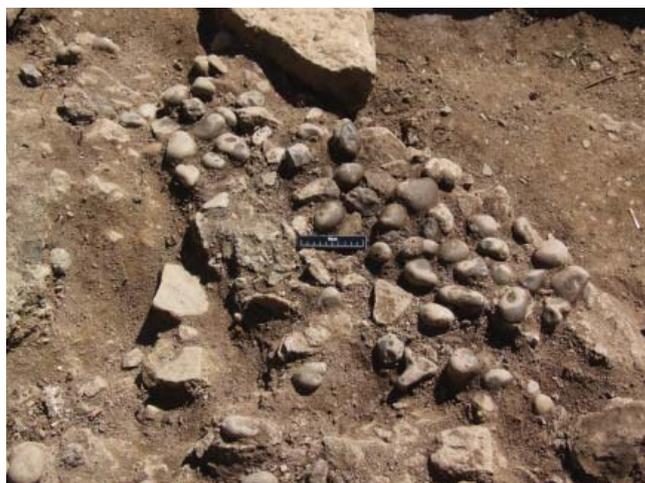
Fig 8 Assemblage of flint cobbles found in Trench 7.

Flint – A large quantity of abraded flint nodules was found in trenches on the western quayside, specifically Trenches 5 and 7. The nodules were of a uniform size, about that of a medium potato, and were found in assemblages at two points along the quay, representing remnants of heaps.

Although flint occurs locally, in the Haldon Hills and in the so-called Aller Gravels, found around Kingsteignton, nodules with abraded cortex are uncommon in this district and these appear to be imports, probably originating from a beach.

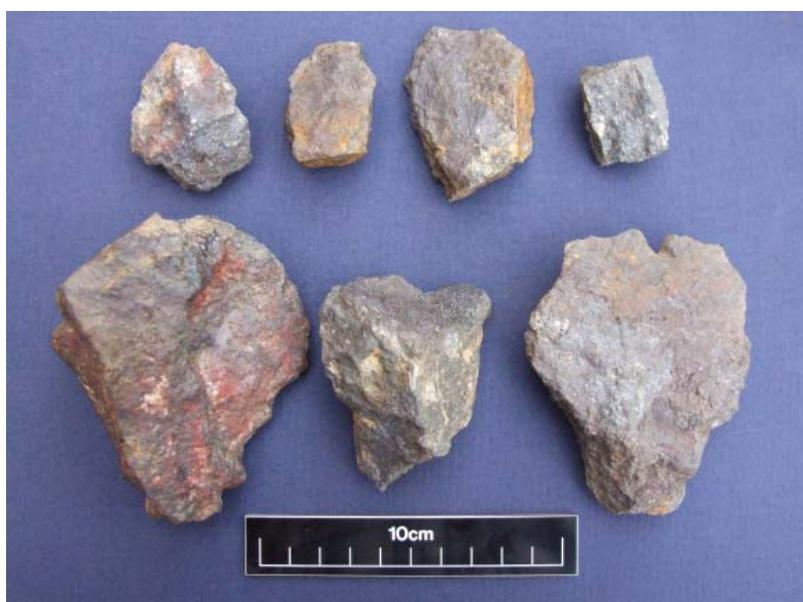
Fig 9 Low grade, unprocessed micaceous hematite ore.

Samples of the ore retrieved included fine particle sands, some of which is assumed to be dressed ore, spilled in transit. In places around the quayside, especially on the western side, this formed strata of approximately 30mm thick. There was also many lumps of low-grade unprocessed ore at the site (Fig 9). The presence of this unprocessed material is something of a puzzle, as this type of ore was always dressed at the mine site to produce a usable commodity. Why it was moved in this raw state remains to be answered.

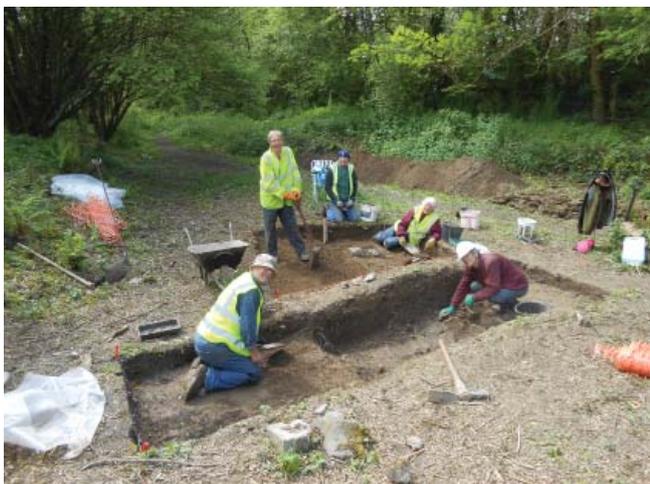
Fig 12 The barge excavation, early stages.
