The Burning House at Atlas Mine, Ilsington, Devon

Historic Building Survey

March 2016

Survey and report
by
Phil Newman

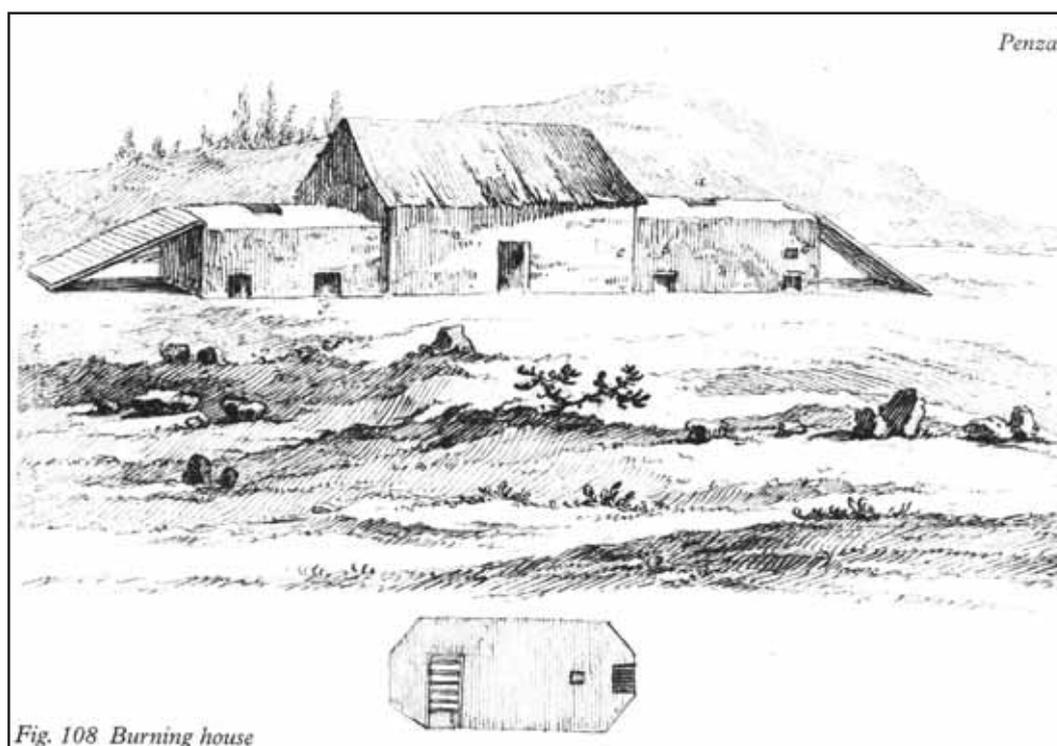
Fig 5 Image of a twin burning house from Angerstein's Illustrated Travel Diary 1753-5.

During a visit to Cornwall by Swedish writer R R Angerstein in 1753-5, he witnessed the use of burning houses where 'the ore that is contaminated with sulphur and copper must be calcined' and he provided several useful drawings (Fig 5) of burning houses of the period (Berg & Berg 2001, 106-7, Figs 97 & 108).

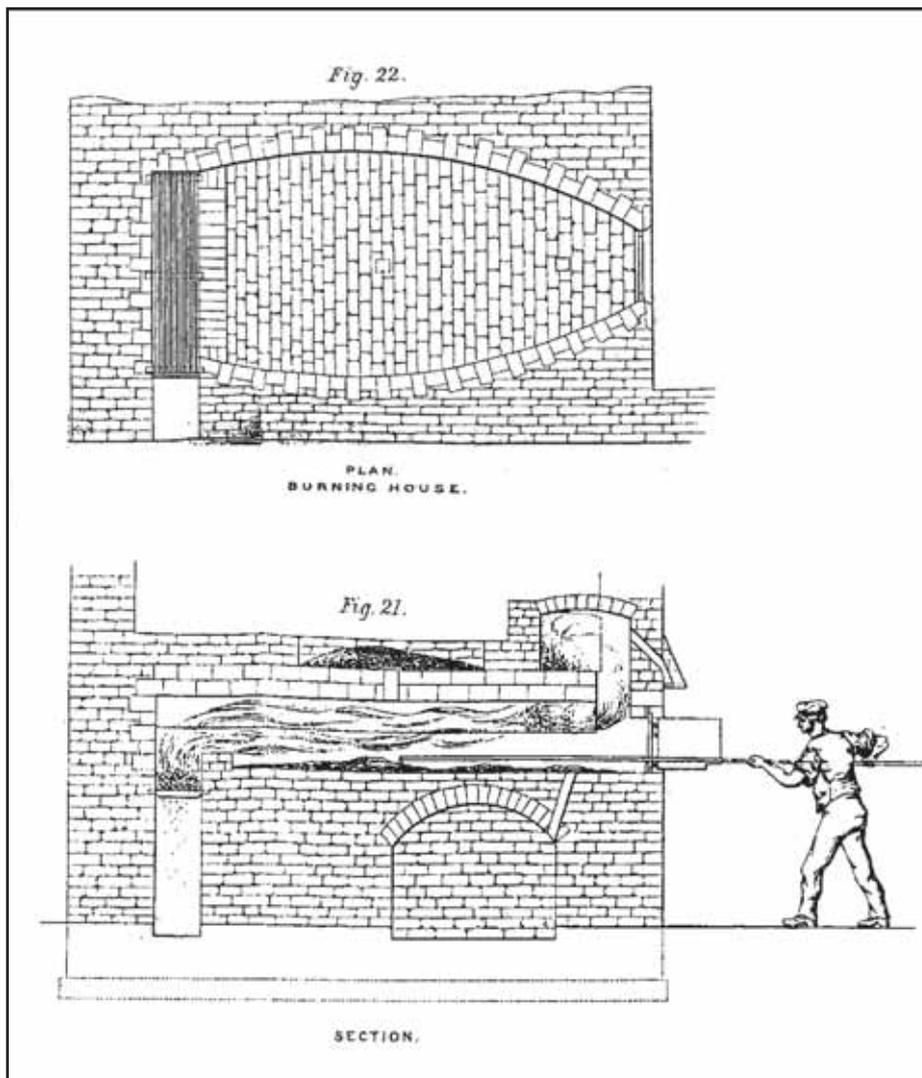
Fig 6 Plan and section drawing of a reverberatory calciner by Henderson 1858.

consisted of a burning chamber with a raised floor and low vaulted roof with a fire set at one end. At the other end was a flue outlet and an opening with an iron door, through which an operator could rake the ore whilst it was being burnt. The dressed ore was fed into the furnace from an upper floor through a small opening in the ceiling. The upper floor, which would have been warmed by the fire below, would also serve to dry the ore before placing it in the furnace. This process, and the design of the structure, was well illustrated by Henderson's plan of 1853 (Fig 6) and all the components depicted exist at the Atlas example.

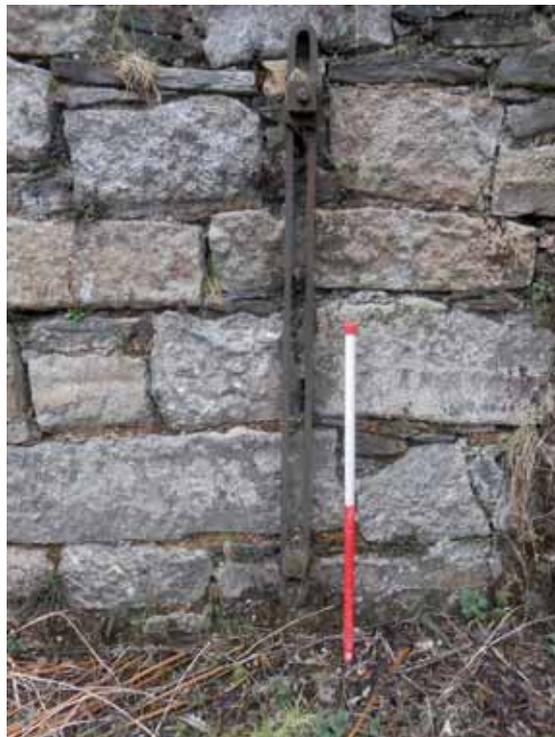
Fig 7 Iron clamps on the exterior of the burning chamber.

The outer walls of the lower levels of both calciners, containing the burning chambers, are constructed largely from the re-used granite tramway blocks, to provide a thicker robust structure. Each chamber has four iron braces passing through it - two above and two below the void - connecting with vertical exterior clamps on the front and rear to further consolidate the walls. Each iron clamp is 1.6m long and secured to the braces with 2½ inch square nuts with round washers, tightened on to square plates (Fig 7). An additional, small, square iron

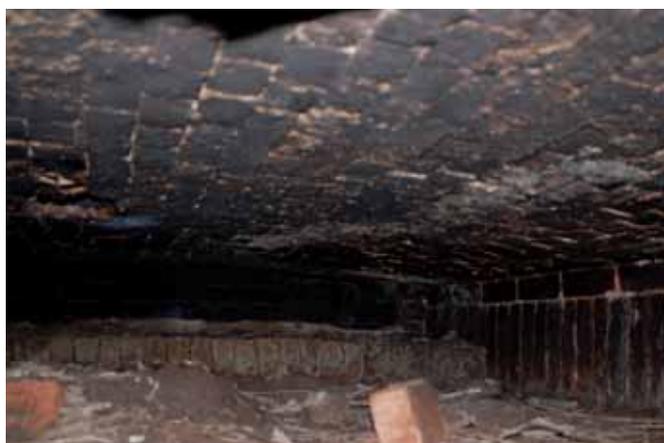
Fig 8 Interior of the east burning chamber, looking east towards the furnace, showing the lining of brick, the curved vault, and the low course of bricks at the edge of the furnace.

The burning chamber and furnace are lined entirely with brick, which is encased by the outer structure of granite and killas. In plan, the burning chamber interiors have parallel sides, 2.45m apart, for over half of their length, which then taper to form funnelled ends, narrowing down to 0.55m at the access door. The walls of the chamber and furnace are between 0.8 and 0.9m thick. The ceiling is subtly vaulted (Fig 8), with a maximum height on the curve of 0.48m.

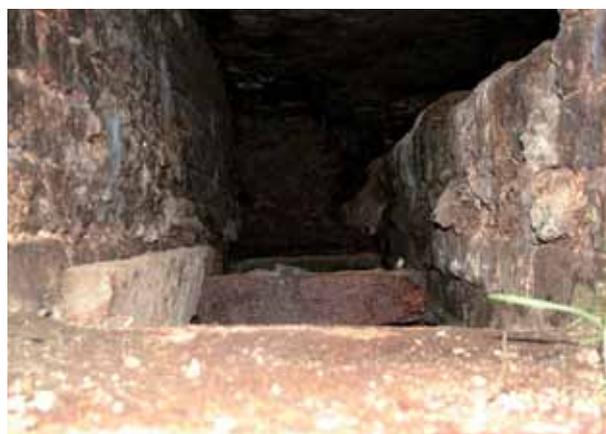
Fig 9 Furnace interior (east) showing the iron rails that supported the grate. Note also the wall to the right which does not extend up to the vault of the burning chamber.

The furnaces are located within the end portion of the building and comprise chambers of 0.5m wide running across the internal width, with the rear, northern end opening through the wall to provide stoking access and draught. These openings had iron doors, which are no longer present, but the iron plates forming the bottom of the portal are still in place. The base of the furnace chamber, where ash would collect, was at approximately the base level of the main walls and in height the furnace extended to the top of the burning chamber, leaving the space between the floor and ceiling of the burning chamber open for the heat to pass across. Iron plates, surviving *in situ*, stretch between the two walls of the furnace (Fig 9). These would have supported a grate, not surviving, on which the fire was set, positioned slightly lower than floor level of the burning chamber. A single course of bricks along the lip of the burning floor (Fig 8) created a low screen to separate the chamber from the furnace, allowing the heat to travel across the chamber but avoiding the flames coming into direct contact with the ore which was spread over it.

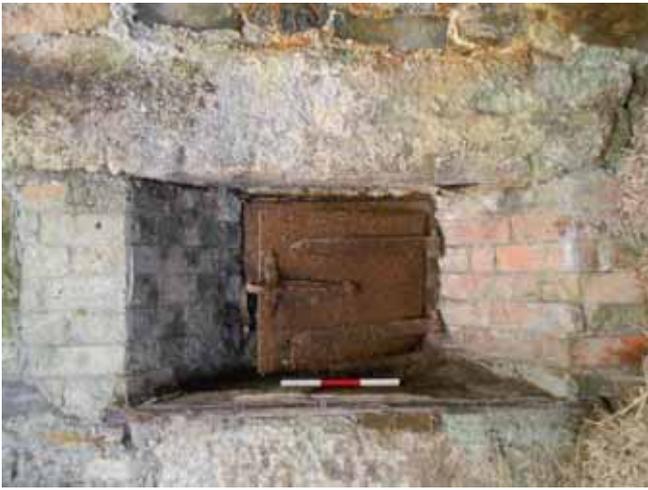
Fig 10 Showing the recessed access door to western burning chamber, with brick lining and granite lintel.

The opening on the eastern chamber is lined with brick on both sides and above, reinforced top and bottom with horizontal iron plates. The western chamber has brick sides, but above the opening a large granite lintel replaces both the brick and the iron plate (Appendix 5; Fig 10).

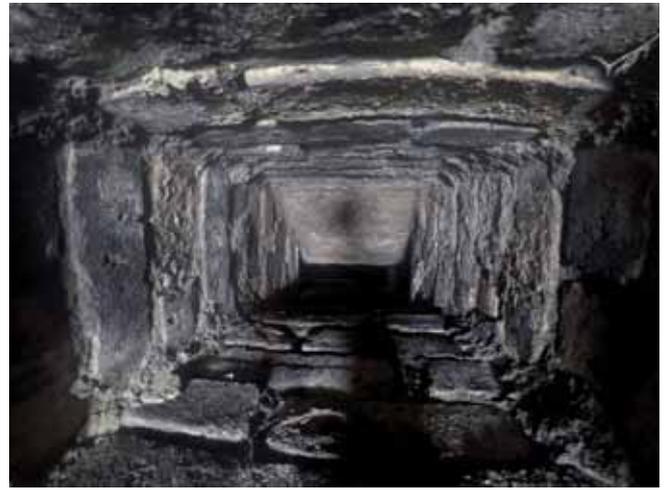
Fig 11 Interior view of the vertical flue looking down from the upper floor.

Just inside the access door, a square vertical flue runs to the top of the building via a chimney (Appendix 4). On the eastern chamber the chimney is made entirely from brick, though on the west the brickwork commences approximately 1m above the opening (Appendix 5). On both sides the brickwork has been incorporated into a mostly stone wall. For the flue not to overlap the recessed access opening situated at its base, it had to be built onto the inside of the calciner's inner end wall, then angled up to the chimney. This can be seen on the upper floor above the burning chamber, where the brickwork protrudes out from the wall at floor level, then is stepped toward the wall to accommodate the angled passage of the flue, which thereafter takes up only the thickness of the wall, and where the brickwork is flush both sides (Fig 12). The height of the stepped section of brickwork varies on the east and west calciners, with that on the east being much higher.

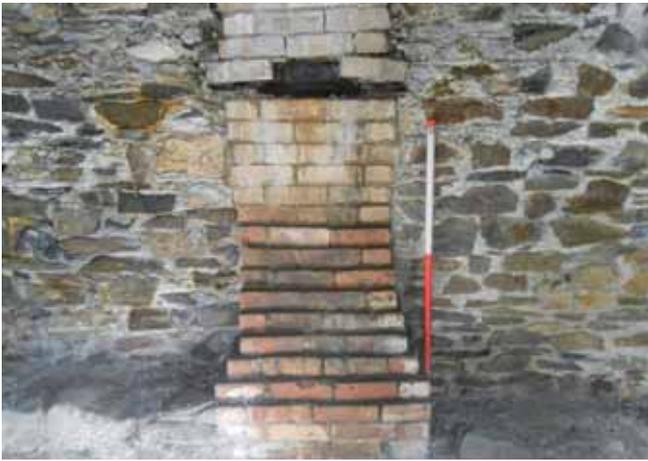
Fig 12 (top) The brick chimney built into the internal wall of the western calciner, showing slot for damper and stepped lower section.

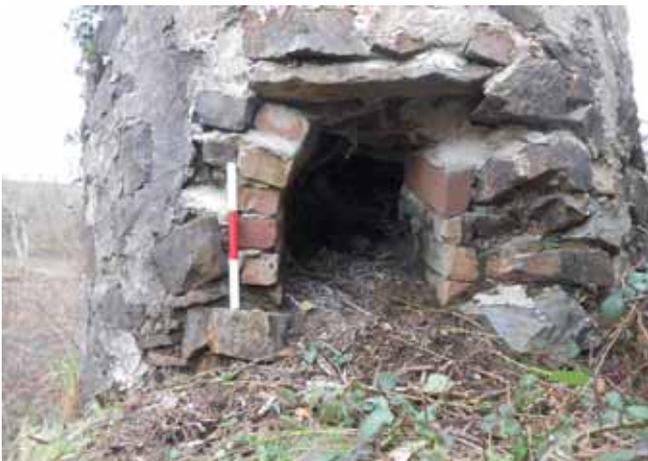
Fig 13 (left) The brick-lined flue opening in the exterior chimney.

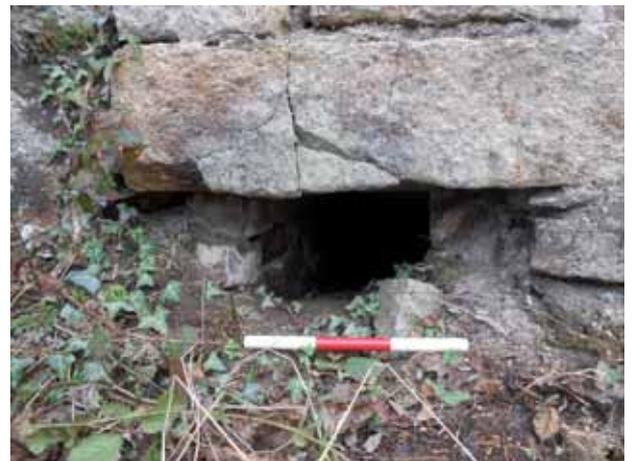
Fig 14 (right) Horizontal flue exiting the rear (north) side of the western calciner.

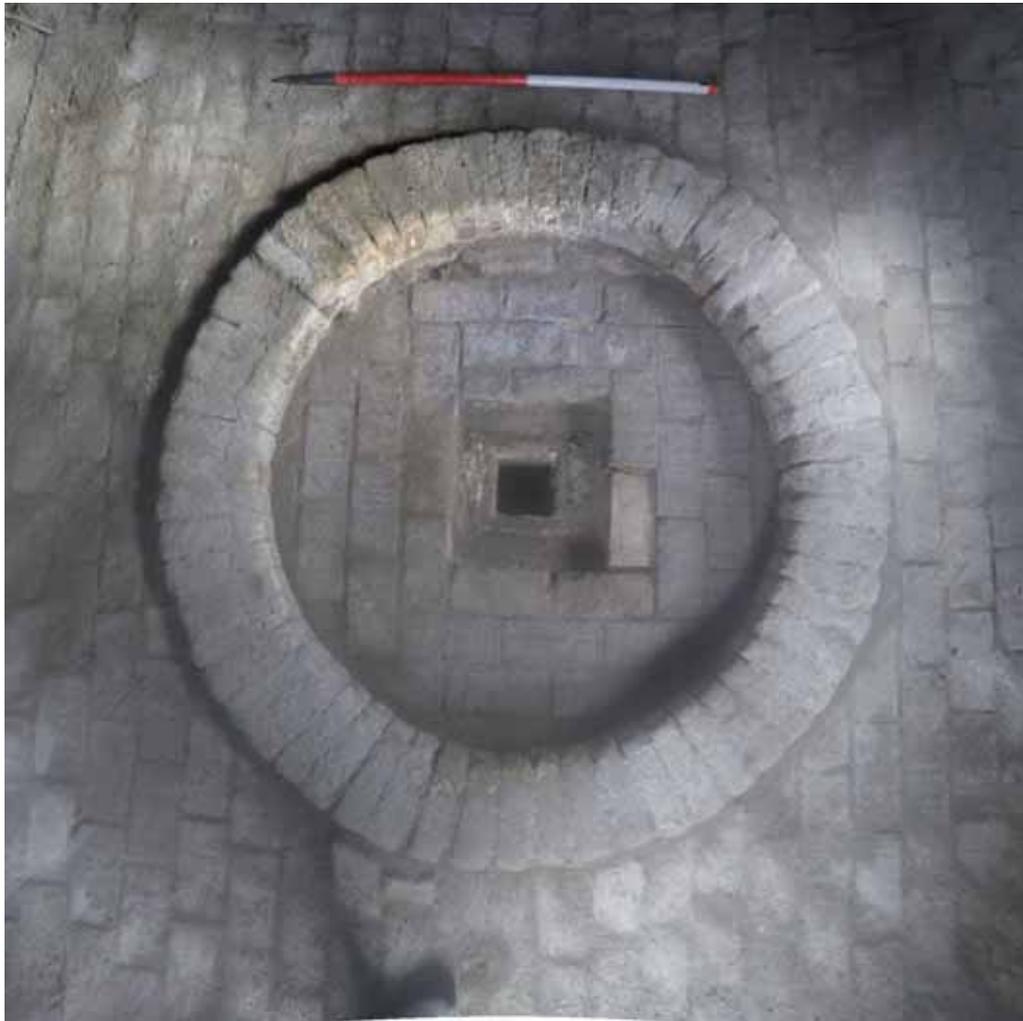
Fig 15 Plan view of the brick floor and brick-lined drying pan in the upper level of the calciner. Shows the central, square opening of the chute down to the burning chamber and square recess of a probable covering hatch.

The upper level of each calciner comprises a brick floor covering the burning chamber and furnace, with a circular depression, which served as drying pan, set approximately centrally within the floor (Fig 15). The circumference of the circle is defined by a rim of edge-set bricks giving an internal diameter of 1.25m (4ft), by 0.12m (4.5 inches) deep. The charge of ore would be placed within this circle to dry, then directed down onto the floor of the burning chamber below, via a narrow square chute placed centrally in the circle. A square recess of approximately 40cm surrounding the chute opening, undoubtedly held a metal hatch to shut it off.

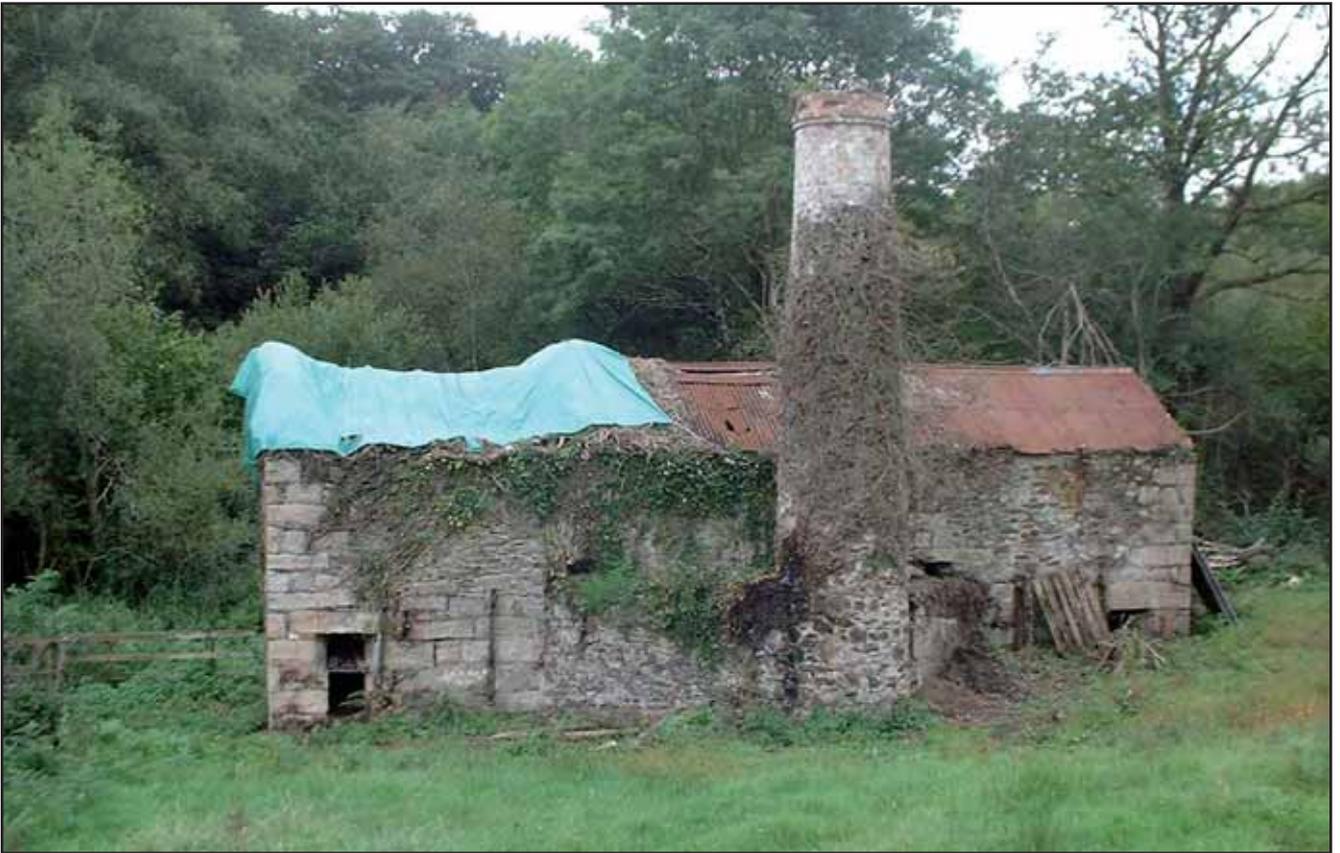
the late Arthur Courtier and his son David, who, at their own expense, took on repairs to the building, which prevented further, potentially catastrophic, decay. When photographed from the south by Peter Richardson in 1990 (Richardson 1990, PI 32), almost the entire structure was engulfed by mature ivy, in particular the eastern end, where the roof was covered. The chimney was also clad with ivy at that time. Much of this ivy was removed in the 1990s and repairs were made to the mortar, where affected by the ivy. However, when the site was visited first by the present author in 2000, large trunks of ivy were still affecting the eastern calciner where the roof had completely decayed (Fig 16).

Fig 16 View of the north side of the burning house in 2000, showing the missing section of roof and extensive ivy growth on the chimney and eastern end of the building.

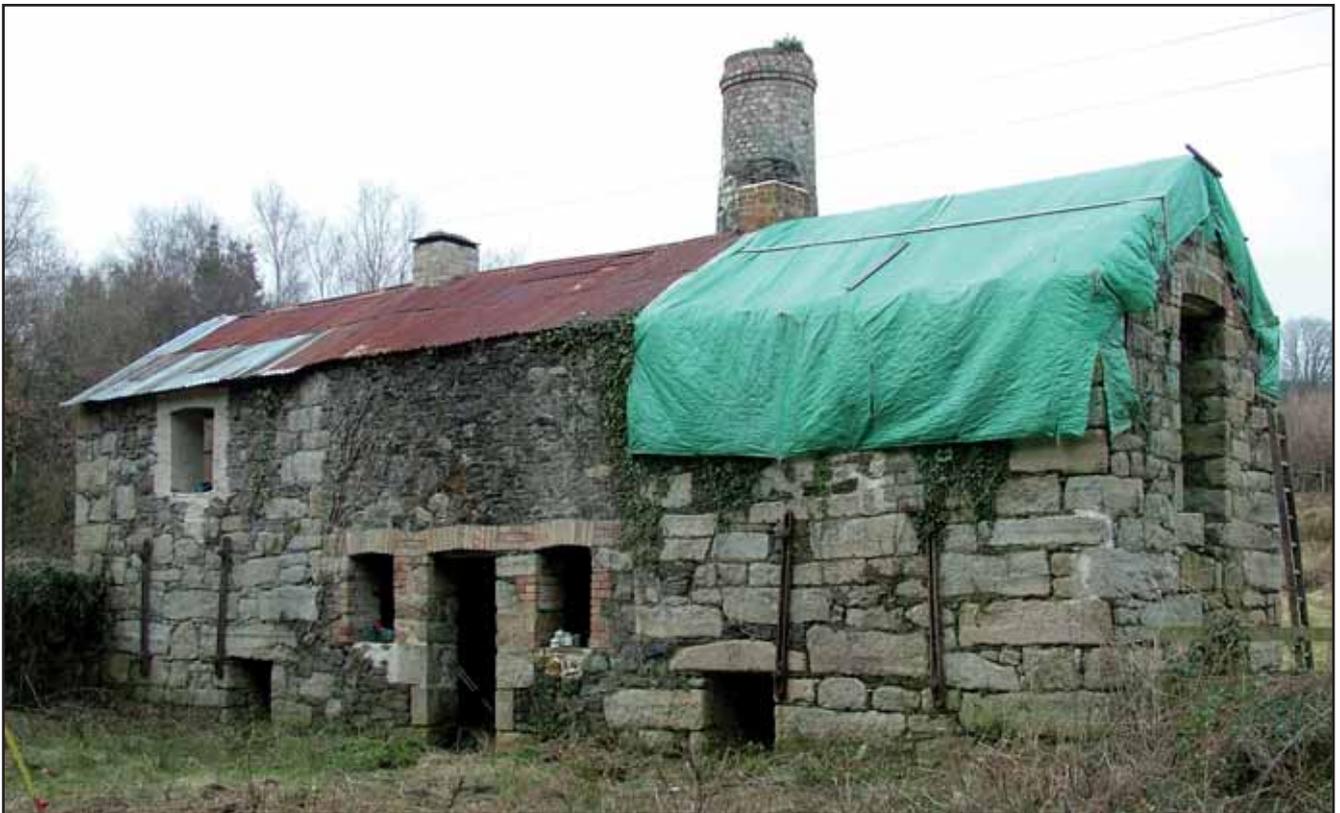
By 2008, just before the property changed hands, all the mature ivy had been removed, additional repairs to stonework and mortar had been carried out, and parts of the roof had been re-sheeted. The new owners completed repairs to the roof in 2009, re-sheeting the eastern end. Following this, nothing further has been achieved and ivy is beginning to make a return, especially on the south wall (Fig 17).

Fig 17 View of the south side of the building in 2008, after the removal of much ivy and some repairs to the mortar. Eastern end still awaiting re-sheeting of the roof.

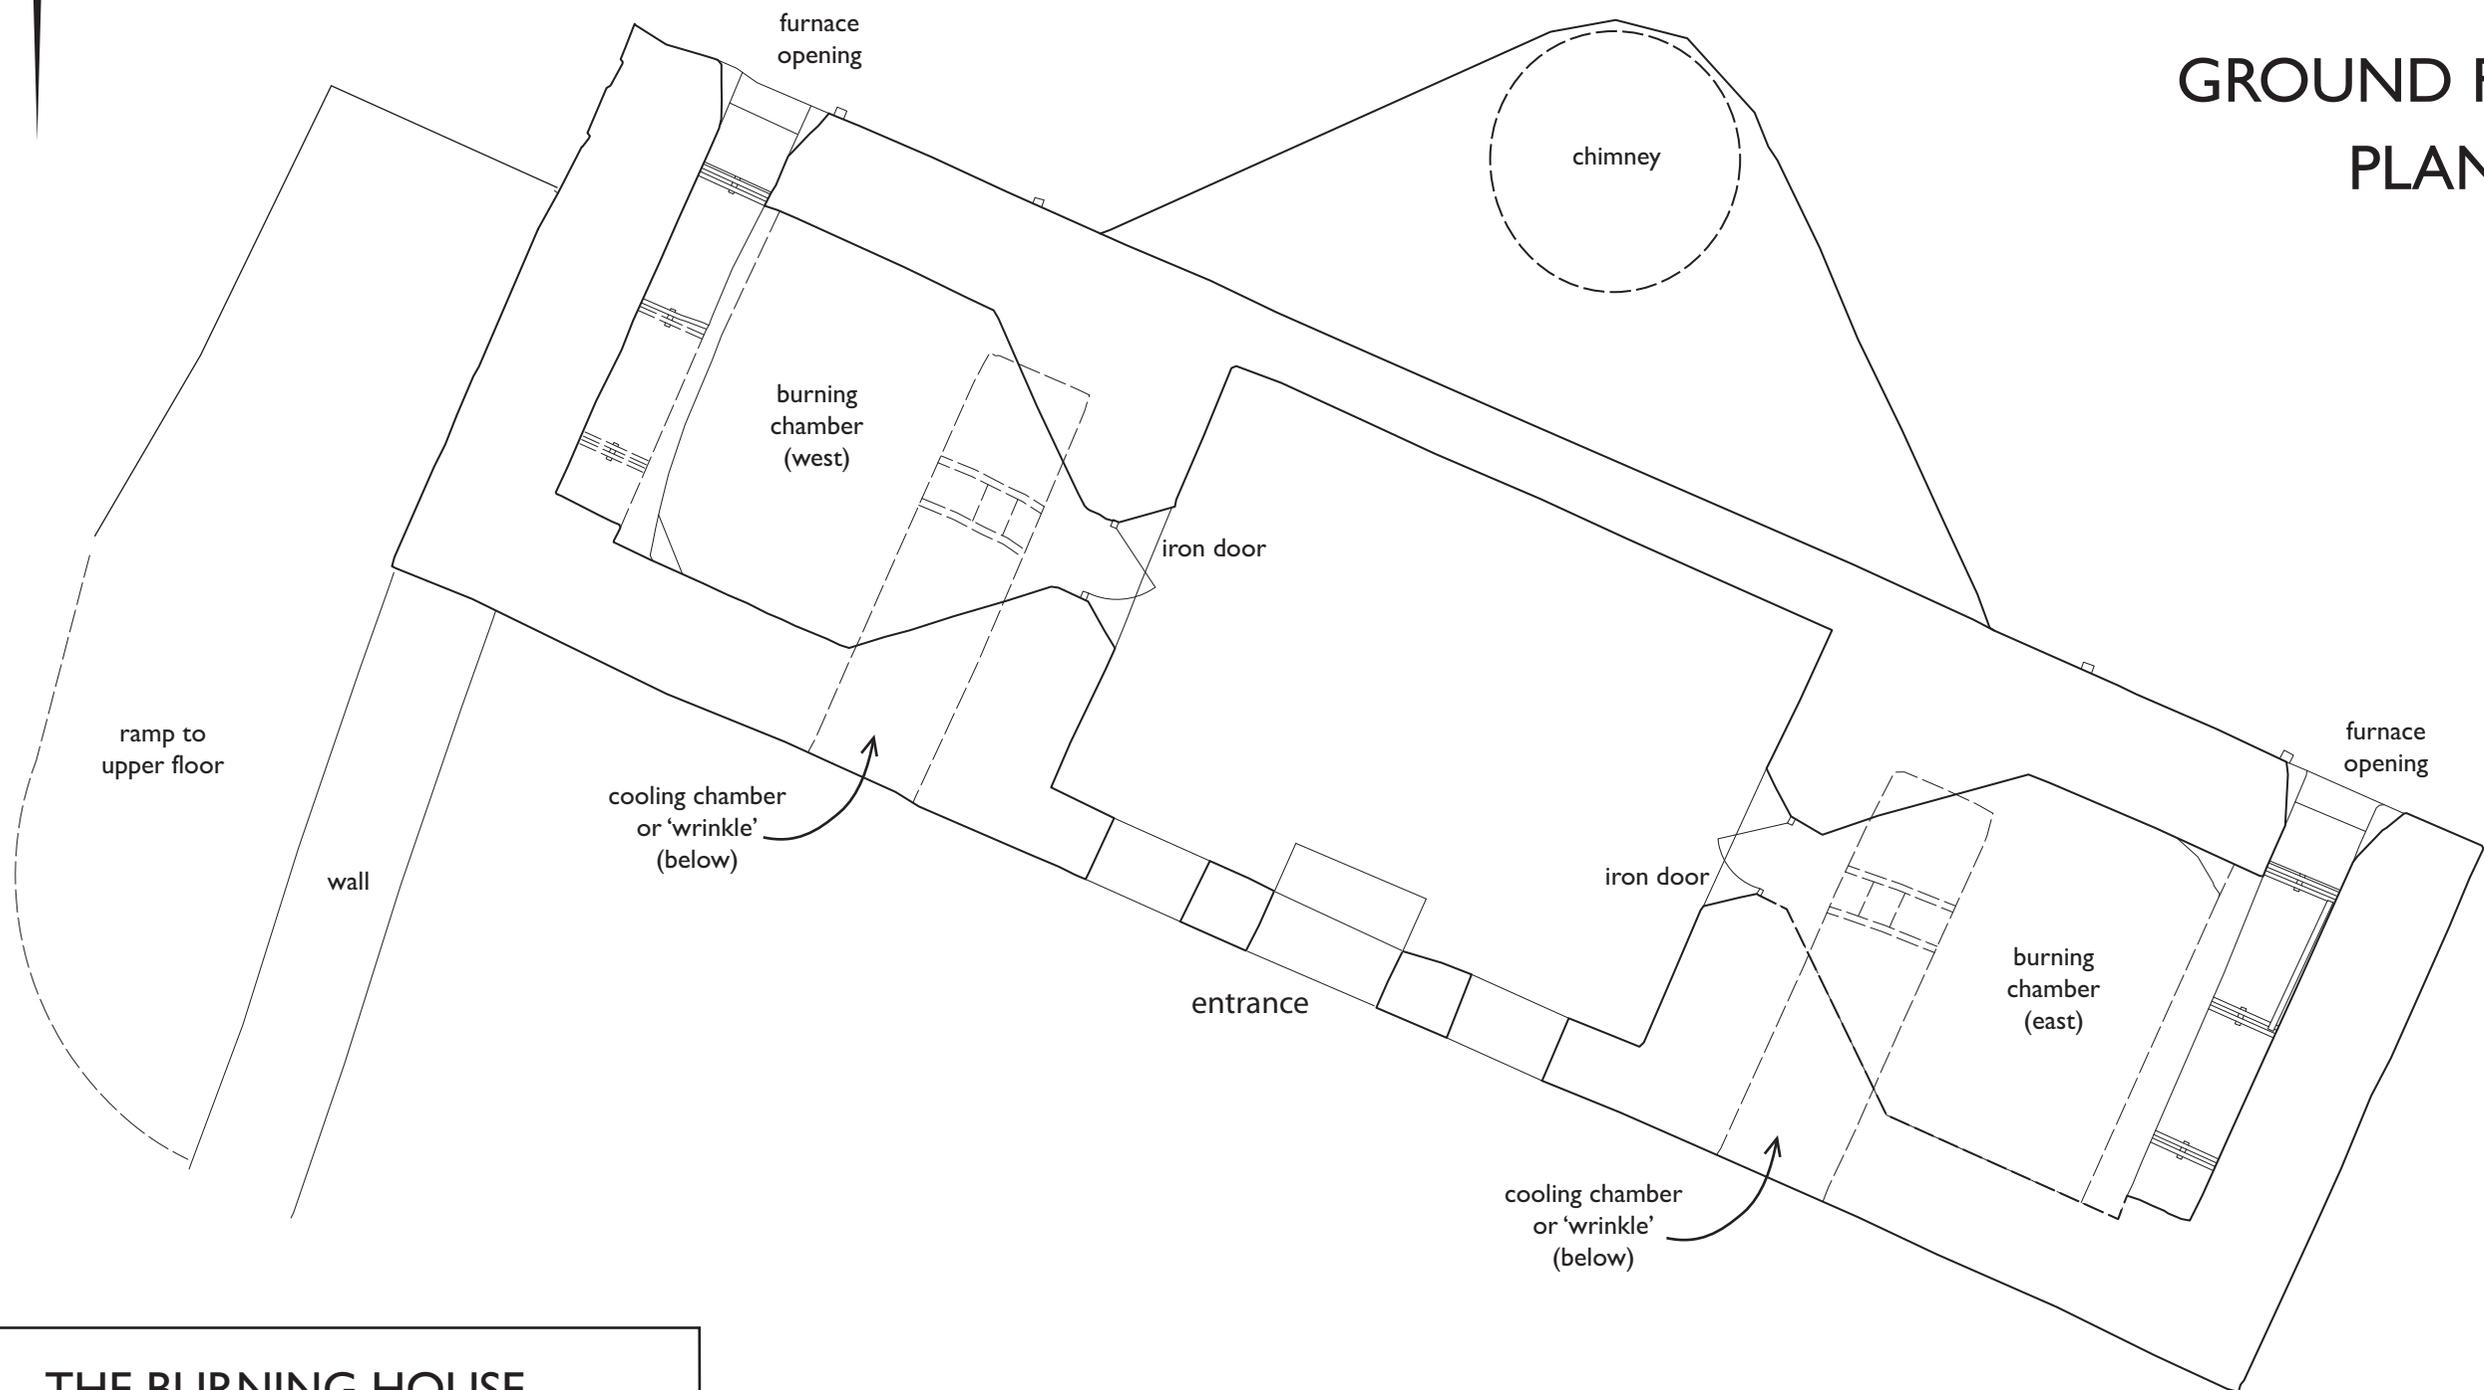
GROUND FLOOR PLAN

Each is built on two levels: the lower level (Appendix 2) contained the furnace at one end, and the burning chamber taking up most of the space. Below the burning chamber, at the opposite end to the furnace, is a cooling chamber. The upper level (Appendix 3) has a brick floor over the burning chamber, and a central drying pan into which ore was fed. This area is enclosed by stone walls and a gable roof.

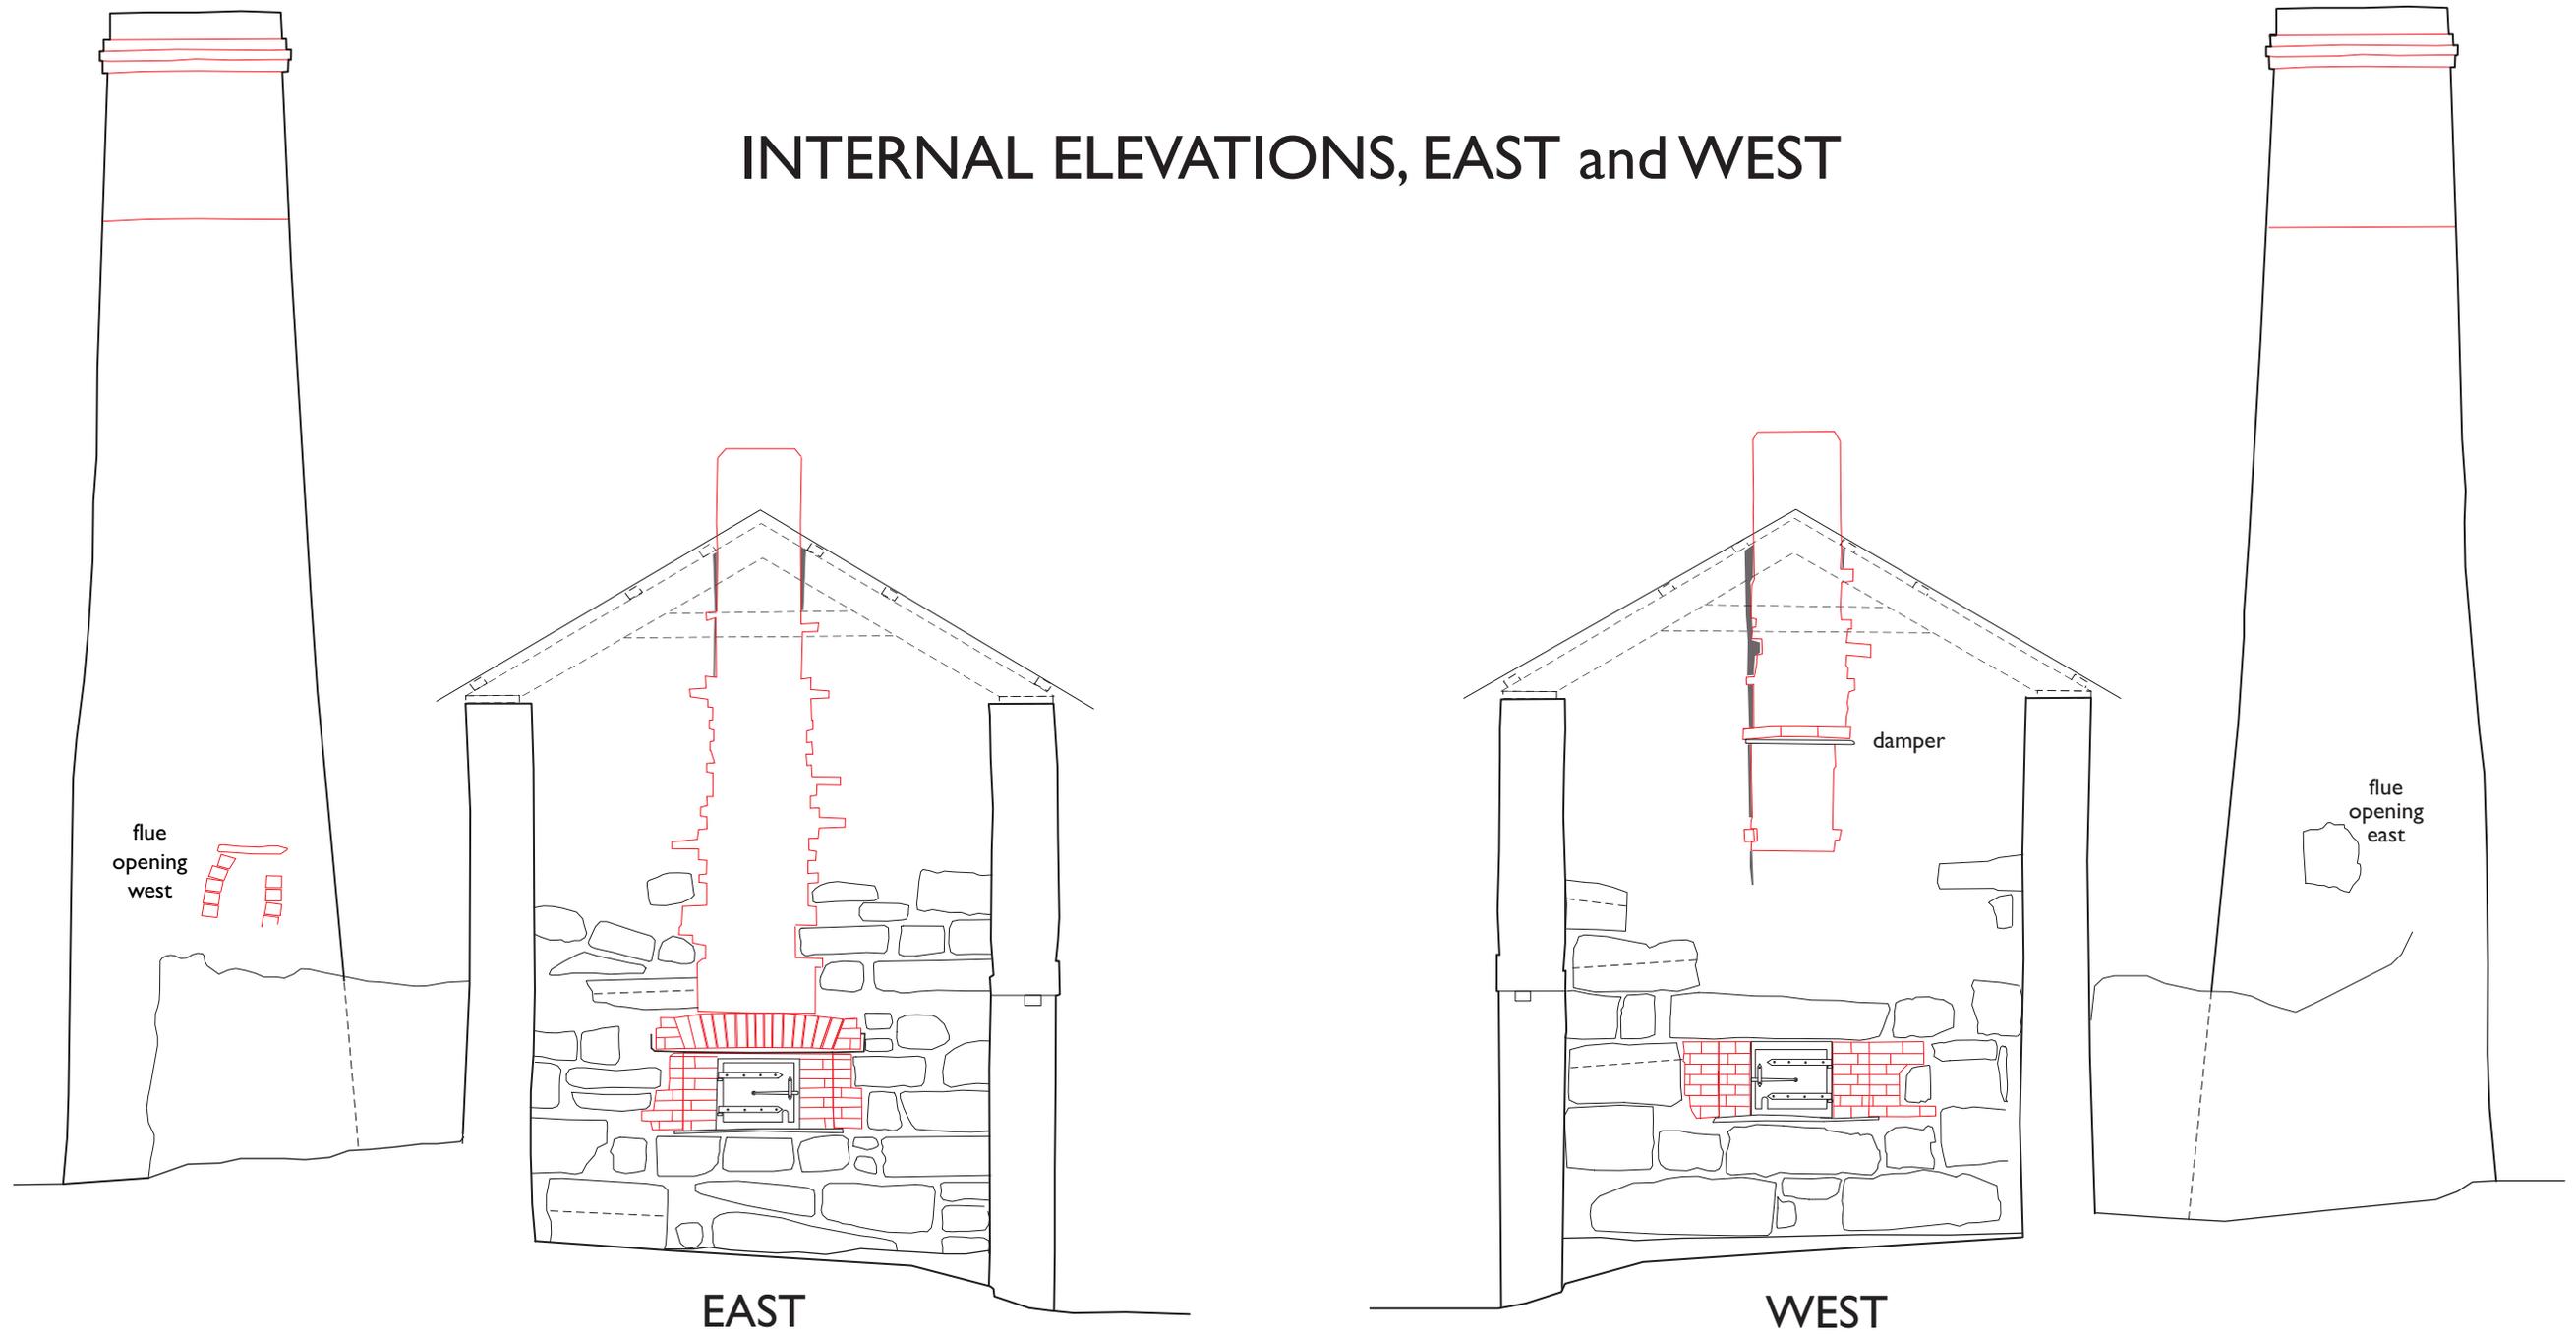
INTERNAL ELEVATIONS, EAST and WEST

Structural movement can be seen on the rear upper wall of the western calciner, and where the brickwork of the internal chimneys connect with the stone work, large cracks have formed, probably due to the ingress of water through gaps in the roof. However, although clearly in need of further consolidation and roof repairs, the building otherwise appears to be holding together.

- brickwork
- structural cracks
- tramline wear marks in granite blocks

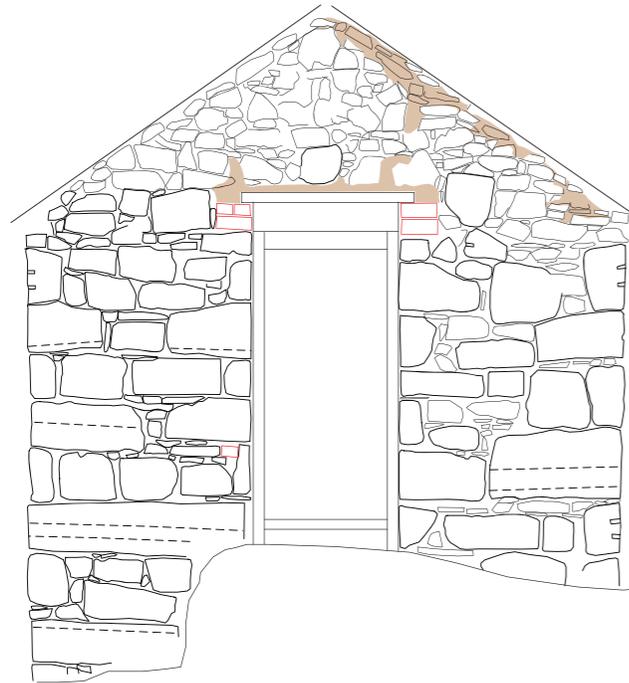
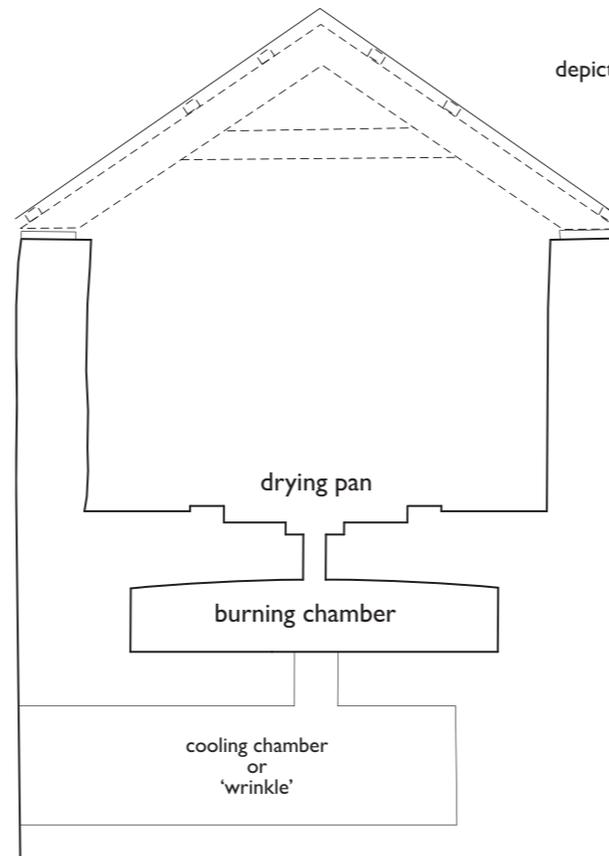
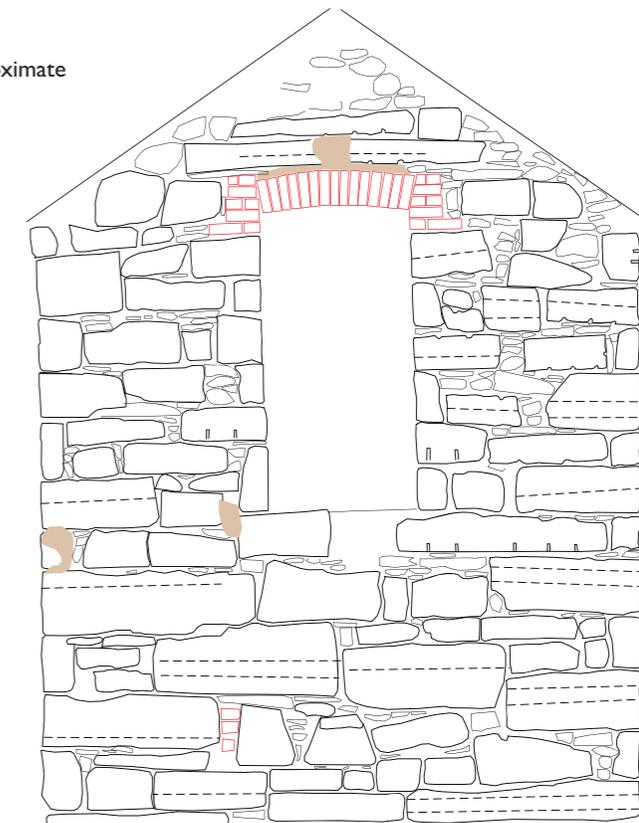
ELEVATION and FABRIC SURVEY
WEST END

The upper floor of both calciners was entered via an external door placed centrally on each end of the building (Appendix 6). Ore could be manhandled or barrowed up to the hopper via a ramp. The ramp on the western end survives *in situ*, comprising a stone revetted structure with a surface sloping to the south. The ramp on the eastern end has been thoroughly effaced, and the entrance was accessible only with the use of a ladder at the time of survey. A timber door and doorframe also survives on the western calciner, but it is not known if it

- patched cement repairs
- tramline wearmarks in granite blocks
- brickwork

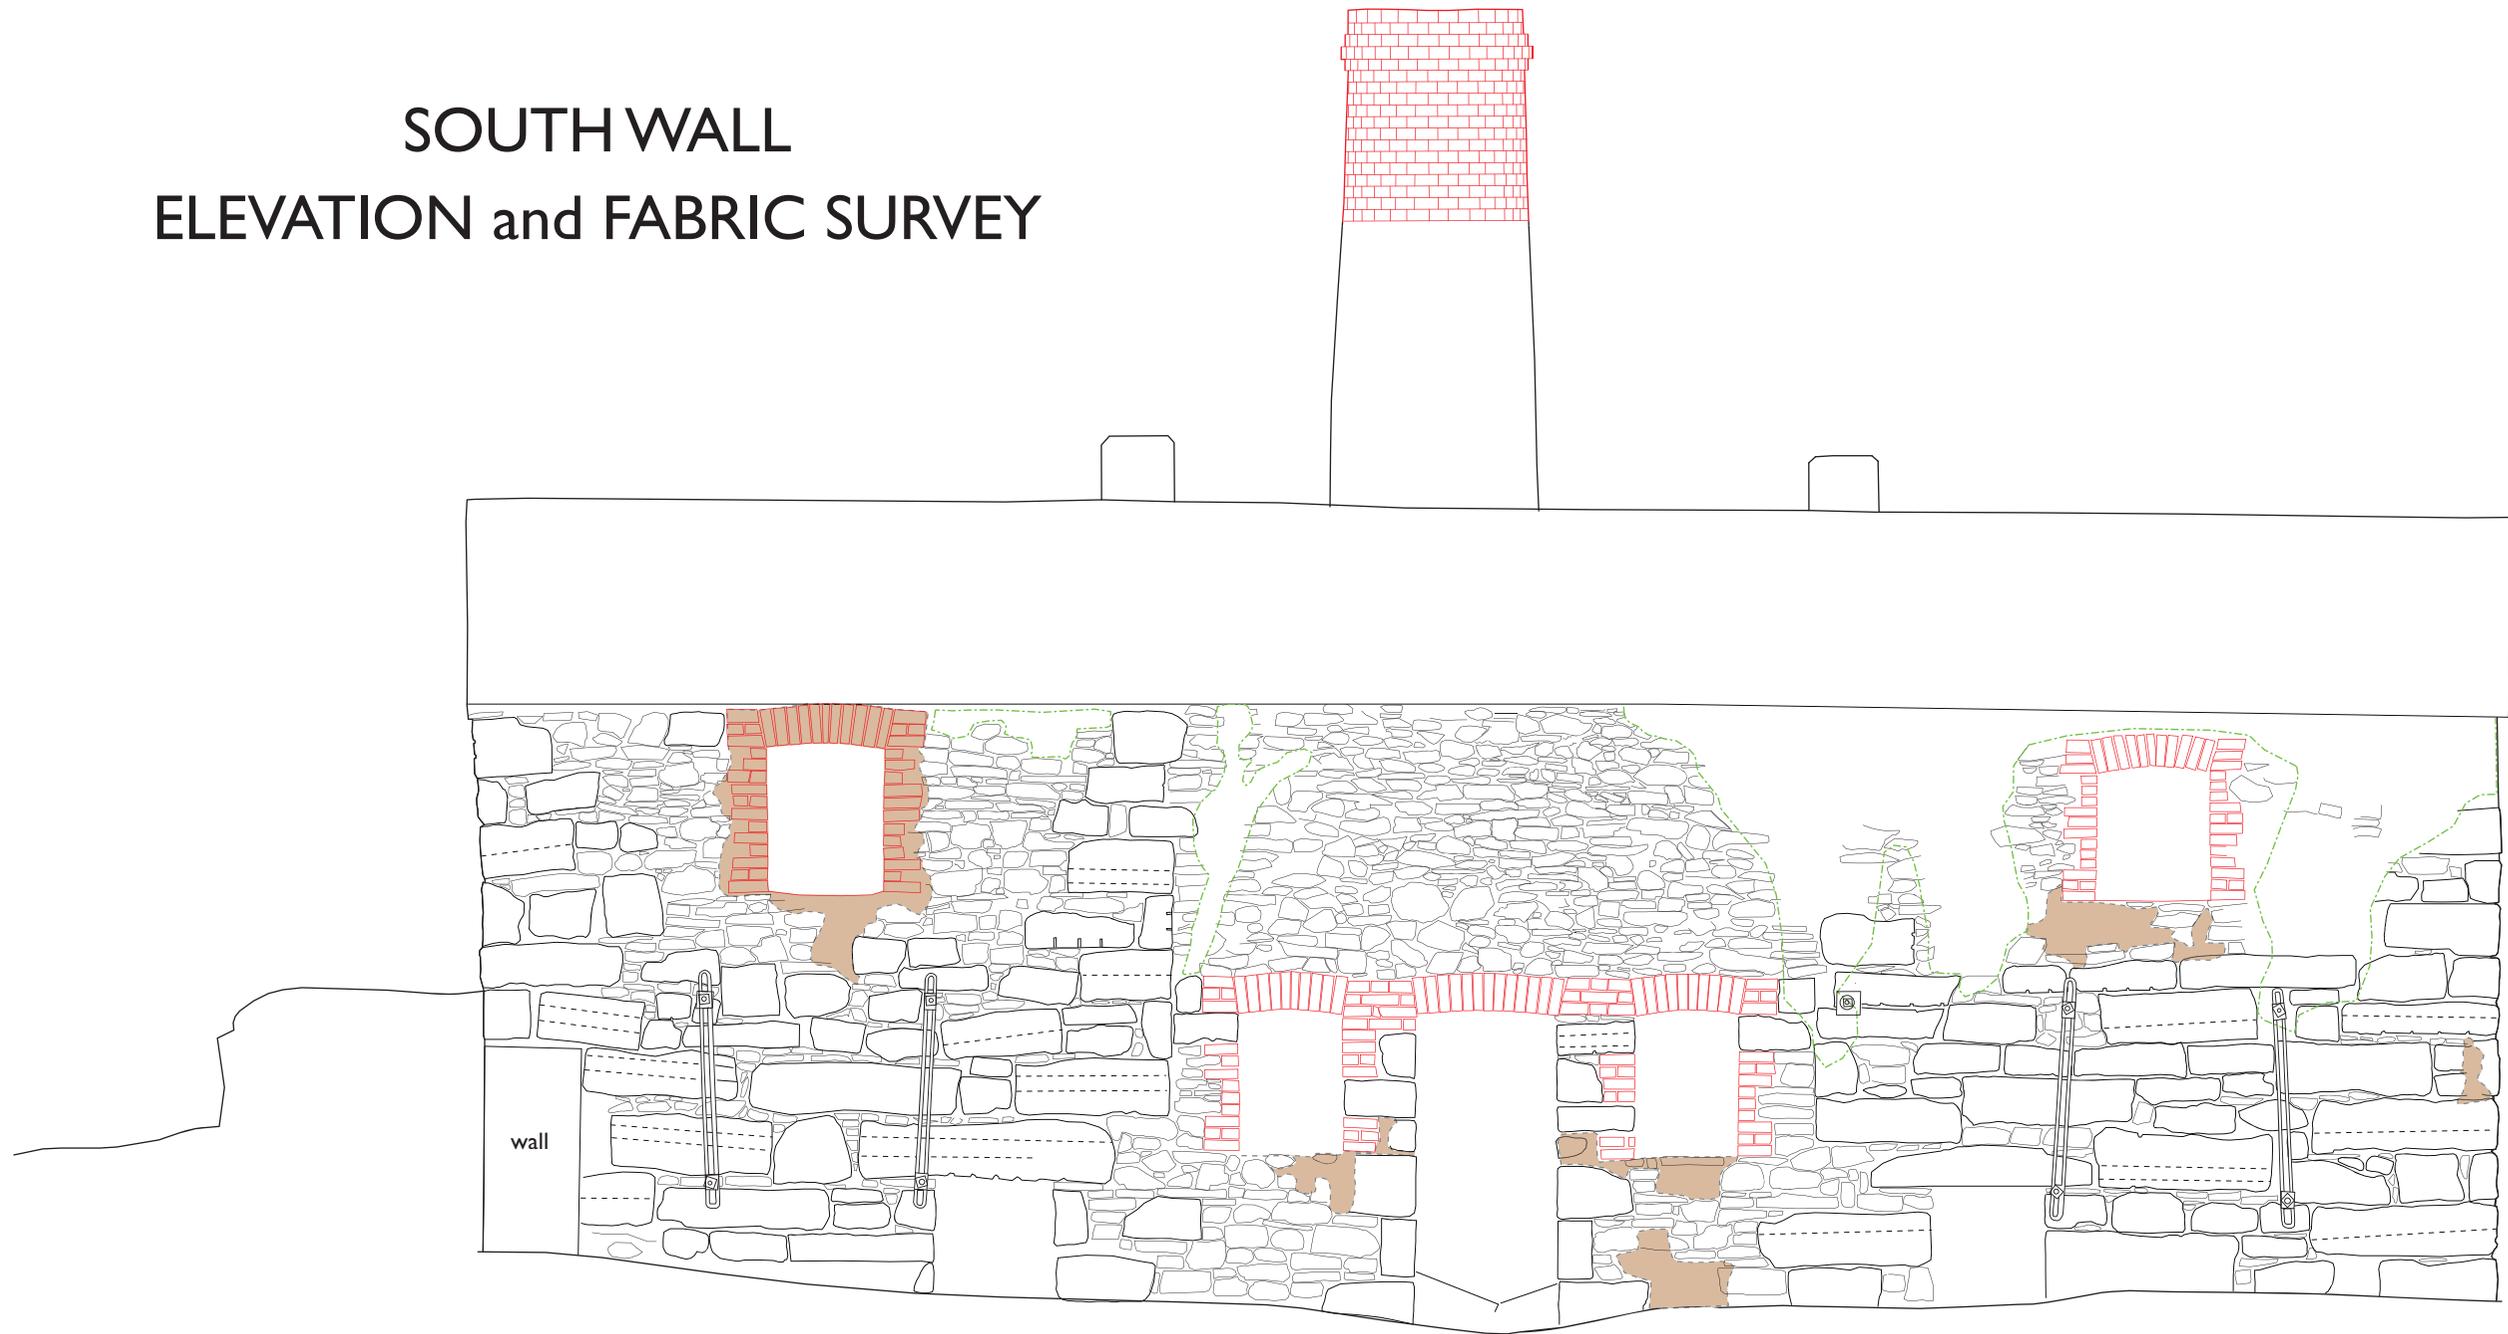
SOUTH WALL ELEVATION and FABRIC SURVEY

- surface obscured by ivy Feb 2009
- patched cement repairs
- tramline wearmarks in granite blocks
- brickwork
