The Burning House at Atlas Mine, Ilsington, Devon

Historic Building Survey

March 2016

Survey and report
by
Phil Newman

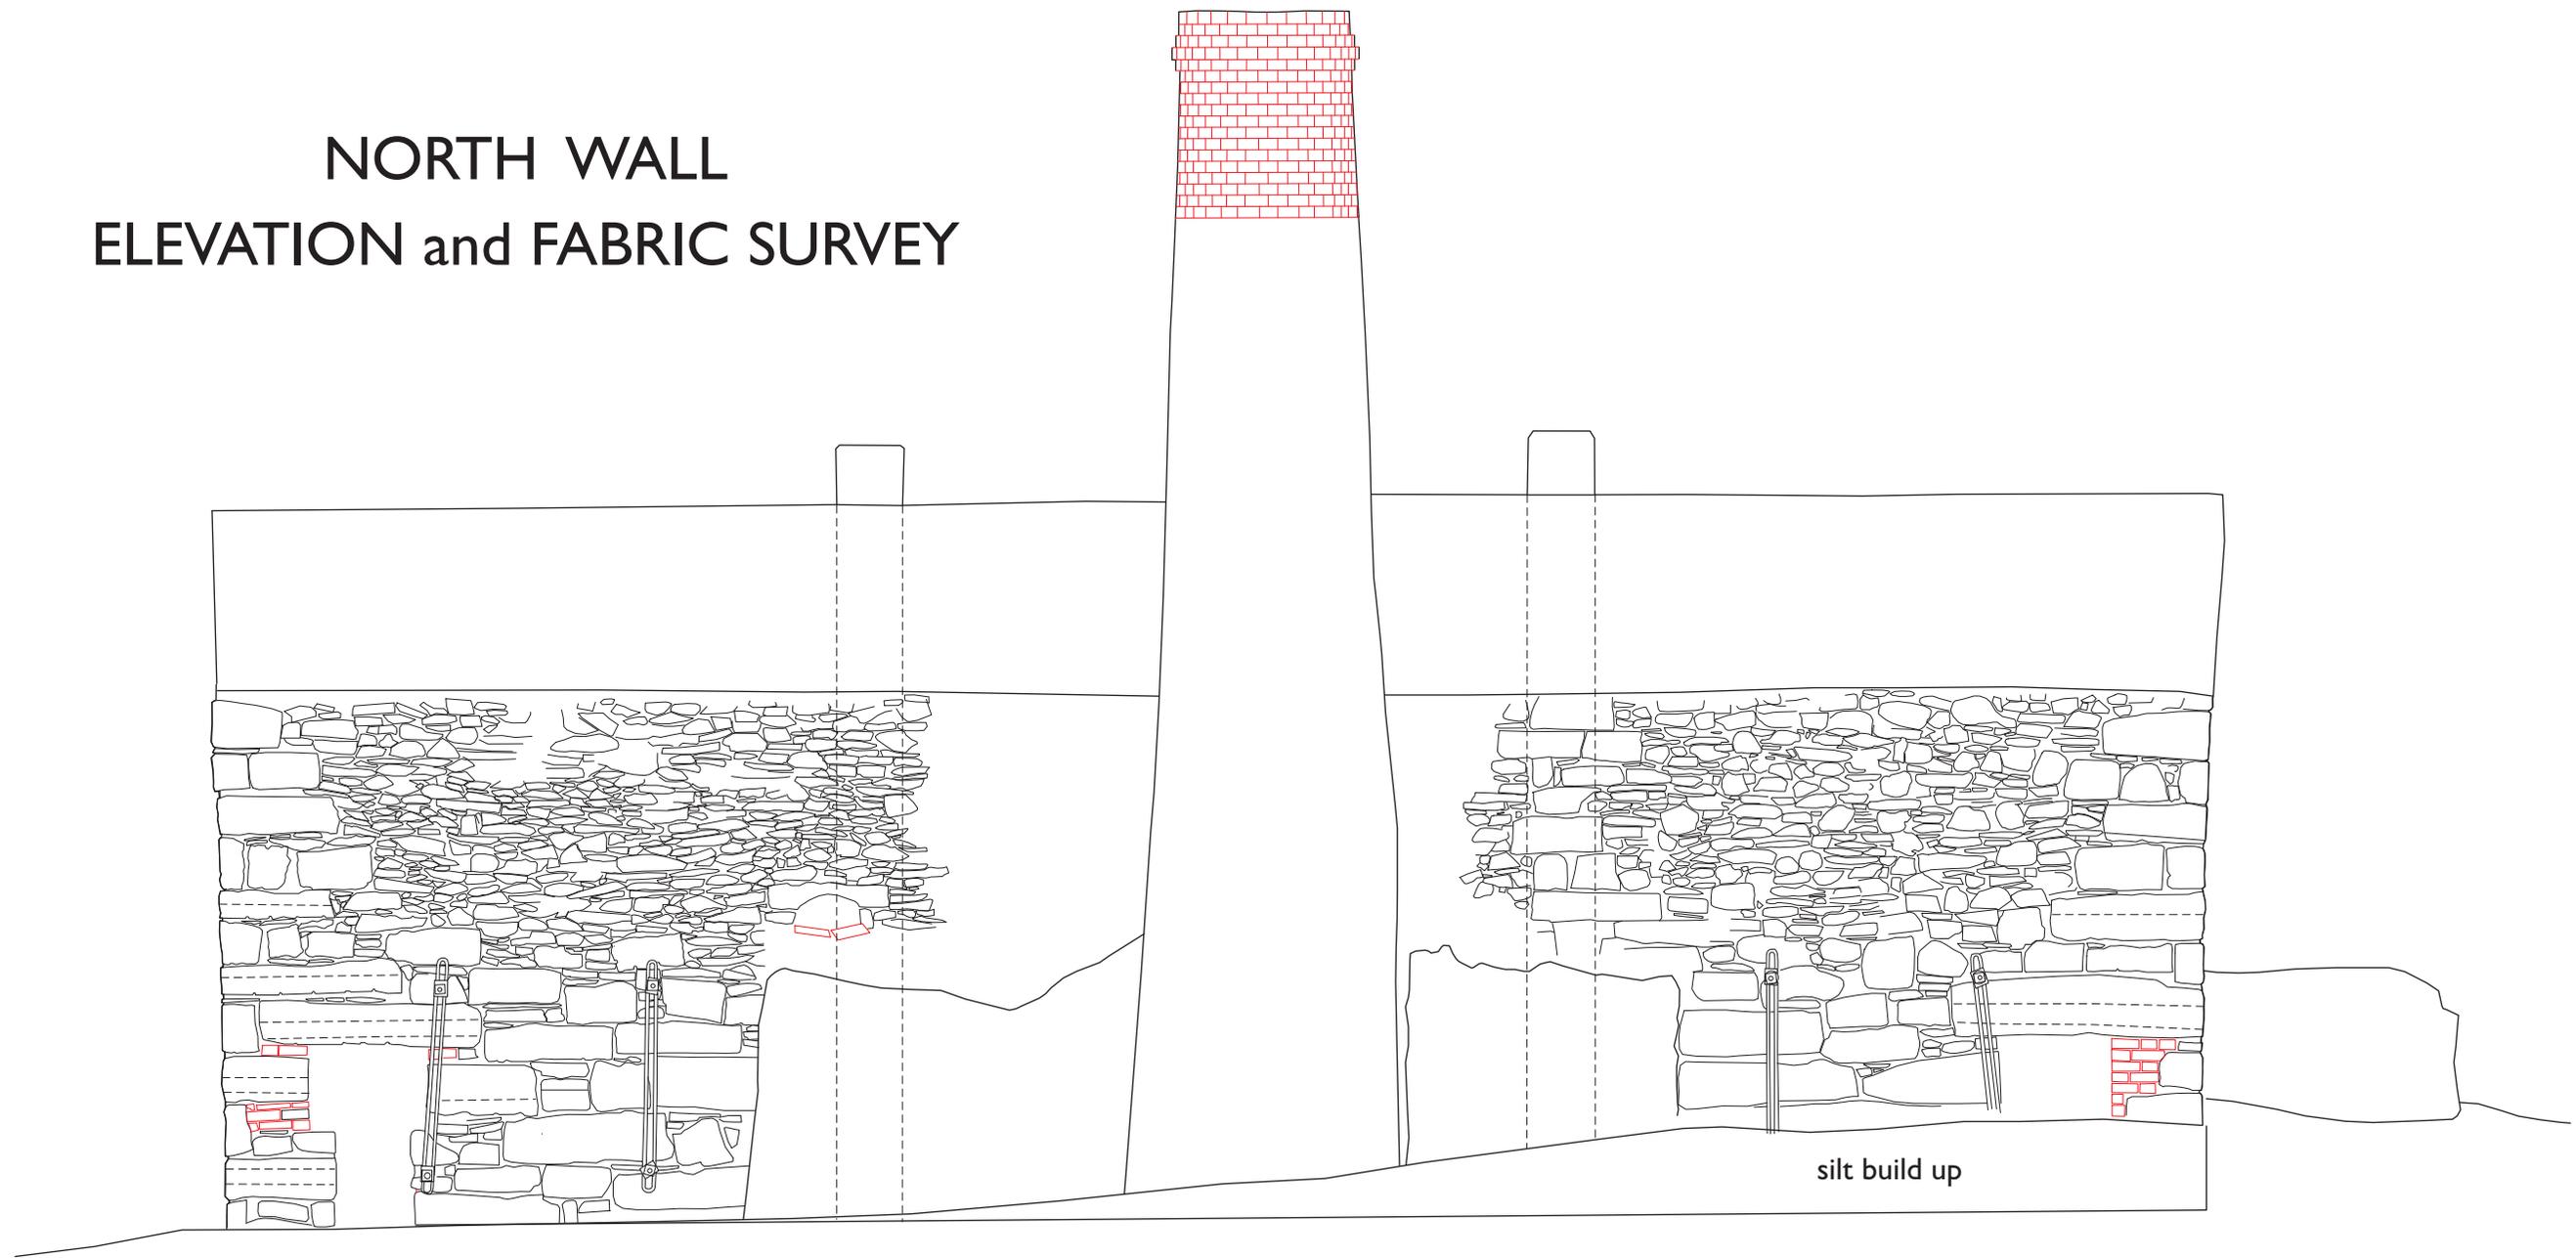
NORTH WALL ELEVATION and FABRIC SURVEY

- surface obscured by ivy Feb 2009
- tramline wearmarks in granite blocks
- brickwork
