The Engine House and Wheel House at Brookwood Mine, Buckfastleigh, Devon

a survey of the standing structures

December 2006
(minor revisions April 2012)

Dr Phil Newman MIFA, FSA

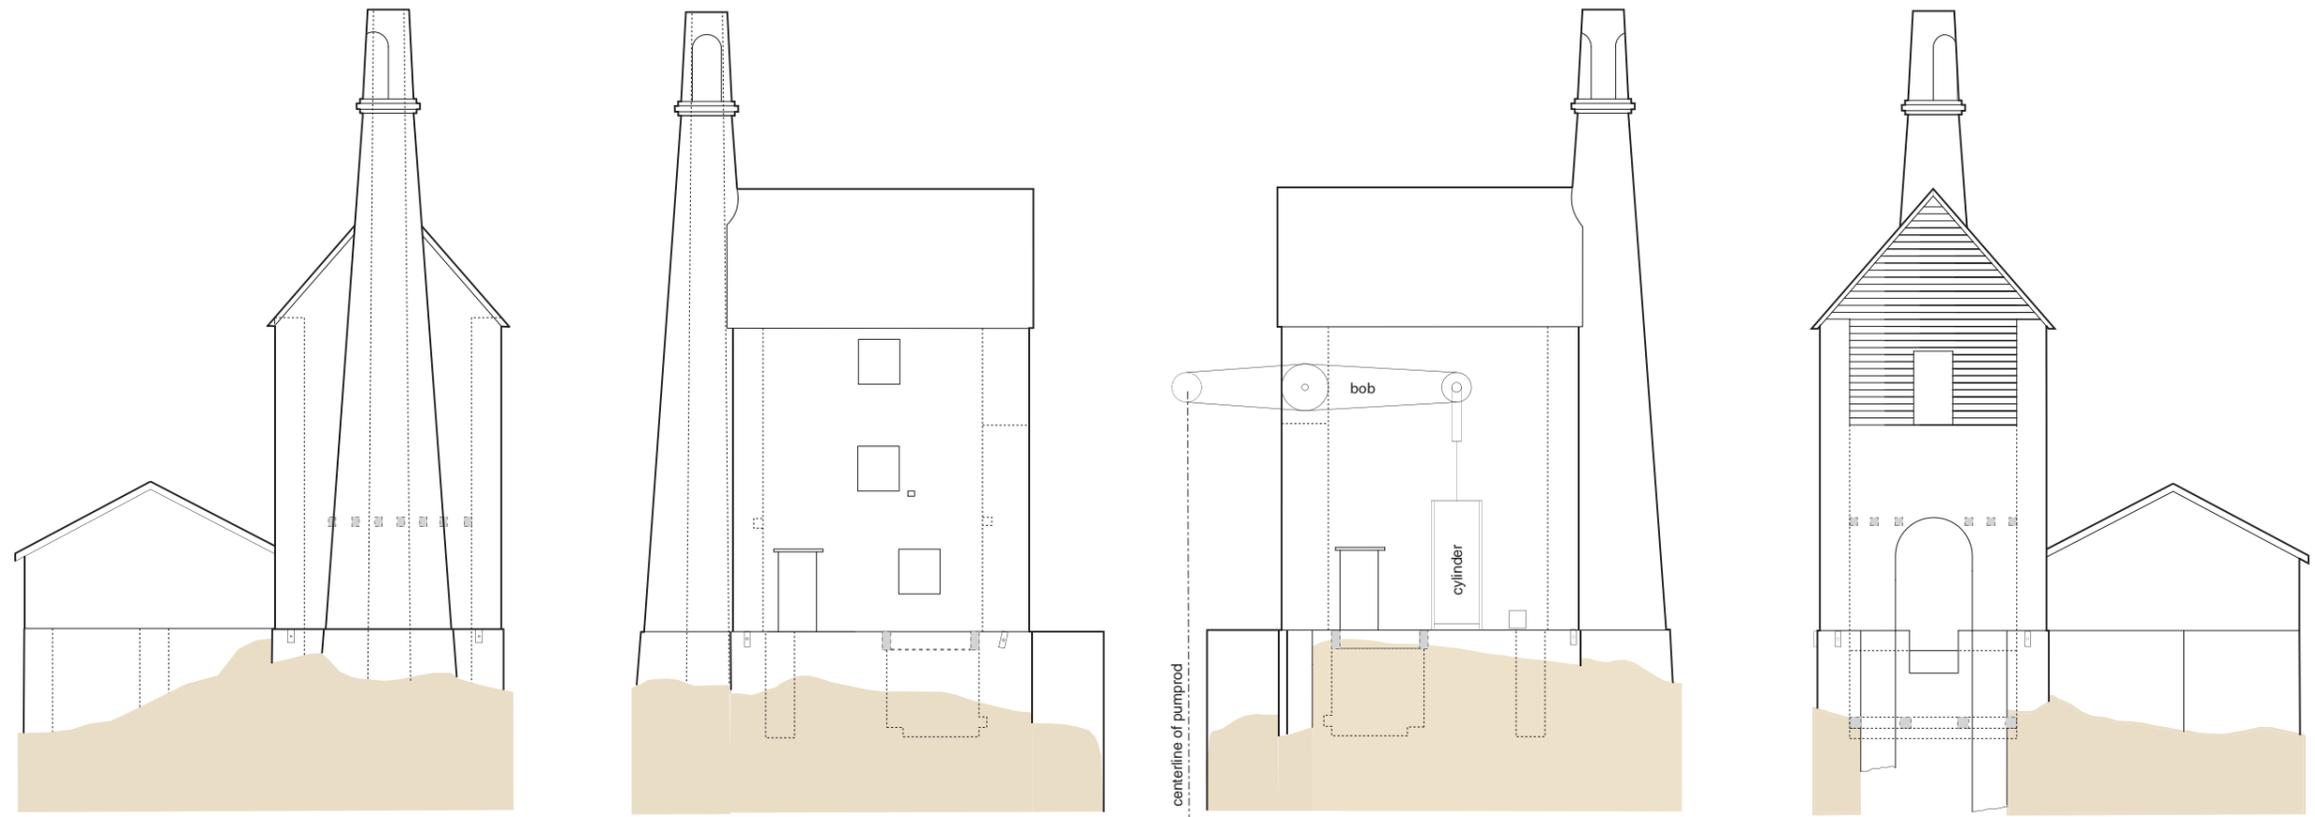
Figure 10
**Brookwood Mine
 Pumping Engine House**
 Reconstruction of walls
 and suggested external appearance

Figure 10 is an interpretation based on dimensions and detail resulting from the survey. To establish the wall heights it has been assumed that the bob wall remains to its original

Although the window positions survive on the lower floors of the south wall, those on the north wall and the upper storeys are based on what is typical on engine houses elsewhere.

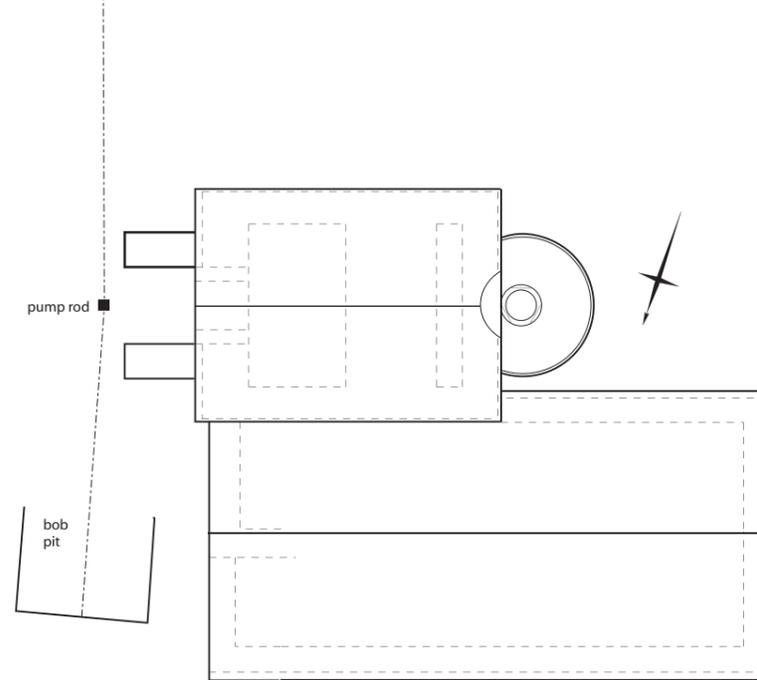
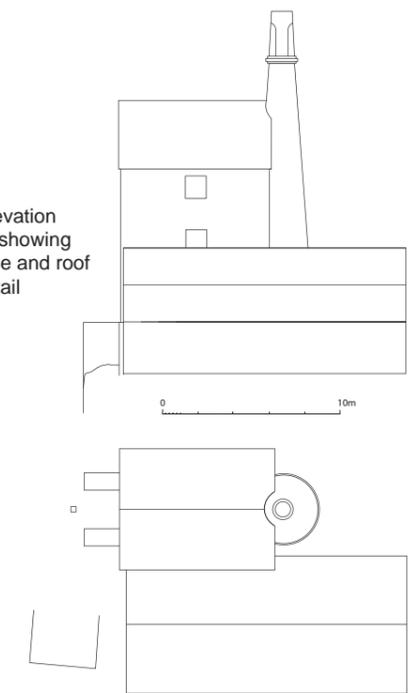
Side elevation
 and plan showing
 boiler house and roof
 detail
