An Archaeological Assessment
of
Castle Plantation,
Milber Down Camp, Newton Abbot, Devon
in advance of damage remediation

March 2015
(revised May 2015)

Phil Newman

Southwest Landscape Investigations

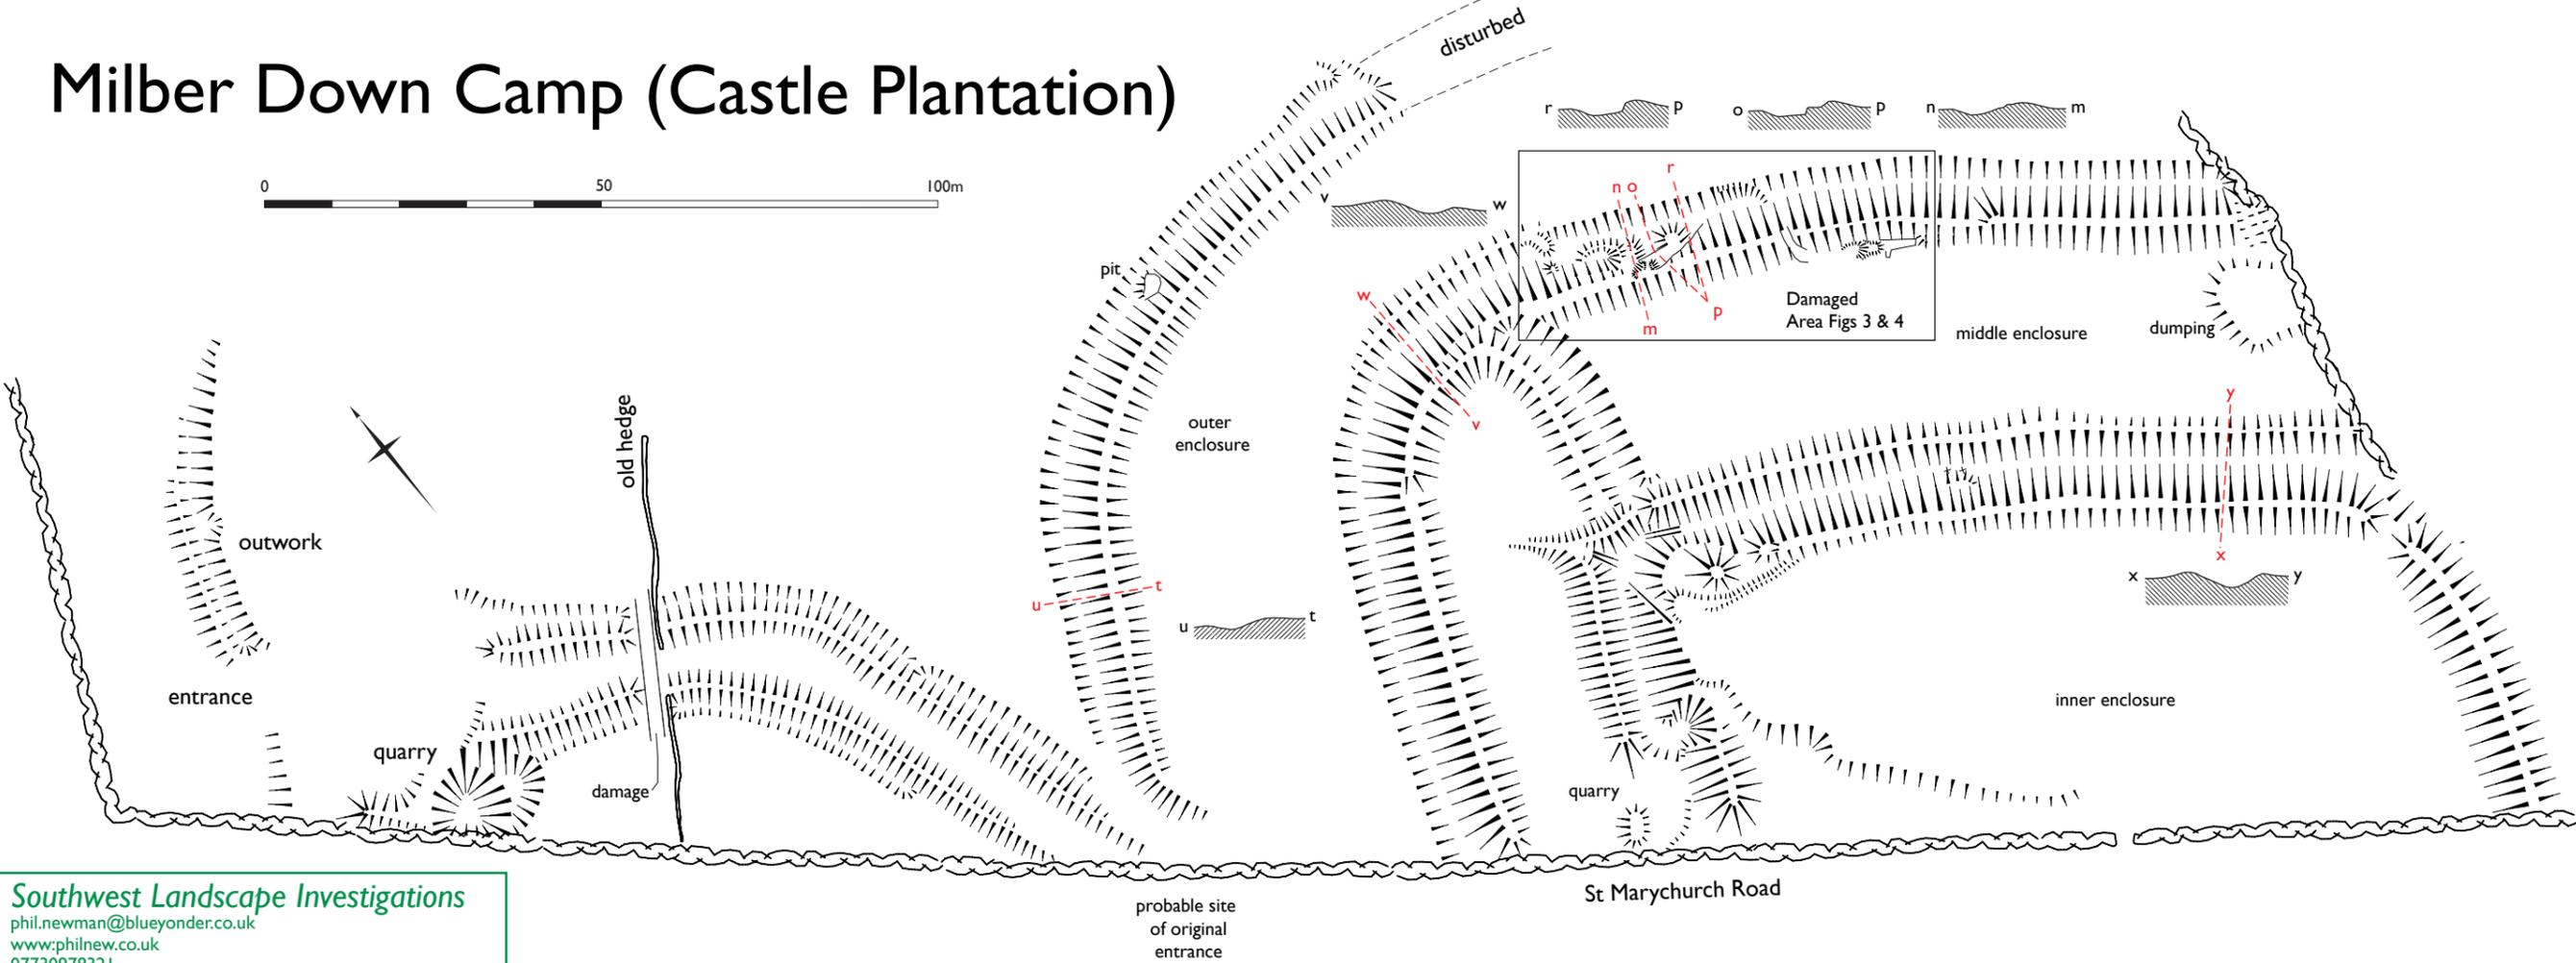
The earthworks of the northern sector of the camp, i.e. north of the St Marychurch road, were surveyed electronically using a total station theodolite from a series of fixed stations on an open traverse. The survey data was downloaded into CAD software then annotated in the field on a tablet computer to produce a 1:1000 earthwork plan with profiles. The same process was used to record the damaged area (Fig 3), although the product was annotated at the larger scale of 1:500.
